# SAFETY RECALL

## Airbag Warning Light - Clockspring

Reference: 14C / NHTSA 25V-765

FCA US LLC

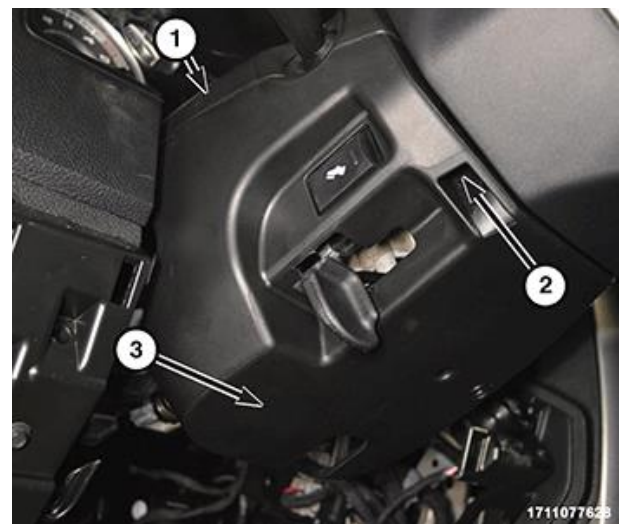
**Figure 1 – Steering Column Upper Shroud**

1. Place the front wheels in the straight-ahead position.
2. Disconnect and isolate the negative battery cable. If equipped with an Intelligent Battery Sensor (IBS), disconnect the IBS connector first before disconnecting the negative battery cable.
3. Wait 2 minutes for capacitor discharge.
4. From below the steering column, remove the two outboard screws within the recess areas (2) that secure the upper shroud (1) to the lower shroud (3) (Figure 1).

5. Remove the upper shroud (1) by pushing gently inward and upward on both sides of the upper shroud above the parting line of the lower shroud to release the snap features that secure the two shroud halves to each other (Figure 1).
6. Release the steering column tilt lever and lower the column to its most downward position for easiest driver airbag removal access.

21. Position the upper shroud (1) onto the steering column over the lower shroud (3) (Figure 1).
22. Align the snaps features on the upper and lower shroud halves and apply hand pressure to snap together.
23. From below the steering column, install the two outboard screws within the recess areas (2) that secure the upper shroud (1) to the lower shroud (3) (Figure 1).

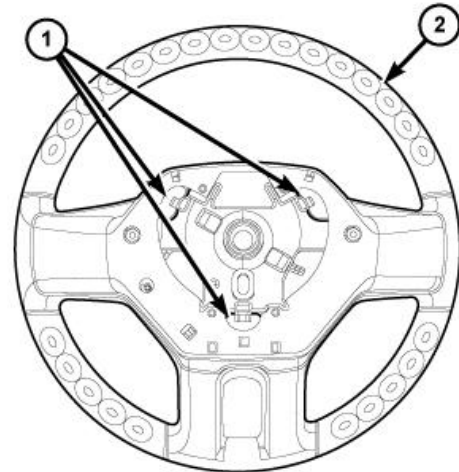
**Figure 2 – Airbag Retainer Access Holes**

7. There are three airbag retainer access holes (1) on the instrument panel side of the hub of the steering wheel (2), located at the two o'clock, six o'clock and ten o'clock positions. The steering wheel must be rotated to bring each of these access holes up to the twelve o'clock position of the steering column one at a time for removal access (Figure 2).

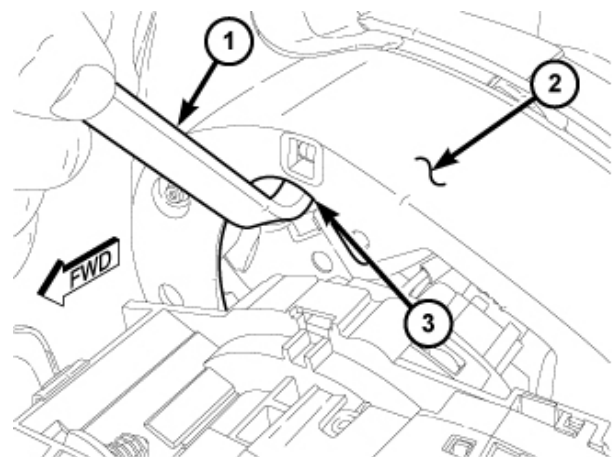
**Figure 3 – DAB Removal Tool 10187**

8. Insert the short blade (Tip A) of the DAB Removal Tool (Special Tool Number 10187 ) (1) or the blade of an equivalent prying tool into either of the upper (two o'clock or ten o'clock) access holes (3) of the steering wheel hub rear trim cover (2), being certain to place the blade of the tool on the inboard (steering wheel hub) side of the airbag snap retainer wire loop (Figure 3).

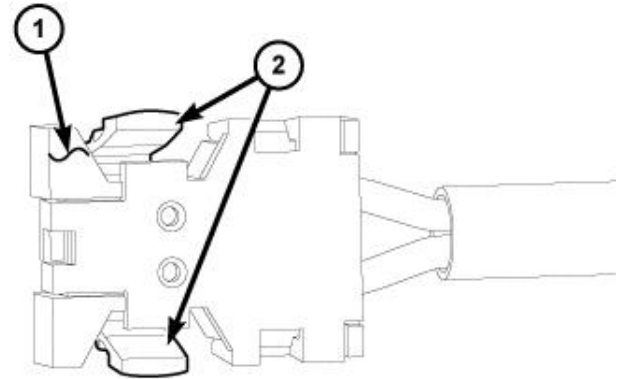
Figure 6 – Connector Insulator Latches

13. The clockspring DAB pigtail wire connector insulators (1) are secured by integral latches (2) to the airbag inflator connector receptacles, which are located on the back of the airbag housing. Pinch both latches firmly, then pull the insulators straight out from the airbag inflator to disconnect them from the connector receptacles (Figure 6).
14. Remove the DAB from the steering wheel.
15. Remove the steering wheel bolt and **DISCARD**.

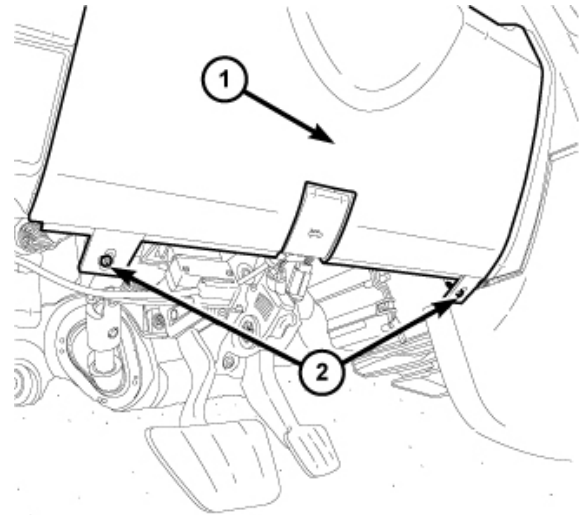
**Figure 8 – Steering Column Opening Cover**

18. Using a trim stick C-4755 or equivalent, disengage the retainer clip that secures the hood release to the steering column opening cover, and remove the hood release handle from the cover (Figure 8).
19. Remove the two fasteners (2) that secure the bottom of the steering column opening cover (1) to the instrument panel (Figure 8).

7. Lift the steering column opening cover into position. Connect necessary wire harness connectors.
8. Align the retainer clips that secure the steering column opening cover (1) to the instrument panel and install the cover (Figure 10).
9. Install the Data Link Connector (3) to the steering column opening cover (2) through the opening on the back side of the cover (Figure 9).
10. Install the two fasteners (2) that secure the bottom of the steering column opening cover (1) to the instrument panel and tighten securely (Figure 8).
11. Engage the retainer clip that secures the hood release to the steering column opening cover (Figure 8).

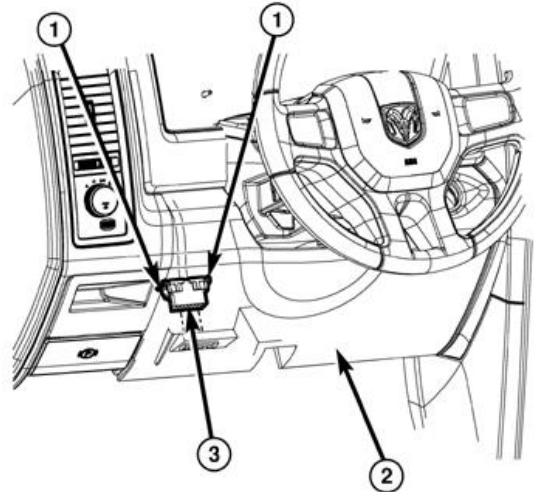
**Figure 9 – Data Link Connector**

20. Remove the Data Link Connector (3) from the steering column opening cover (2) by pressing in the tabs (1) and pushing the connector through the opening on the back side of the cover (Figure 9).

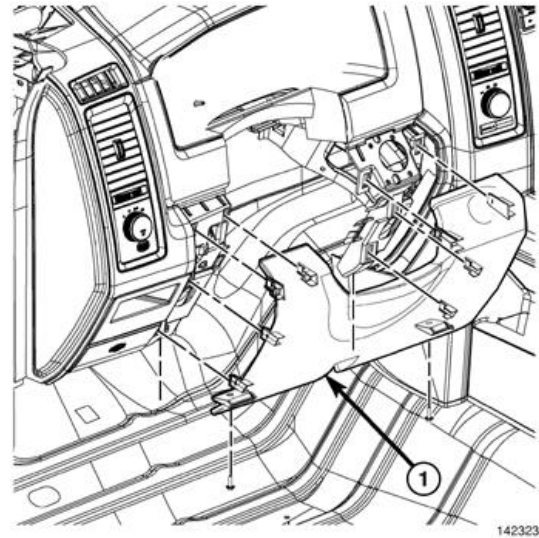
**Figure 10 – Steering Column Opening Cover**

21. Using a trim stick C-4755 or equivalent, release the retainer clips that secure the steering column opening cover (1) to the instrument panel and remove the cover (Figure 10).
22. Disconnect necessary wire harness connectors.

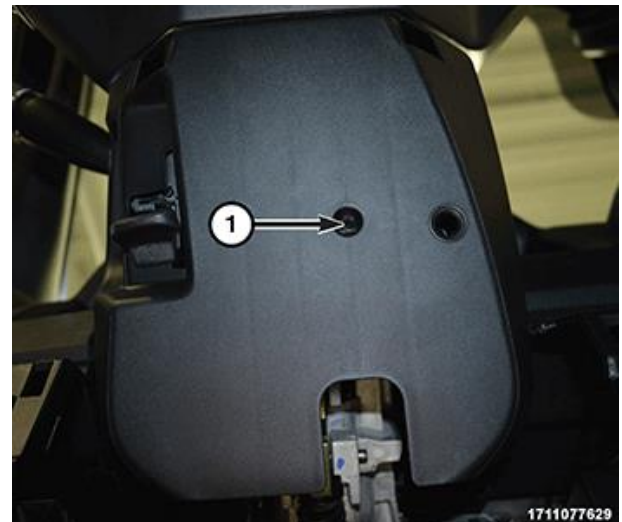
**Figure 11 – Steering Column Lower Shroud**

23. Remove the lower shroud to column retaining screw (1) and carefully move the lower shroud over the steering column tilt lever and off the steering column (Figure 11).

6. Install the lower shroud, shroud to column retaining screw (1) and tighten securely (Figure 11).

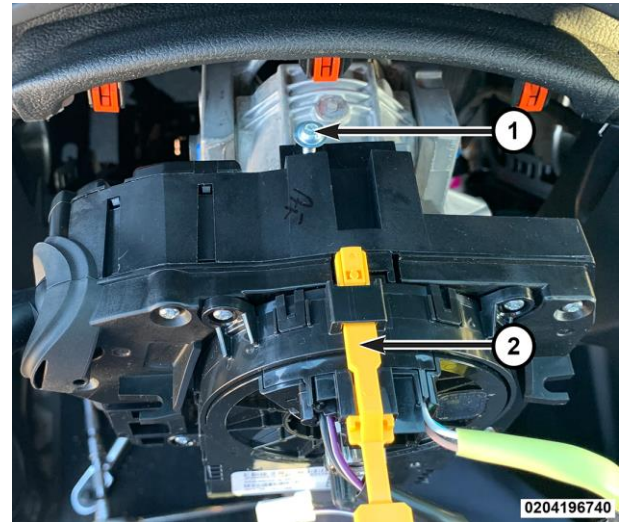
Figure 12 – SCCM Screw

24. Remove the screw (1) (Figure 12).

1. Connect the wire harness connectors (2&3) (Figure 14).
2. Secure the wire harness routing clip (1) (Figure 14).
3. While sliding the SCCM over the steering column connect the pedal adjustment wire harness connector, if equipped.
4. Install and securely tighten the screws (1) (Figures 12 & 13).
5. Remove the lock tab or any other device that is being used to secure the SCCM rotor to the SCCM case to maintain SCCM centering.

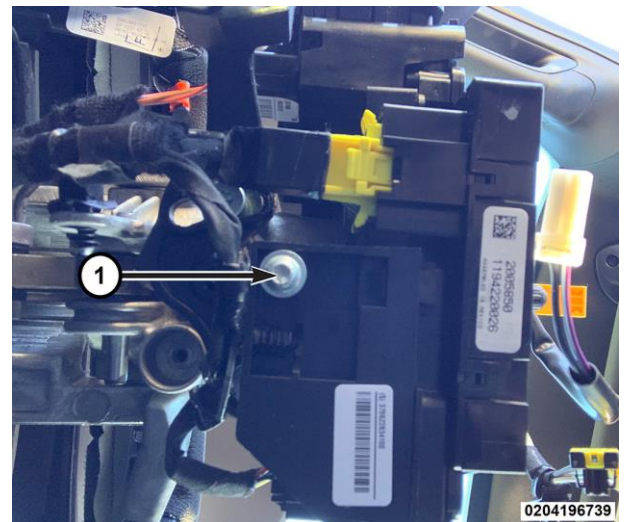
Figure 13 – SCCM Screw

25. Remove the screw (1) (Figure 13).
26. Pull the SCCM slightly away from the steering column and disconnect the pedal adjustment wire harness connector, if equipped.

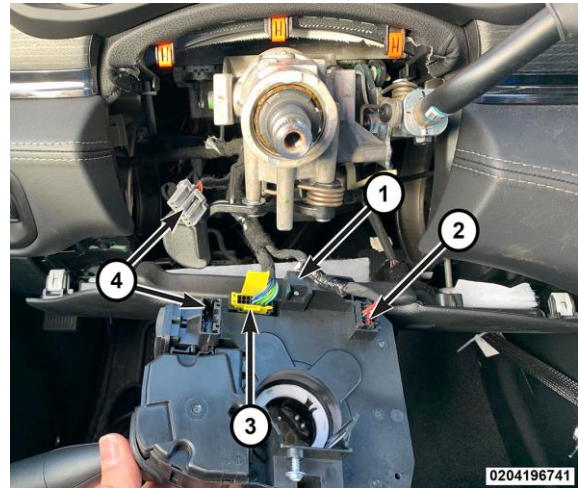
Figure 14 – SCCM Removal

27. Remove the SCCM from the steering column (Figure 14).
28. Disengage the wire harness routing clip (1) (Figure 14).
29. Disconnect the wire harness connectors (2 & 3) (Figure 14).
30. Remove the SCCM from the vehicle.

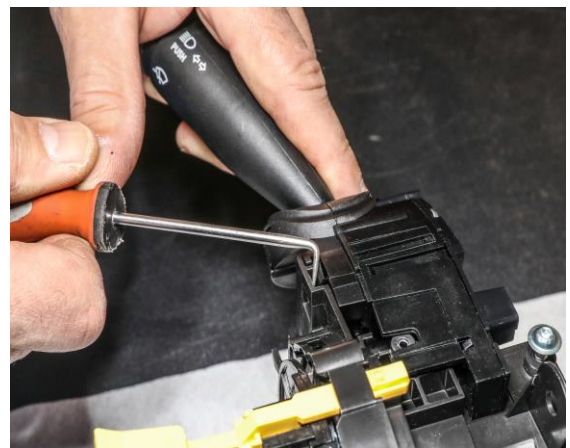
Figure 15 – SCCM Stalk

31. Release the stalk tab from the old SCCM (Figures 15).
32. Remove the stalk from the old SCCM (Figures 16).
33. Discard the old SCCM
34. Transfer the old stalk to the **NEW** SCCM (Figure 16).

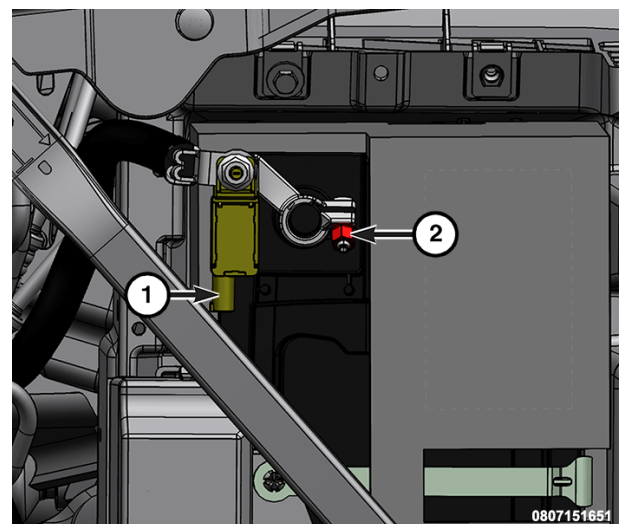
Figure 19 – IBS Connector

2. Disconnect the Intelligent Battery Sensor (IBS) wire harness connector (1) (Figure 19).

3. Loosen the ground terminal nut (2) and remove the negative battery cable with IBS from the battery and isolate it.

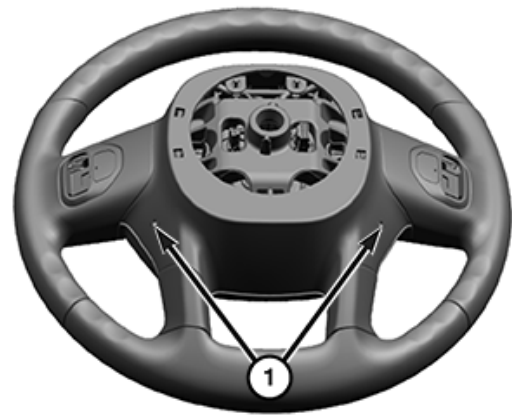
**Figure 20 – DAB Removal**

5. Wait 2 minutes for capacitor discharge.
6. Locate the access hole dimples (1) in the lower surface of the steering wheel hub rear trim cover near each of the two horizontal spokes.
7. Using the Remover, Driver Air Bag 2050200100, pierce the trim cover at the dimple and insert it through one of the steering wheel access holes. A guide and notch integral to each side of the steering wheel hub rear trim cover and the mounting/horn switch plate will assist in directing the tool to the ends of the retainer spring (Figure 20).

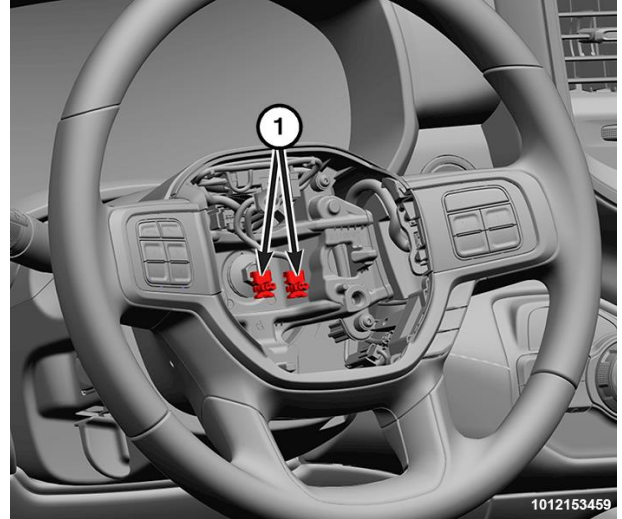
**Figure 21 – Steering Wheel Wire Harness Connectors**

11. Pull the DAB away from the steering wheel far enough to access the steering wheel wire harness connector to the DAB inflator initiators (1) (Figure 21).

13. Connect the two steering wheel wire harness connectors (Figure 21).
14. Position the DAB close enough to the steering wheel to connect the steering wheel wire harness connectors to the DAB inflator initiators (1) (Figures 21 and 22).

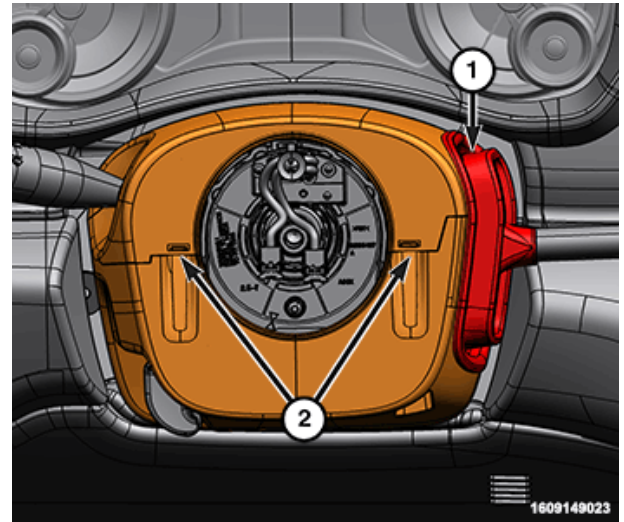
Figure 24 – Steering Column Shroud

18. If equipped, release the shifter boot (1) from the steering column shroud (Figure 24).
19. Disengage the upper steering column shroud tabs (2) from the lower steering column shroud (Figure 24).

7. Install the upper steering column shroud to the lower steering column shroud (Figure 24).
8. If equipped, install the shifter boot to the steering column shroud.

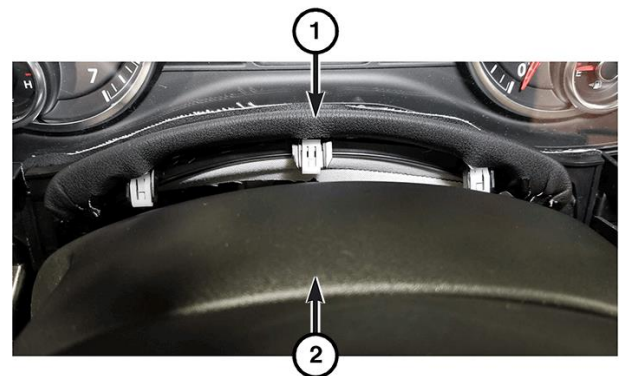
Figure 25 – Gap Hider

20. Disengage the gap hider (1) from the upper steering column shroud (2) and remove the upper steering column shroud (Figure 25).

6. Engage the upper steering column shroud (2) to the gap hider (1) (Figure 25). **Verify that the top shroud is properly secured to the gap hider. Move the tilt column up and down to ensure the gap hider stays connected to the upper shroud.**

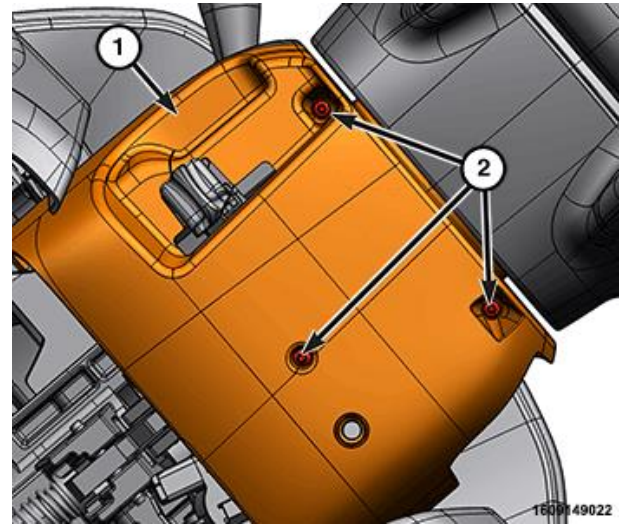
Figure 26 – Lower Steering Column Shroud

21. Remove the lower steering column shroud screws (2), then the shroud (1) (Figure 26).

4. Install and securely tighten the SCCM screws (1) (Figure 27 and 28).
5. Position the lower steering column (1) shroud to the steering column (Figure 26).

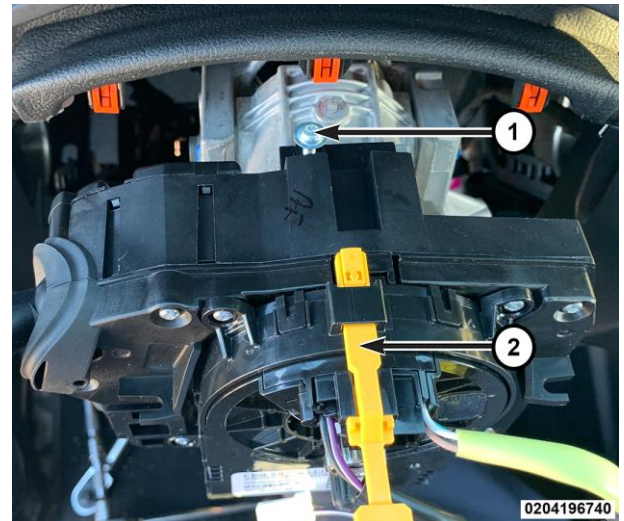
Figure 27 – SCCM

22. Secure the SCCM in the straight-ahead position.
23. Remove the screws (1) (Figure 27 and 28).

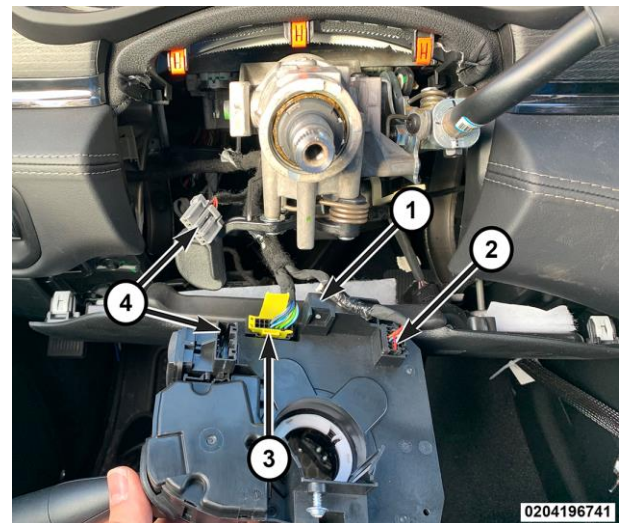
Figure 29 – SCCM

24. Pull the SCCM slightly away from the steering column and disconnect the pedal adjustment wire harness connector (4), if equipped (Figure 29).
25. Remove the SCCM from the steering column.
26. Disengage the wire harness routing clip (1) (Figure 29).
27. Disconnect the wire harness connectors (2 & 3) (Figure 29).
28. Remove the SCCM from the vehicle.

1. Connect the wire harness connectors (2 & 3) (Figure 29).
2. Secure the wire harness routing clip (1) (Figure 29).
3. While sliding the **NEW** SCCM over the steering column connect the pedal adjustment wire harness connector.

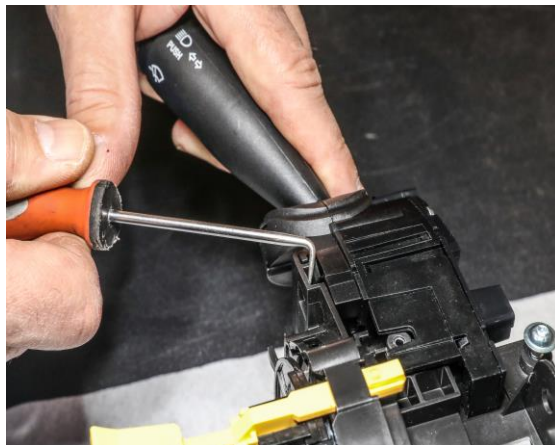
**Figure 30 – Stalk Tab**

29. Release the stalk tab from the old SCCM (Figures 30).
30. Remove the stalk from the old SCCM (Figures 31).
31. Discard the old SCCM.
32. Transfer the old stalk to the **NEW** SCCM.
