SAFETY RECALL

Airbag Warning Light - Clockspring

Reference: 14C / NHTSA 25V-765

2021-2022 (D2) Ram 3500 Pickup

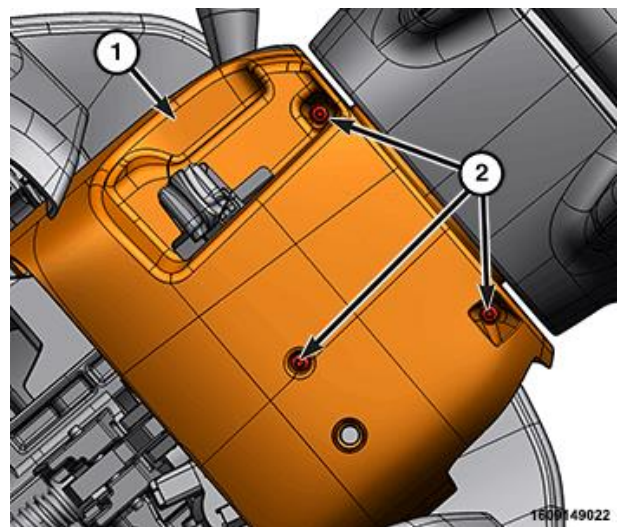
Figure 23 – Steering Column Shroud Screws

17. Remove the three steering column shroud screws (Figure 23).

9. Install and securely tighten the three steering column shroud screws (2) (Figure 23).
10. If equipped, connect the heated steering wheel wire harness connectors and secure the steering wheel wire harness.

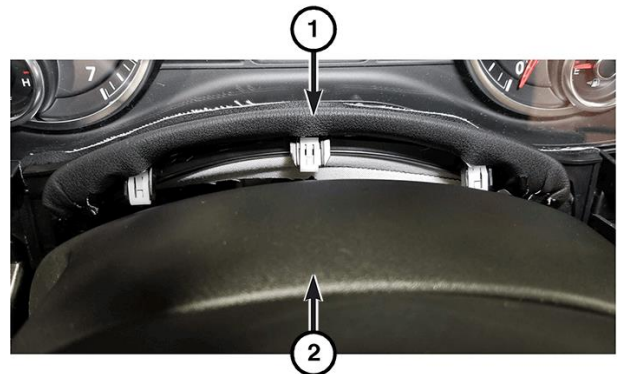
Figure 25 – Gap Hider

20. Disengage the gap hider (1) from the upper steering column shroud (2) and remove the upper steering column shroud (Figure 25).

6. Engage the upper steering column shroud (2) to the gap hider (1) (Figure 25). **Verify that the top shroud is properly secured to the gap hider. Move the tilt column up and down to ensure the gap hider stays connected to the upper shroud.**

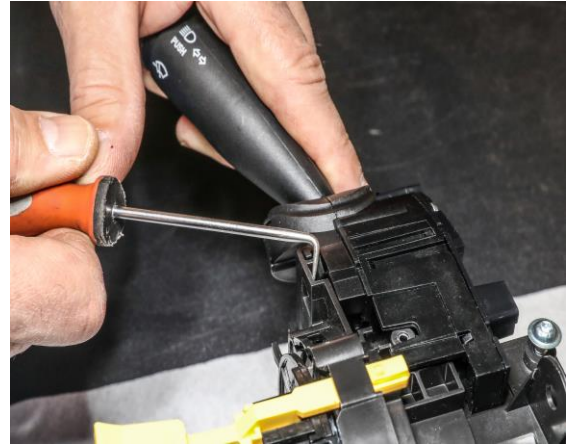
Figure 30 – Stalk Tab

29. Release the stalk tab from the old SCCM (Figures 30).
30. Remove the stalk from the old SCCM (Figures 31).
31. Discard the old SCCM.
32. Transfer the old stalk to the **NEW** SCCM.
