## Safety Recall Launch Notification

| Campaign # | NHTSA ID | Description | <b>Update Battery Management System Software</b> |

| Total Recall Population | 169 | <b>Model(s)/<br/>Platform(s)</b> | EQB SUV (243 platform) |

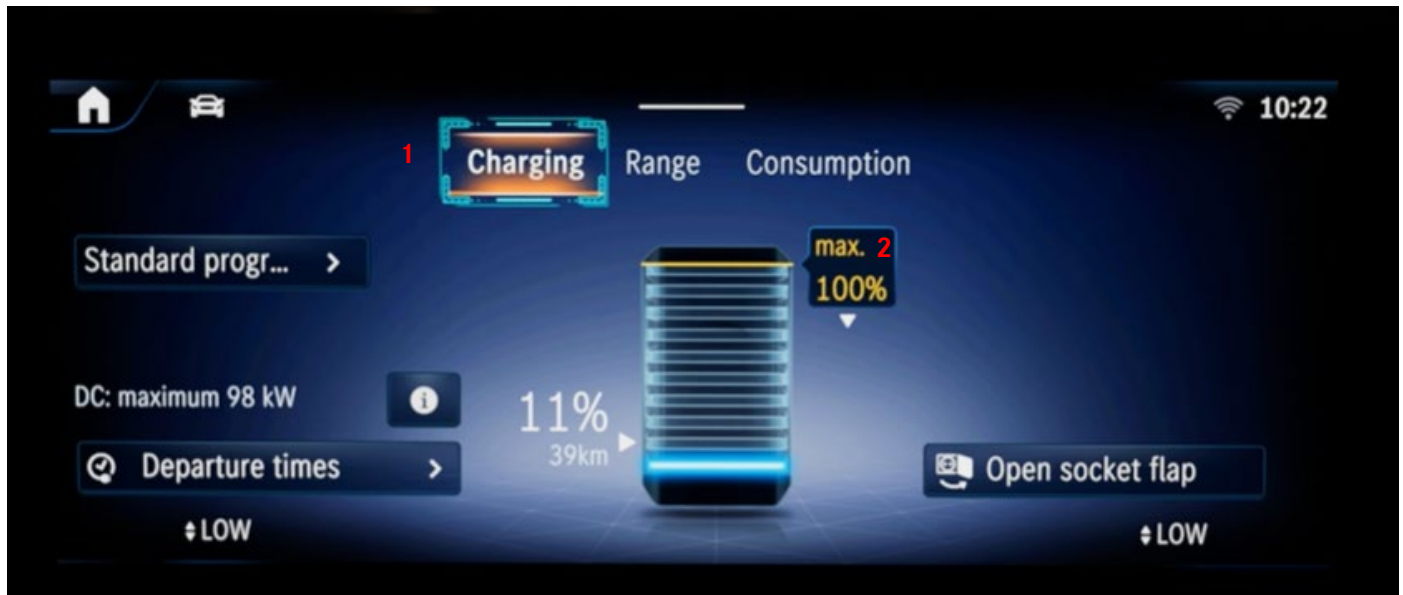
## HOW TO CHANGE STATE OF CHARGE (MBUX):

- 1) On the multimedia system, select the “Home” icon, then “EQ”, to navigate to the “Charging” screen.
- 2) Tap and drag the “max. percentage” icon to the right of the battery state of charge display to read “max. 80%.”
  - a. NOTE: After software update, the Maximum Charge Level can be set to “max.100%”
