Compliance Recall

Code: 90TV

Rearview Camera Software

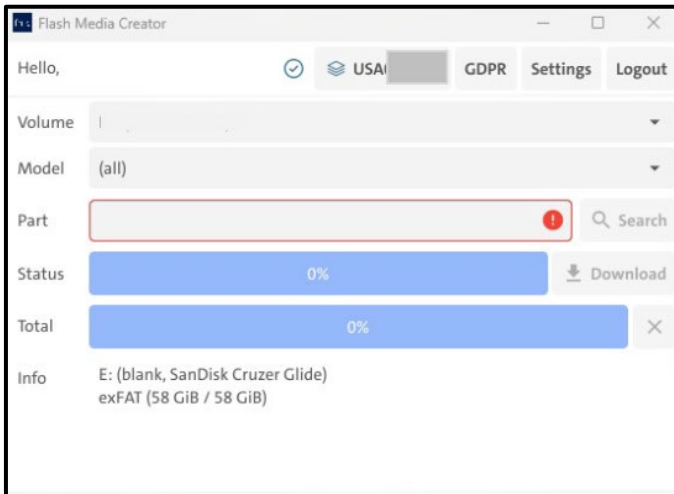
Required SD Card / USB Drive

- The required software will have to be downloaded onto a SD Card or USB drive using the Flash Media Creator (Edgebox).
- **Reference the latest version of AOS-25-48 for additional information about the Flash Media Creator.**
