# Compliance Recall

## Code: 90TV

**Rearview Camera Software**

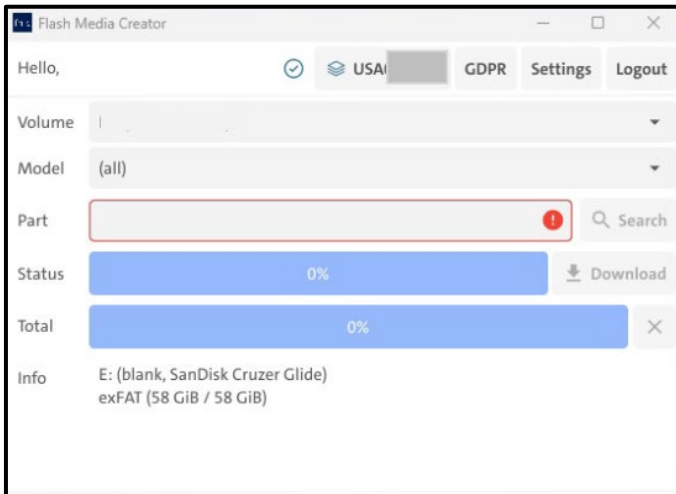
## Required SD Card / USB Drive

- The required software will have to be downloaded onto a SD Card or USB drive using the Flash Media Creator (Edgebox).
- **Reference the latest version of AOS-25-48 for additional information about the Flash Media Creator.**
