Safety Recall

N252494000 L87 Engine Loss of Propulsion

Release Date: June 2025

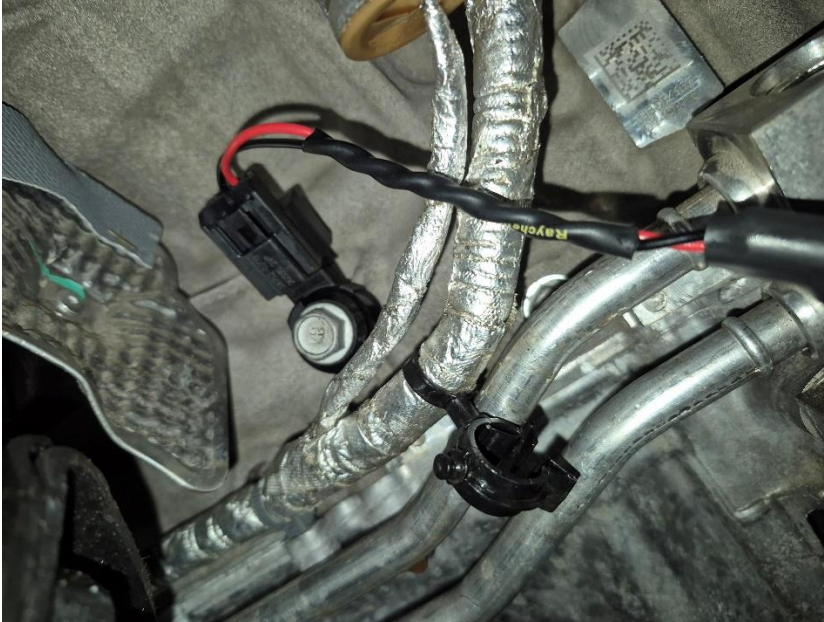
6932366

Caution: Using compressed air, blow out the M8 boss in which the test sensor is installed in the above picture.

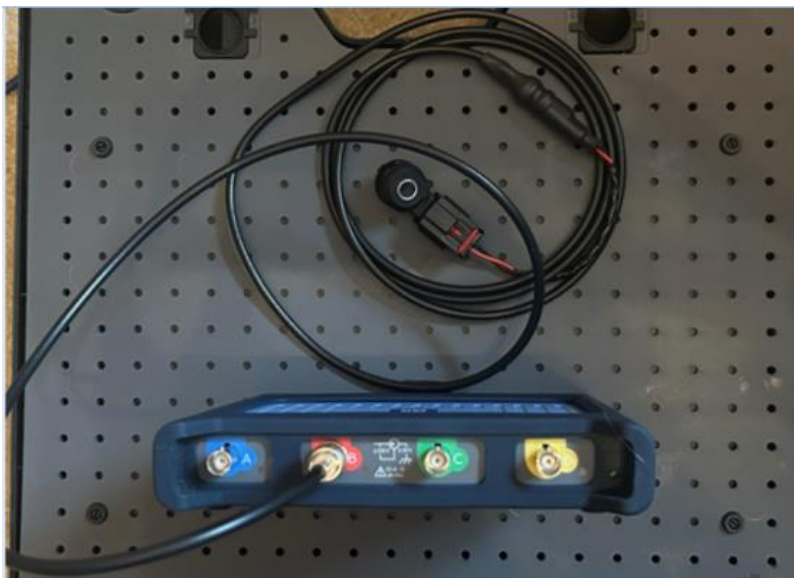
6952616

- Install the test sensor into the unused M8 boss on the left-hand side of the engine directly above and in front of the engine oil cooler line junction block. Torque the M8X1.25X35 bolt to 16 lb-ft/22 N-m.
- Route the test sensor harness in a manner in which it is not contacting any hot components of the vehicle and which allows the harness to reach your laptop or PC.
