SIB 51 01 26

Recall 26V-478 Software Update and Ignition Switch Function Check

2026-10-01

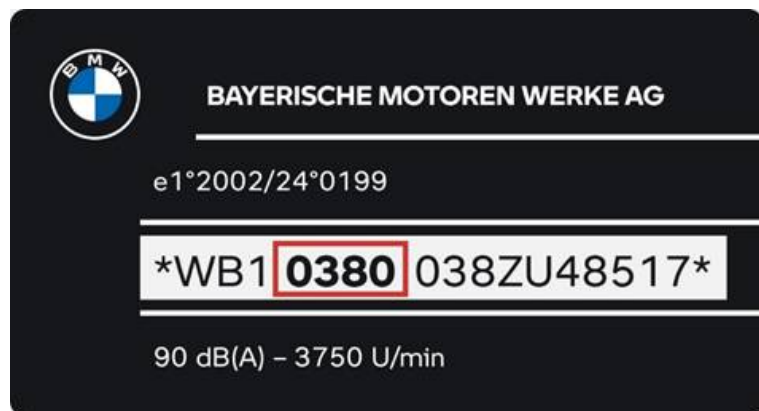
This code is part of the VIN. These 4 digits are the 4<sup>th</sup>, 5<sup>th</sup> 6<sup>th</sup> and 7<sup>th</sup> place of the VIN.

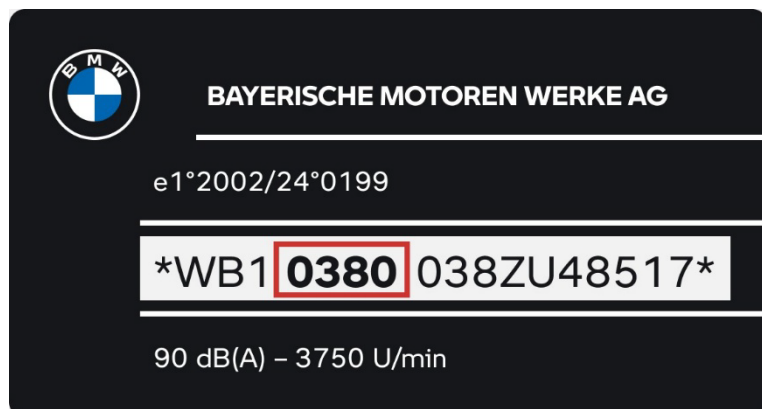
This code is part of the VIN. These 4 digits are the 4<sup>th</sup>, 5<sup>th</sup>, 6<sup>th</sup> and 7<sup>th</sup> place of the VIN.
