Safety Recall

Code: 93EA

Subject	High-Voltage (HV) Battery				
Document History	Date		Summary		
	04/07/2026		Labor operations have been updated.		
	03/17/2026		Original publication		
Affected Vehicles	Country	Beginning Model Year	Ending Model Year	Vehicle	Vehicle Count
	USA	2023	2025	ID.4	43,881
	CAN	2023	2025	ID.4	8,526
Problem Description	<p>In rare circumstances, the high-voltage battery modules may experience a thermal propagation, possibly resulting in a vehicle fire.</p> <p><i>Check Campaigns/Actions screen in ELSA on the day of repair to verify that a VIN qualifies for repair under this action. ELSA is the <u>only</u> valid campaign inquiry & verification source.</i></p> <ul style="list-style-type: none"> ✓ Campaign status must show "open." ✓ If ELSA shows other open action(s), inform your customer so that the work can also be completed at the same time the vehicle is in the workshop for this campaign. 				
Corrective Action	<p>Conduct a battery health check inspection and install updated Self Discharge Diagnosis (SDD) software and replace potentially affected HV battery cell modules (if needed) based on the inspection and/or SDD software warning.</p> <p>Any authorized Vol

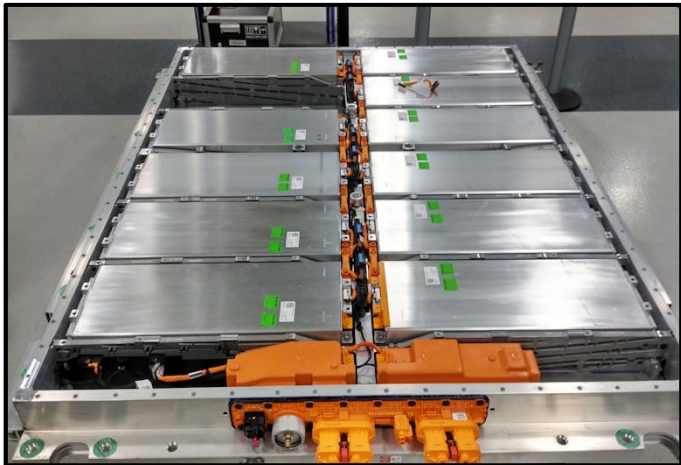
Repair Overview

- Update software of battery regulation control module.
- Perform HV battery cell module evaluation.
- Replace HV battery cell modules if necessary.

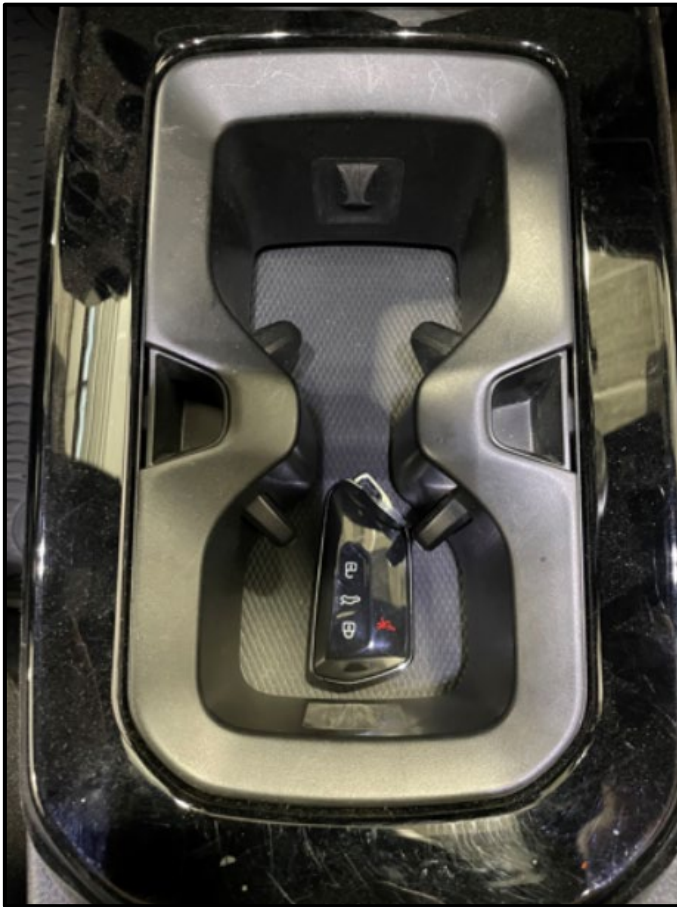
- Place the vehicle key over the reader coil in the cup holder area as shown.
- Any additional keys must be a minimum of 20 meters away from the vehicle.

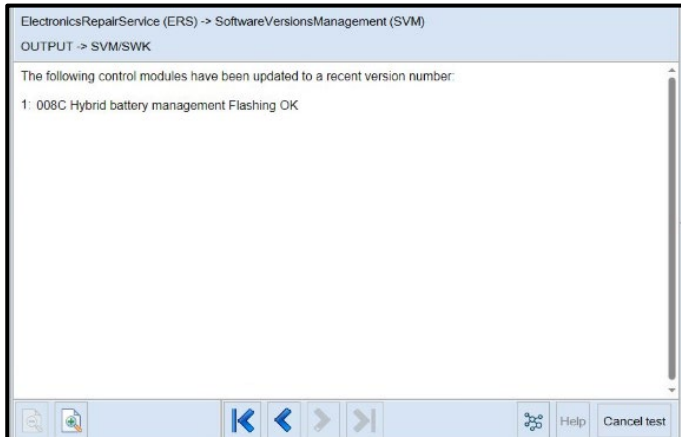
- Pay attention to the status report of the control module update.
- If the status report states “NOT OK”, the module will have to be updated again.
- Do not end the diagnostic session
- **DO NOT proceed to the next section until the software update has been completed successfully.**

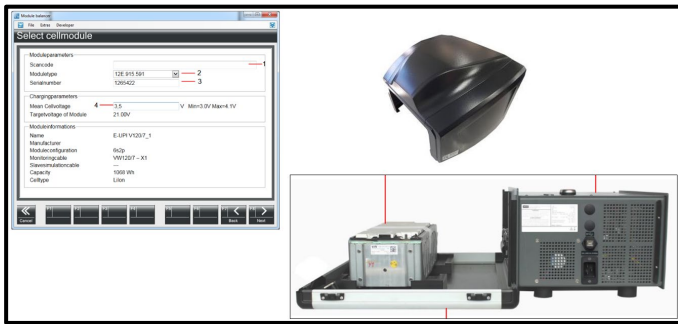
- Check Measured Value Block (MVB) “maximum voltage for battery cells, IDE08217.
- The voltage reading listed will be entered in the DSS Manager program when balancing the new cell module.

- When charging or discharging a new cell module, follow the instructions in the ELSA repair manual in conjunction with the operating instructions for the cell balancer being used.

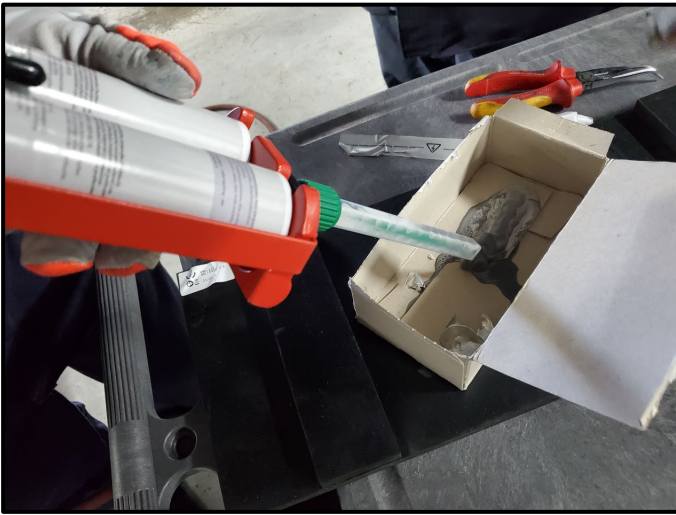
- Double check the expiration date of the paste before applying.
- Use Double Cartridge Adhesive Gun -VAS5237- to apply the heat paste.
- Before applying the heat paste, release a small amount through the applicator to ensure the paste is mixing properly.

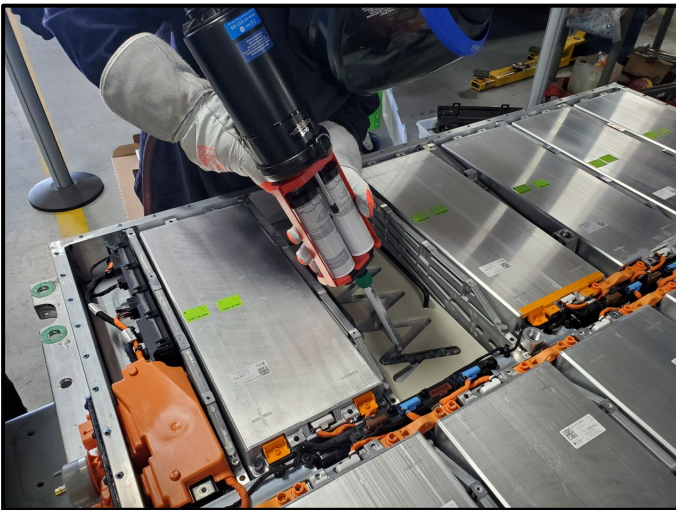
- When filling Template -T10606-, ALL of the heat paste must be used.

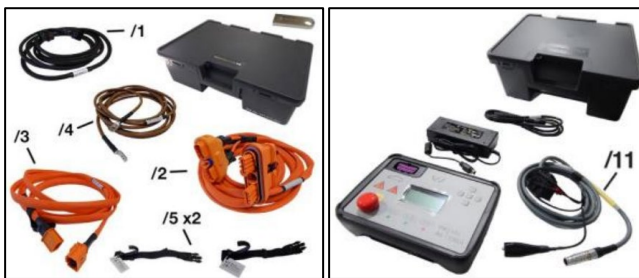
Check for high-voltage battery faults:

- Using -VAS671007- or -VAS5581A-, in conjunction with the Diagnostic Tester, verify there are no faults stored for any high-voltage battery component before installing the high-voltage battery cover.
