# Safety Recall

## Code: 93EA

| Subject | High-Voltage (HV) Battery | | | | |

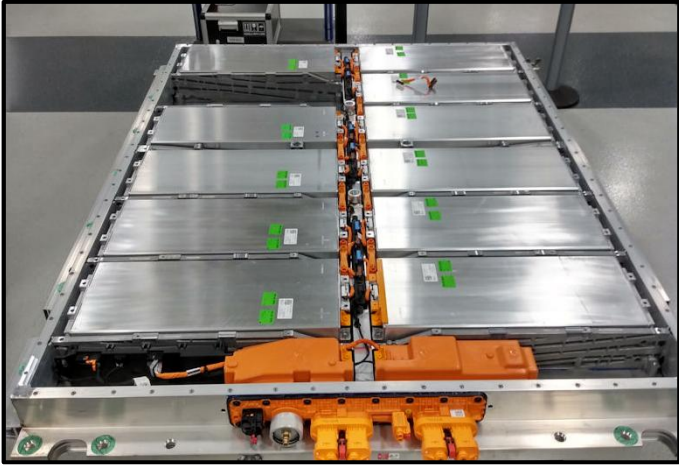
## Repair Overview

- Update software of battery regulation control module.
- Perform HV battery cell module evaluation.
- Replace HV battery cell modules if necessary.

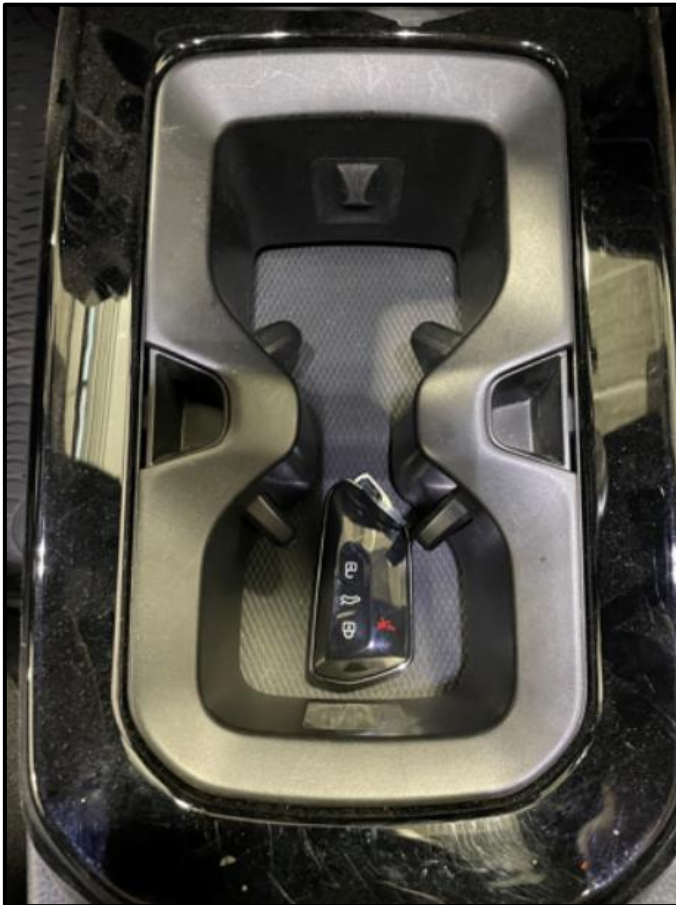
- Place the vehicle key over the reader coil in the cup holder area as shown.
- Any additional keys must be a minimum of 20 meters away from the vehicle.

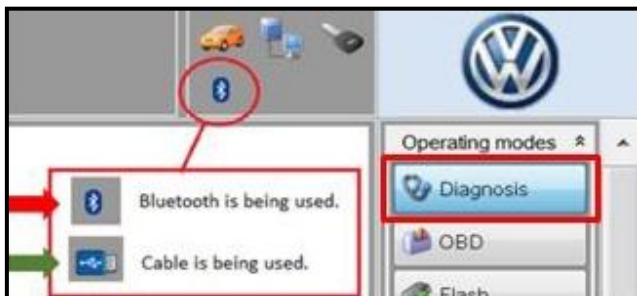
- Confirm that scan tool is communicating with the diagnostic head by USB <Green Arrow>.
  - If the Bluetooth symbol is shown <Red Arrow> then disconnect the diagnostic head from the vehicle and reconnect the USB cable to the diagnostic head and then reattach to the vehicle.
- Upon ODIS startup, verify the "Diagnosis" operating mode is selected <as shown>.

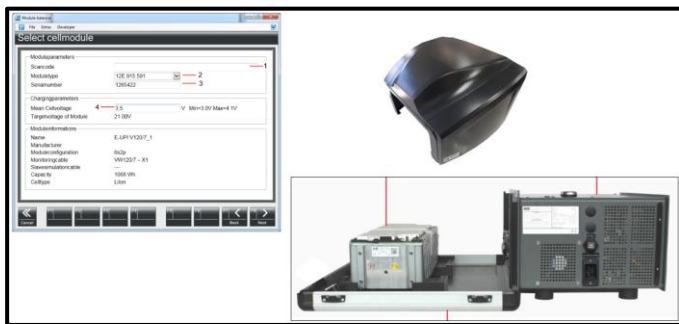
### Perform cell balancing on new cell module:

- Check Measured Value Block (MVB) “maximum voltage for battery cells, IDE08217.
- The voltage reading listed will be entered in the DSS Manager program when balancing the new cell module.

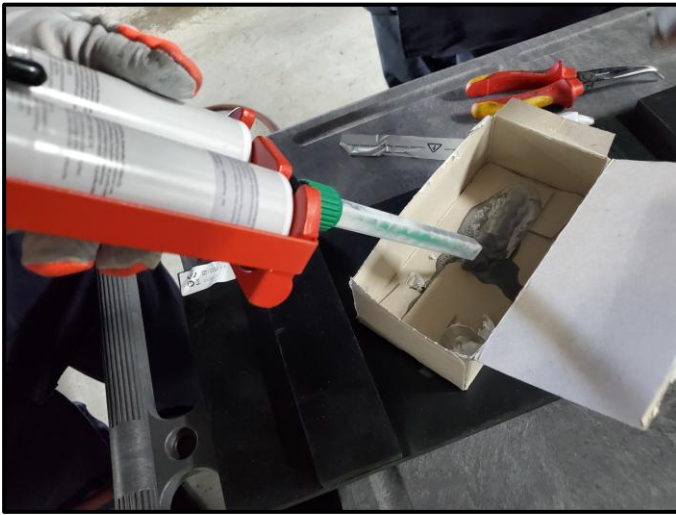
- Double check the expiration date of the paste before applying.
- Use Double Cartridge Adhesive Gun -VAS5237- to apply the heat paste.
- Before applying the heat paste, release a small amount through the applicator to ensure the paste is mixing properly.

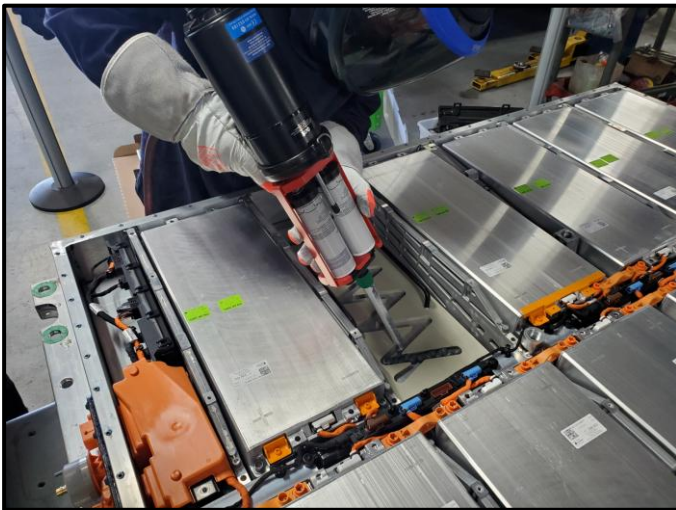
- When filling Template -T10606-, ALL of the heat paste must be used.

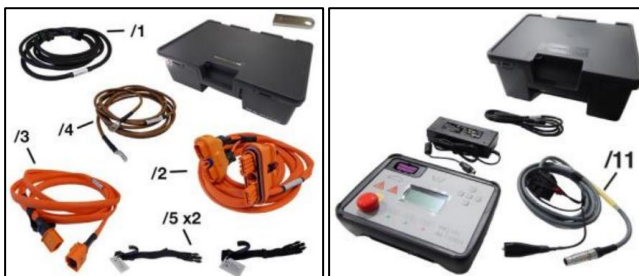
### Check for high-voltage battery faults:

- Using -VAS671007- or -VAS5581A-, in conjunction with the Diagnostic Tester, verify there are no faults stored for any high-voltage battery component before installing the high-voltage battery cover.
