TECHNICAL INSTRUCTIONS
FOR
SAFETY RECALL 26TA02
REPROGRAMMING FOR PARKING ASSIST ECU
CERTAIN 2024 - 2025 TUNDRA / TUNDRA HYBRID

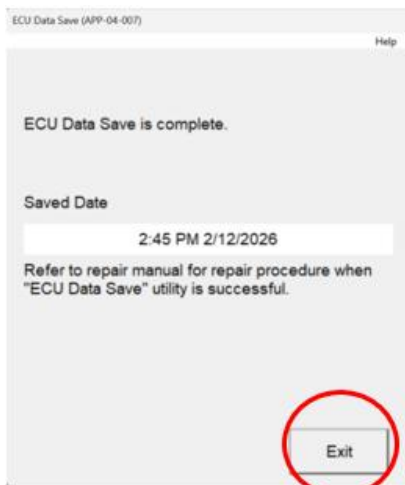
6. SELECT UTILITY & ECU DATA SAVE (This will generate a vehicle specific file saved in the background that will be used during the data write process)

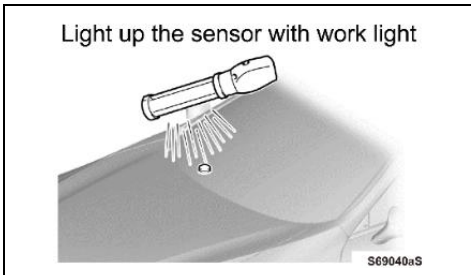
a) Confirm the following conditions:

- Vehicle in the IG position (READY OFF).
- Transaxle in Park.
- Parking brake engaged.
- Turn off all electrical accessories (i.e. climate control, audio system, etc.)
- Headlight switch in the DRL OFF position. (w/ DRL OFF position)
- Windshield wiper switch in the OFF position.

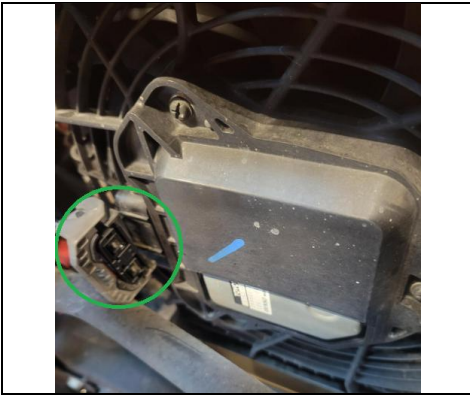
2. FOR HYBRID VEHICLES DISABLE THE ELECTRIC RADIATOR FAN BY UNPLUGGING THE CONNECTOR.

1. DISCONNECT THE DCA-8000
2. RECONNECT THE ELECTRIC RADIATOR FAN (HYBRID VEHICLES)

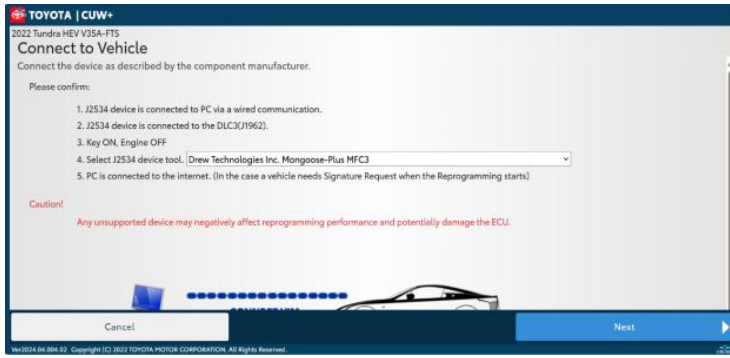
2. REFLASH THE PARKING ASSIST ECU USING FILE **8679FAN33FBL**

b) Once the wizard loads, please follow instructions on screen.

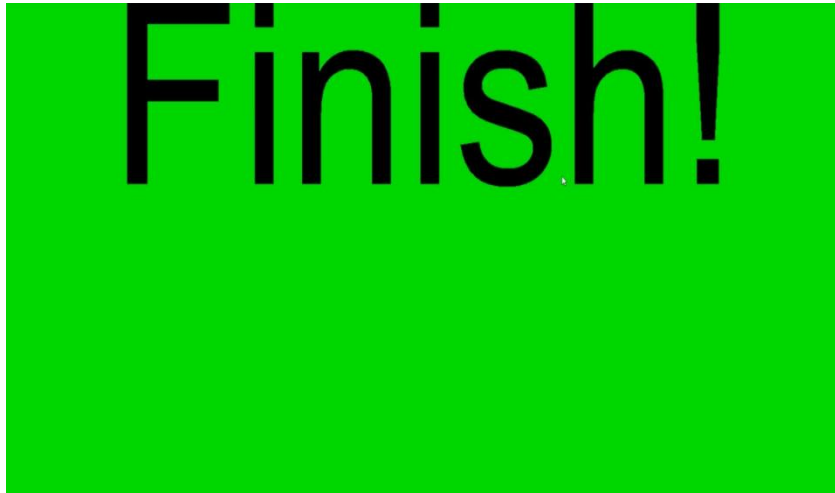
- a) Once GTS+ displays the "Finished" green screen, allow at least 10 seconds before cycling the ignition, failure to follow this step **will result in damage to the ECU** which is not covered by this campaign.

Must wait at least 10 seconds

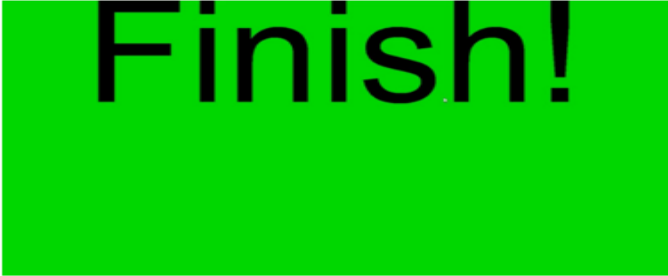
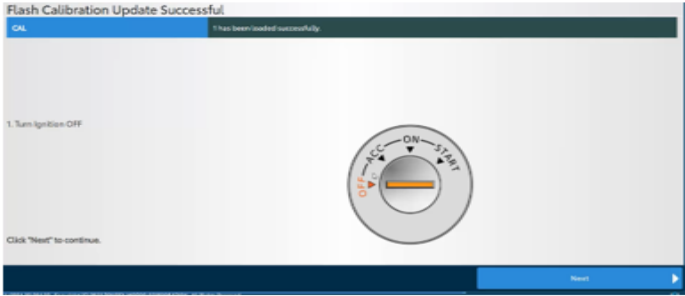
a) Once GTS+ displays the “Finished” green screen, allow at least 10 seconds before cycling the ignition, failure to follow this step **will result in damage to the ECU** which is not covered by this campaign.

Must wait at least 10 seconds

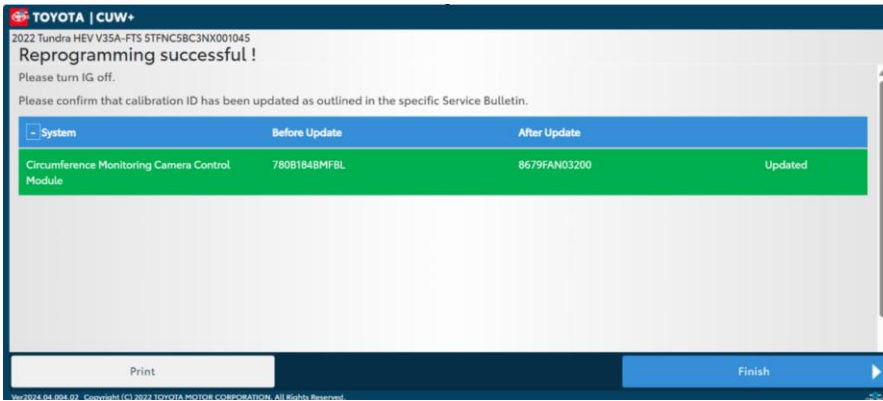
7. SELECT “FINISH” ONCE COMPLETED

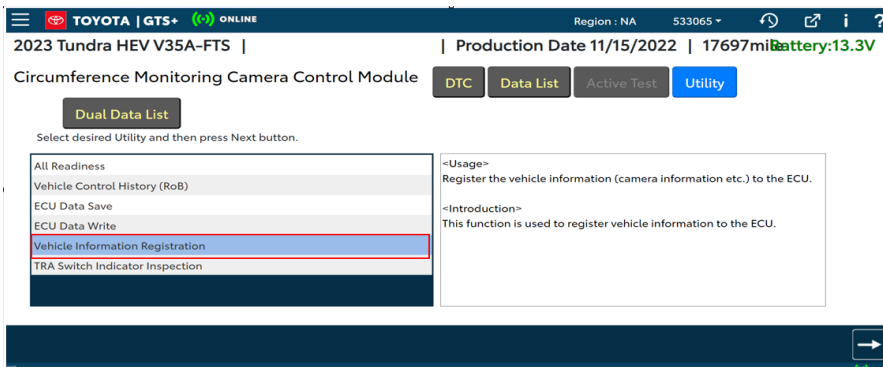
8. SELECT “VEHICLE INFORMATION REGISTRATION”

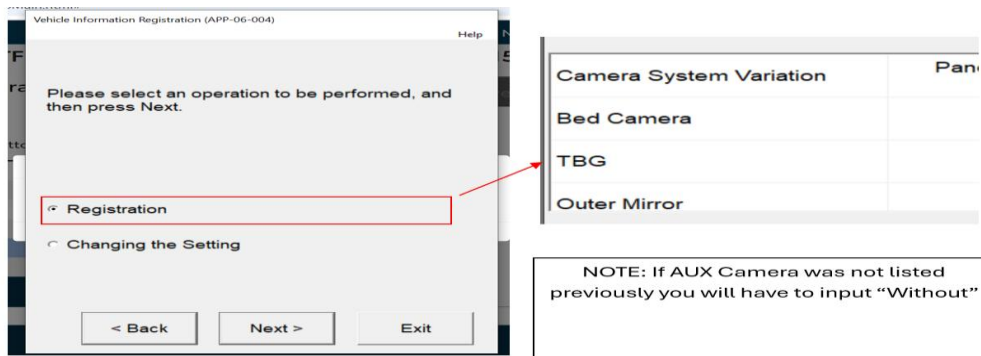
9. SELECT REGISTRATION AND INPUT THE VALUES SAVED FROM SECTION VI STEP 7
 Please note that some of the values we will enter might be in a different order or have a different name than that of the list previously recorded.

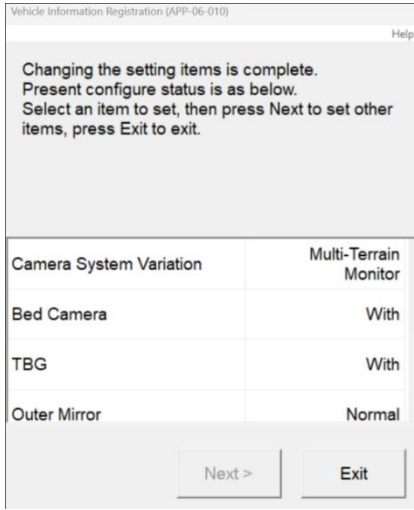
- Camera System Variations are Multi-Terrain Monitor system or Panoramic View monitor system. Since our list shows “Support” next to MTM we will select “Multi-Terrain Monitor”.

- Bed Camera will show only “With” or “Without”. Since our list shows “SUPPORT” for Bed camera we will be using “With”.

- TBG will be referred to on our list as TRA. Will use “With” since our list shows “Support”

- Outer Mirror will show Normal, Towing Mirrors (Extended). We will select “Normal” since our list shows “Support”

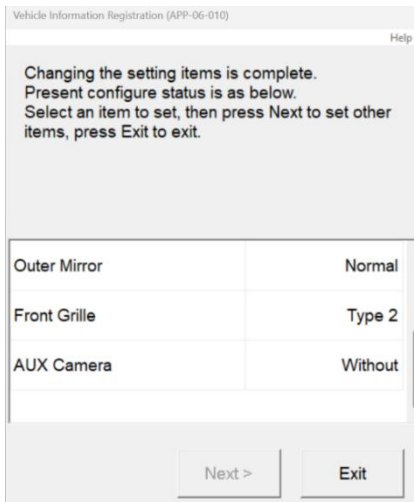
- Front Grille will show Type 1 or Type 2. We will use “Type 2” in this example because our list shows “Support” for Type 2

- AUX Camera was not on our list so we will select “Without” In this example

- **Once all values have been entered select “Exit” to save values.**

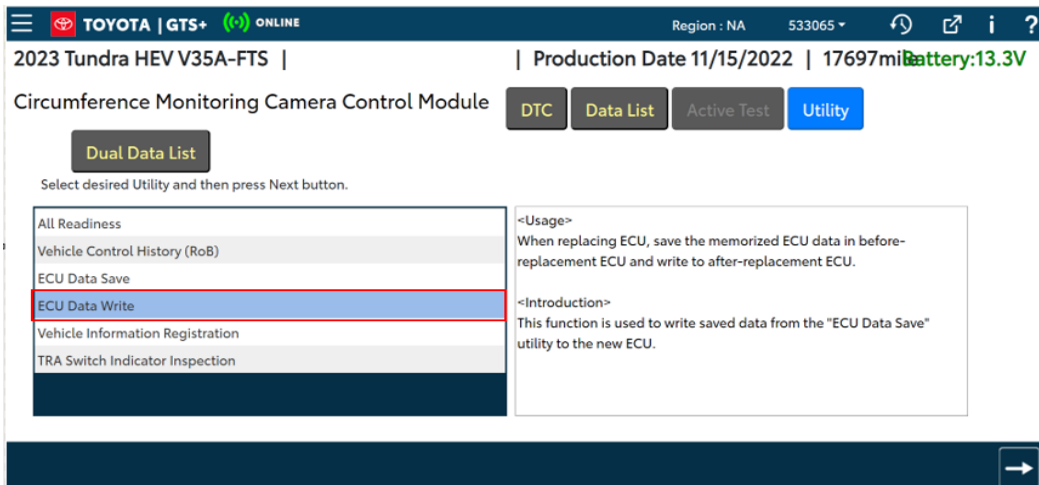
10. ECU DATA WRITE (This function will write the data saved from the ECU prior to reprogramming)

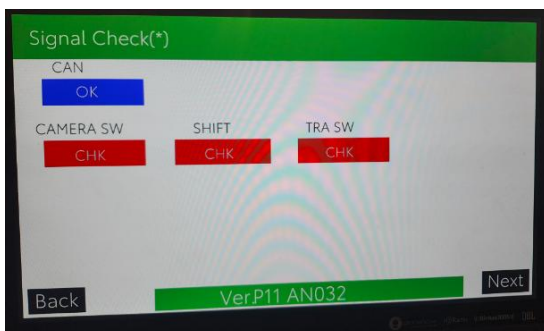
11. SIGNAL CHECK

Once Data Write is complete the screen on the vehicle will show a signal check screen.

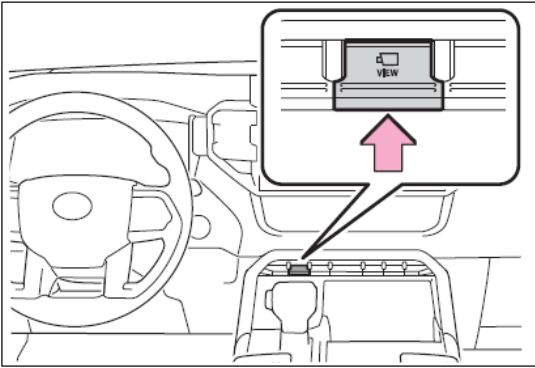
a) Press Physical camera button on the vehicle for the “CHK” to turn into “OK”.

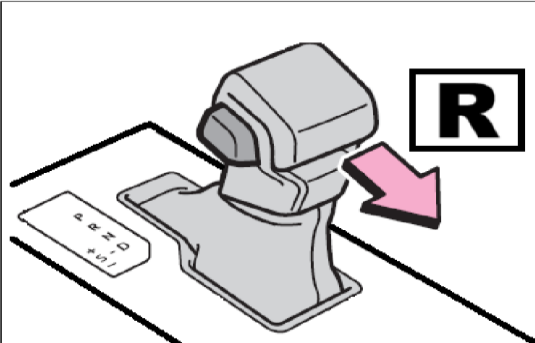
b) Put the gear selector in Reverse and back on Park for “CHK” to turn into “OK”.

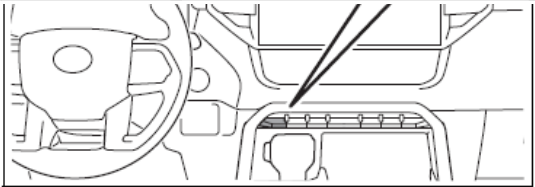
c) Activate the “TRA” button for the “CHK” to turn into “OK”.

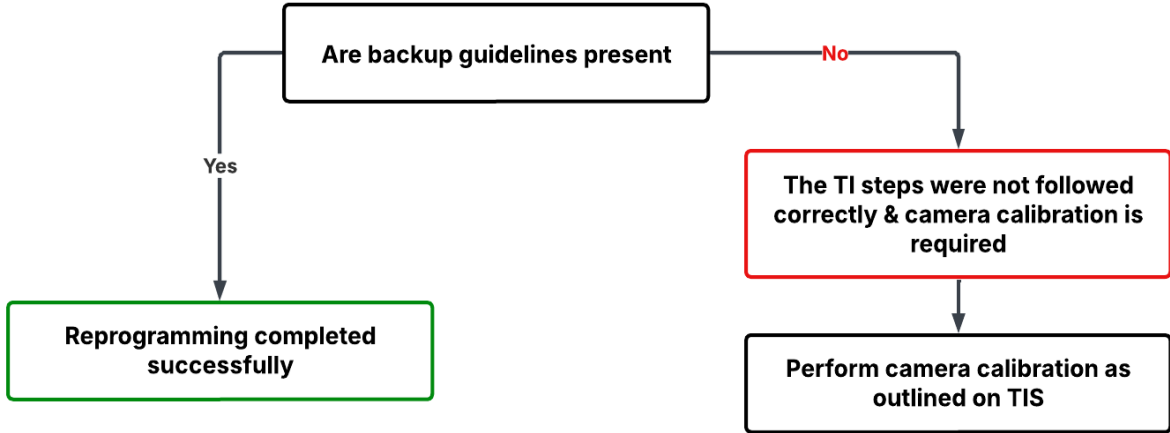
- a. If backup guidelines were present on initial check, proceed to put vehicle in reverse and check for the presence of backup guidelines.

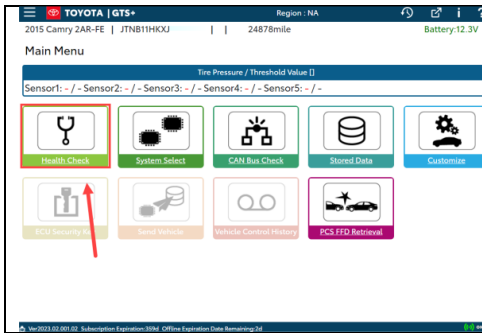
3. PERFORM VERIFICATION HEALTH CHECK

- Using a GTS+, click the “Health Check” button on the Main Menu.
- Clear DTC’s that may have set during the re-flash procedure.
- Re-run the Health Check to confirm that no DTC’s reappear.
