| Non-Compliance Safety Recall Campaign | 2025-2026MY Multiple Models |
| SC361 (Rev 1, 02/13/2026) | January 2026 |

INSTRUMENT CLUSTER SOFTWARE

LOGIC IMPROVEMENT (SC361)

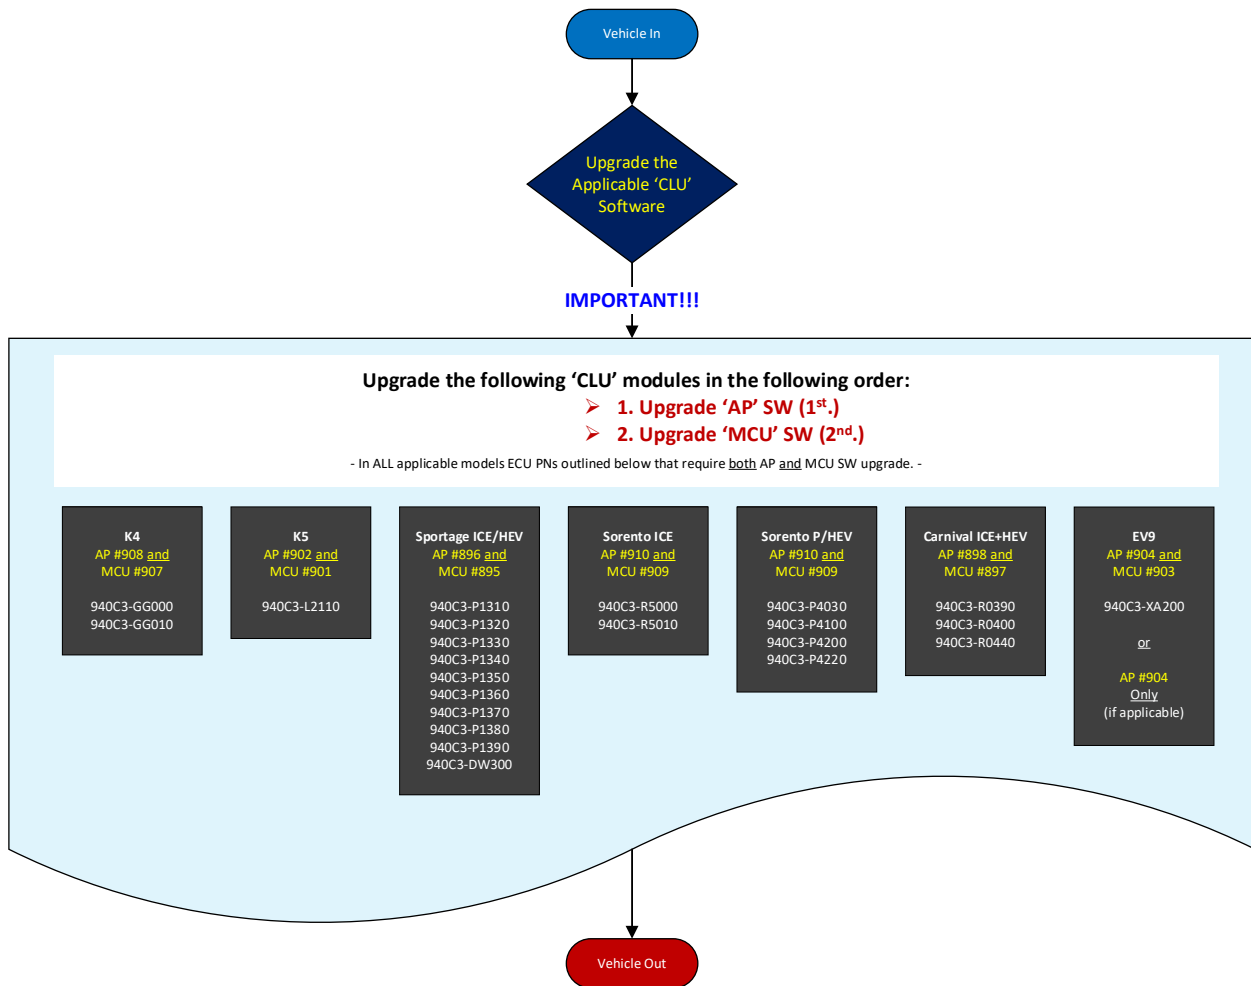
Refer to the flowchart below and the Event # list on page 3:

1. Identify the software required for the applicable model.
2. Check the ECU PN for the required SW Event # ___.
3. Follow the software upgrade order below AP → MCU (if applicable).
4. Upgrade the AP and/or MCU as required.

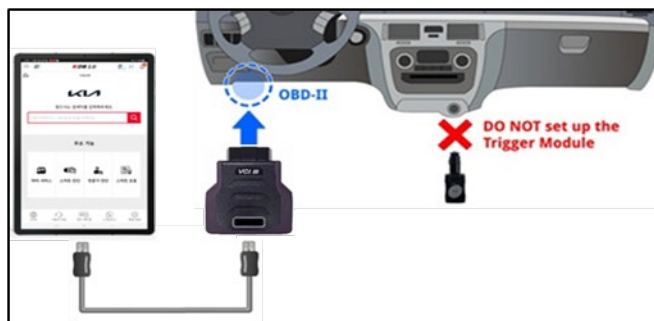
Using KDS + VCI-III Connection

1. Connect the VCI-III USB-C connector to the KDS tablet.
2. Connect VCI-III to the OBD-II connector of the vehicle.
