| SC361 | January 2026 |

NONCOMPLIANCE SAFETY RECALL CAMPAIGN

INSTRUMENT CLUSTER SOFTWARE LOGIC IMPROVEMENT (SC361)

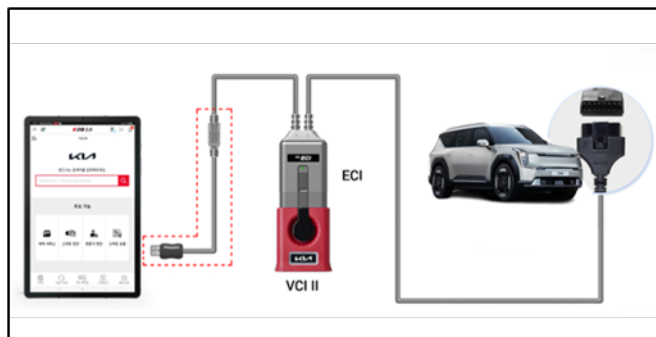
1. Connect the ECI DLC connector to the OBD-II connector, located under the driver's side of the instrument panel.
2. Connect the ECI USB -C connector to the KDS tablet.
3. Connect the VCI II to the ECI OBD-II connector.

Ensure the ECI cable is configured by referring to the ['KDS Configuration for ECI Cable Usage'](#).

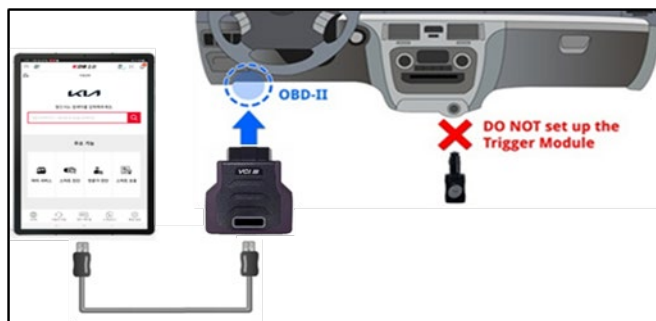
Using KDS + VCI-III Connection

1. Connect the VCI-III USB-C connector to the KDS tablet.
2. Connect VCI-III to the OBD-II connector of the vehicle.
