HYUNDAI Technical Service Bulletin

26-01-011H-1

INSTRUMENT CLUSTER LOGIC UNIT (CLU) SOFTWARE UPDATE
(RECALL 293)

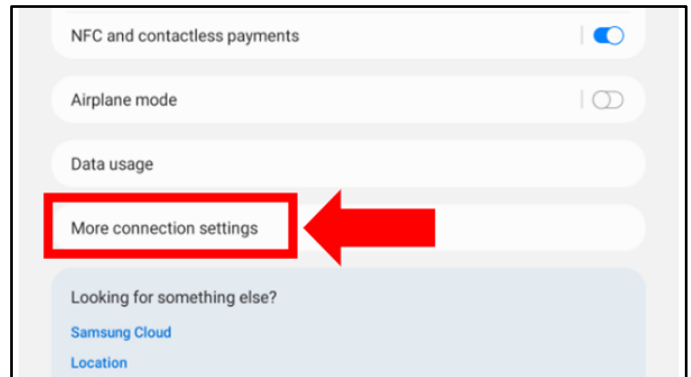
3. Select **More connection settings**.

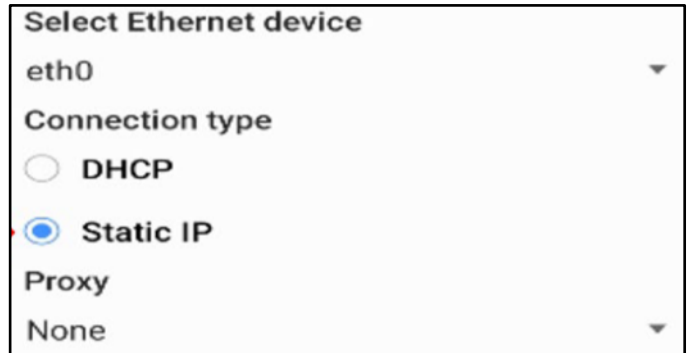
6. Select **Static IP**.

Select Ethernet device
eth0

Connection type
 DHCP
 Static IP

Proxy
None

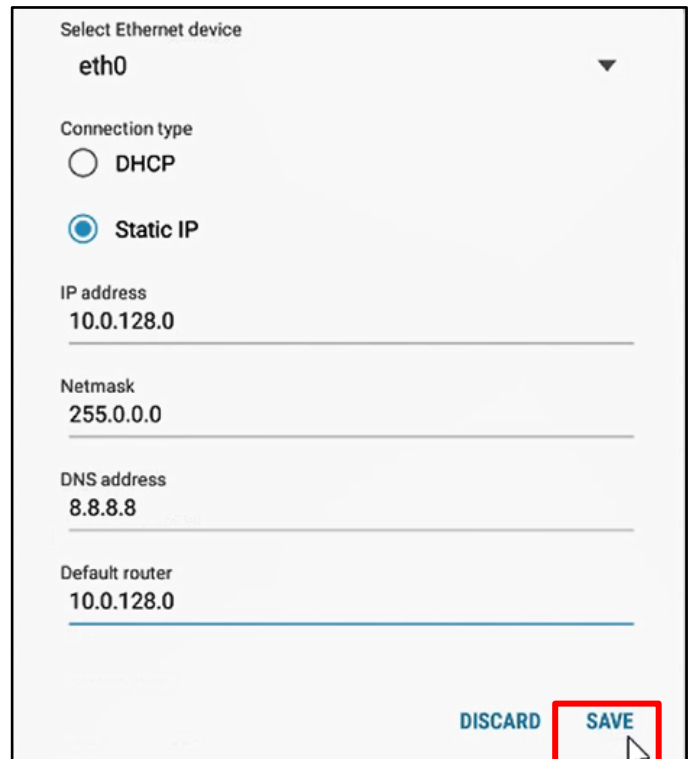
7. Enter the following information into each field:

- IP address: 10.0.128.0
- Netmask: 255.0.0.0
- DNS address: 8.8.8.8
- Default router: 10.0.128.0

Select **SAVE**.

Select Ethernet device
eth0

Connection type
 DHCP
 Static IP

IP address
10.0.128.0

Netmask
255.0.0.0

DNS address
8.8.8.8

Default router
10.0.128.0

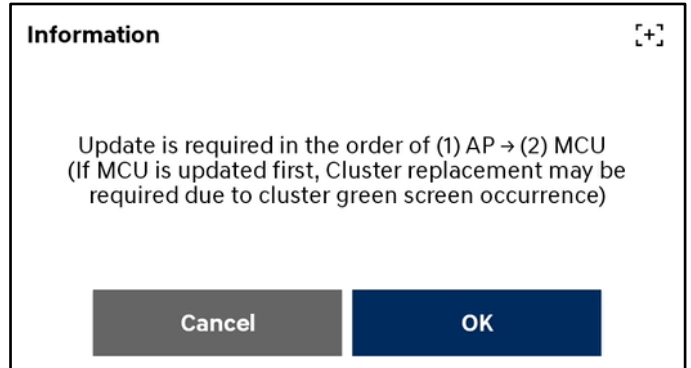
1. Perform the **first of 2** required ECU updates in **Auto Mode (AP)**.

2. Verify the ROM ID by selecting the **CLU** system to scan the vehicle’s current ROM ID.

AP should be updated first and then **MCU**, otherwise the cluster module can be damaged and will require replacement.

Check the current ROM ID version and compare it to the ROM ID Information table before attempting to perform the software update.

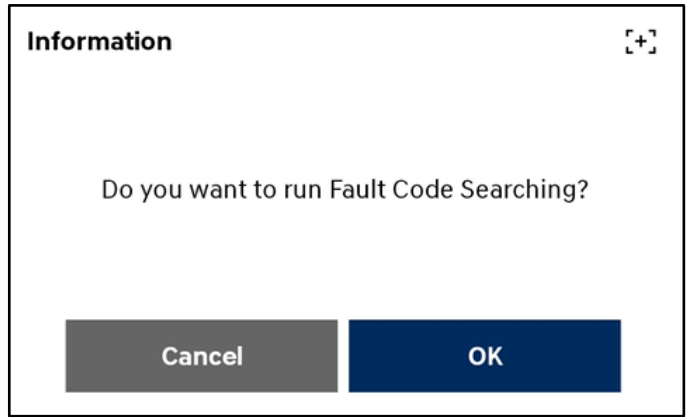
- Select **Cancel** and proceed to updating the **MCU**.

No need to perform the Fault Code Searching as this procedure will be performed after disconnecting the power connector.

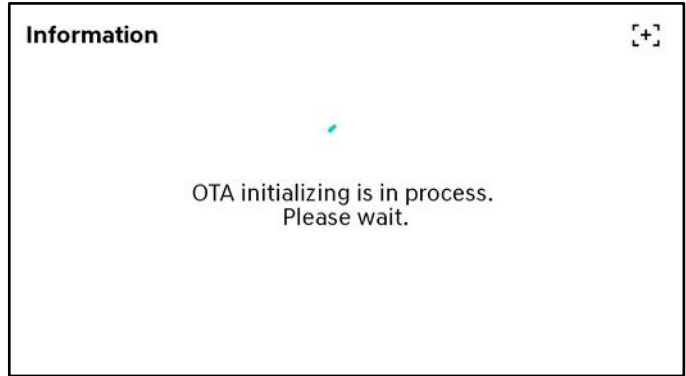
- 9. The GDS will automatically perform the OTA initializing.

If the GDS does **NOT** automatically perform the OTA initializing, then perform this procedure after the software is updated successfully.
