Technical Service Bulletin

GROUP RECALL	NUMBER 26-01-011H-2
DATE JANUARY 2026	MODEL(S) SEE BELOW

SUBJECT: INSTRUMENT CLUSTER LOGIC UNIT (CLU) SOFTWARE UPDATE
(RECALL 293)

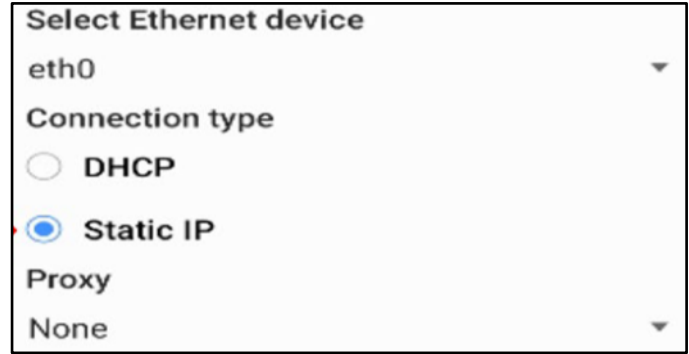
6. Select **Static IP**.

Select Ethernet device
eth0

Connection type
 DHCP
 Static IP

Proxy
None

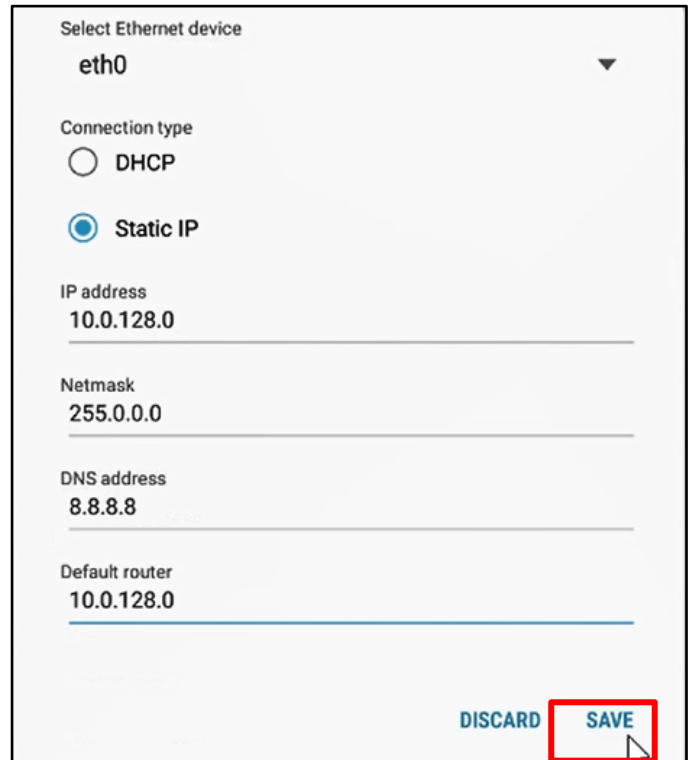
7. Enter the following information into each field:

- IP address: 10.0.128.0
- Netmask: 255.0.0.0
- DNS address: 8.8.8.8
- Default router: 10.0.128.0

Select **SAVE**.

Select Ethernet device
eth0

Connection type
 DHCP
 Static IP

IP address
10.0.128.0

Netmask
255.0.0.0

DNS address
8.8.8.8

Default router
10.0.128.0

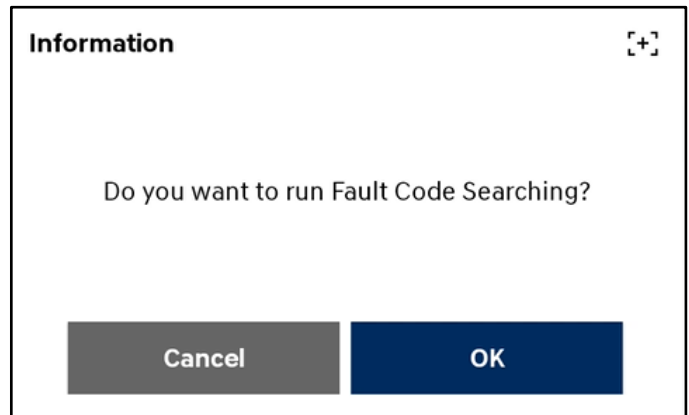
- Select **Cancel** and proceed to updating the **MCU** if applicable.

No need to perform the Fault Code Searching as this procedure will be performed after disconnecting the power connector.

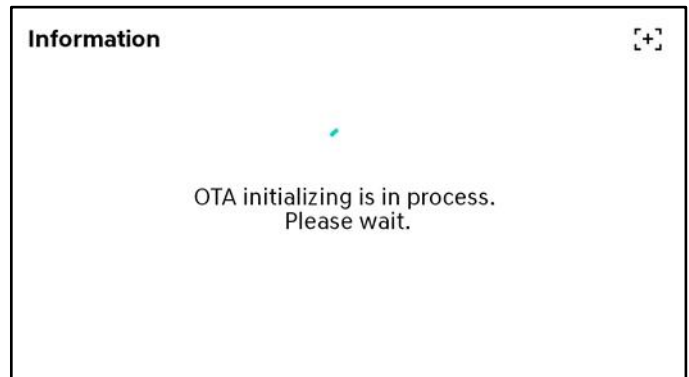
- The GDS will automatically perform the OTA initializing.

If the GDS does **NOT** automatically perform the OTA initializing, then perform this procedure after the software is updated successfully.

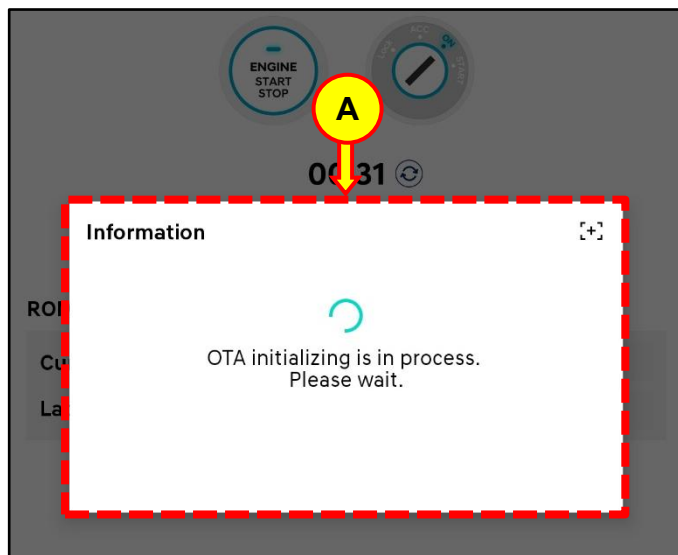
15. OTA initialization (A) should perform automatically after the software update:
- If OTA initialization performs automatically, then proceed with the service procedure.
 - If the OTA initialization process fails, complete it manually under:
S/W Management > CCU_CCNF - Central Communication Unit (CCNF) > OTA Initialization (B).

Follow the instructions on the screen.
