HYUNDAI Technical Service Bulletin

GROUP RECALL	NUMBER 26-01-011H
DATE JANUARY 2026	MODEL(S) SEE BELOW

SUBJECT: INSTRUMENT CLUSTER LOGIC UNIT (CLU) SOFTWARE UPDATE
(RECALL 293)

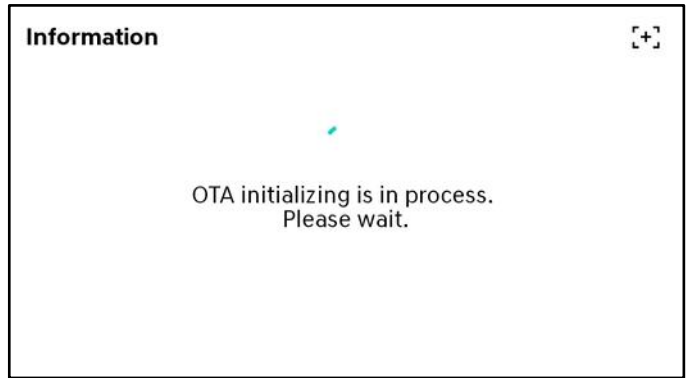
9. The GDS will automatically perform the OTA initializing.

If the GDS does not automatically perform the OTA initializing, then perform this procedure after the software is updated successfully.

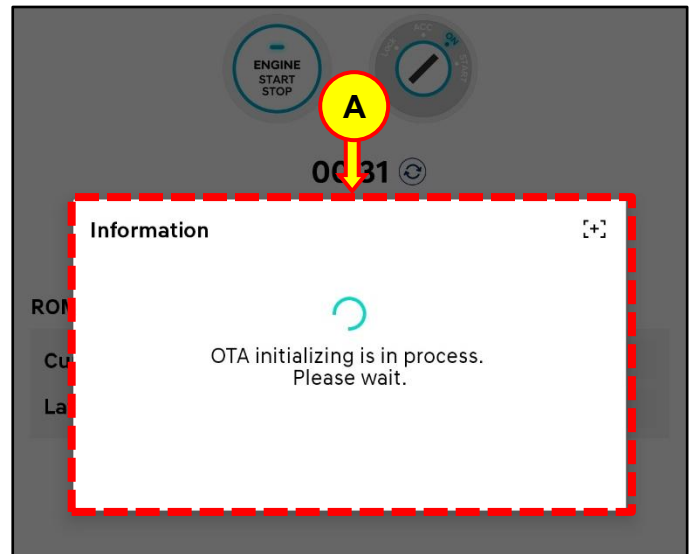
14. OTA initialization (A) should perform automatically after the software update:
 - If OTA initialization performs automatically, then proceed with the service procedure.
 - If the OTA initialization process fails, complete it manually under: **S/W Management > CCU_CCNF - Central Communication Unit (CCNF) > OTA Initialization (B).**

Follow the instructions on the screen.
