Recall Information Bulletin

Safety Recall C10136 – HV System 0% State of Charge While Stationary

FEC7K (E16L/E16M), FEC9K (E18L/E18M), FECXK (E18)

eCANTER 23MODEL BMS Software Update Procedure

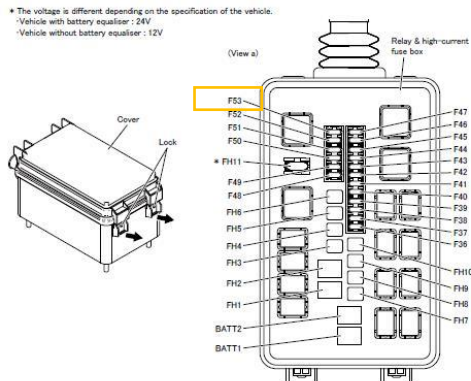
Location of high-current fuse F53 (10 A) to be removed (excerpt from maintenance instructions)

1	Identify any of the work BMS1,2,3 where there was a communication failure (remember when re-writing)
2	Disconnect DTD from vehicle and switch off key
3	Disconnect high-current fuse F53 (10 A) (see picture below)
4	WAIT 1 MINUTE (FOR HARDWARE RESET OF BMS ECU)
5	Reconnect the disconnected high-current fuse F53 (10 A) (Two people are required to work on the system as it must be switched on within 10 seconds)
6	Key ON within 10 seconds (If more than 10 seconds pass, the BMS will be in a state where it cannot be written to again.)
7	Reboot DTD PC and reconnect to vehicle
8	Resume BMS Rewrite Operation with Communication Failure (BMS1 if BMS1, BMS2 if BMS2, BMS3 if BMS3)
9	If the same error screen appears again Repeat the work from step 2

1	Disconnect DTD from vehicle and switch off key
2	Disconnect high-current fuse F53 (10 A) (see picture below)
3	WAIT 1 MINUTE (FOR HARDWARE RESET OF DCB ECU)
4	Reconnect the disconnected high-current fuse F53 (10 A) (Two people are required to work on the system as it must be switched on within 10 seconds)
5	Key ON within 10 seconds (DCB cannot write again after more than 10 seconds)
6	Restart DTD PC and reconnect to vehicle
7	Resume DCB rewriting operation, refer to the Software Update Procedure after Rewrite Failure in Section 4(2)(b)
8	If the same error screen appears again Repeat the work from step 1.

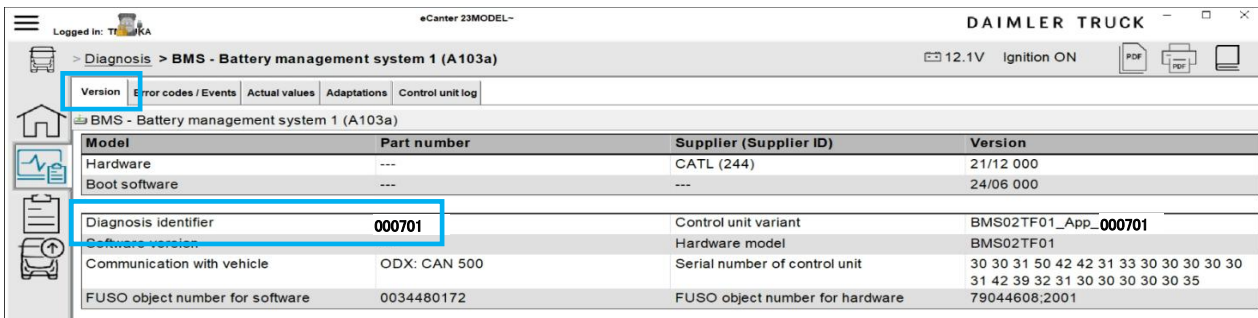
4. In the version screen, make sure that the diagnosis ID is "000701".
 (Ultimately, this diagnosis ID will be changed to "000801" as a result of this work.)
 To carry out the programming, select the Adaptations tab.

*During the recovery process of VI, "017001" is displayed in the diagnosis ID.

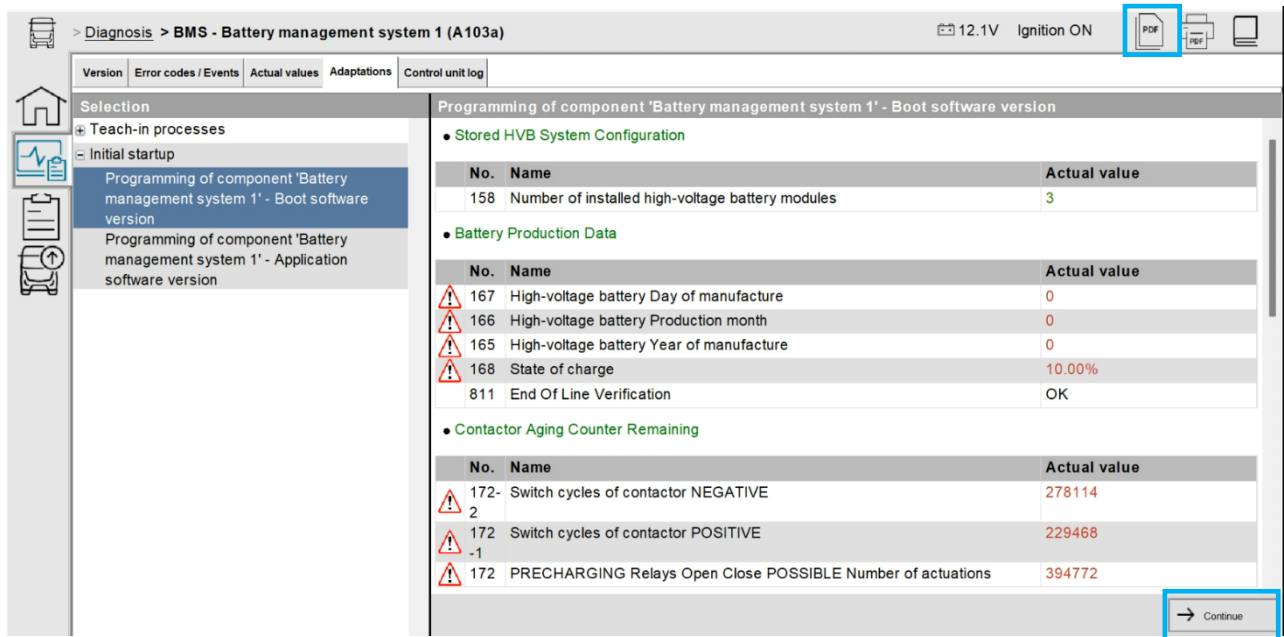
6. Save actual values as PDF ⇒ "Continue"

Suggestion: This screen will be used to compare the actual values when programming the application software at a later time. Shooting with a smartphone or similar will make the update process smoother.

Actual values to be compared

158: Number of installed high-voltage battery modules

168: State of charge

220: Ageing state 1

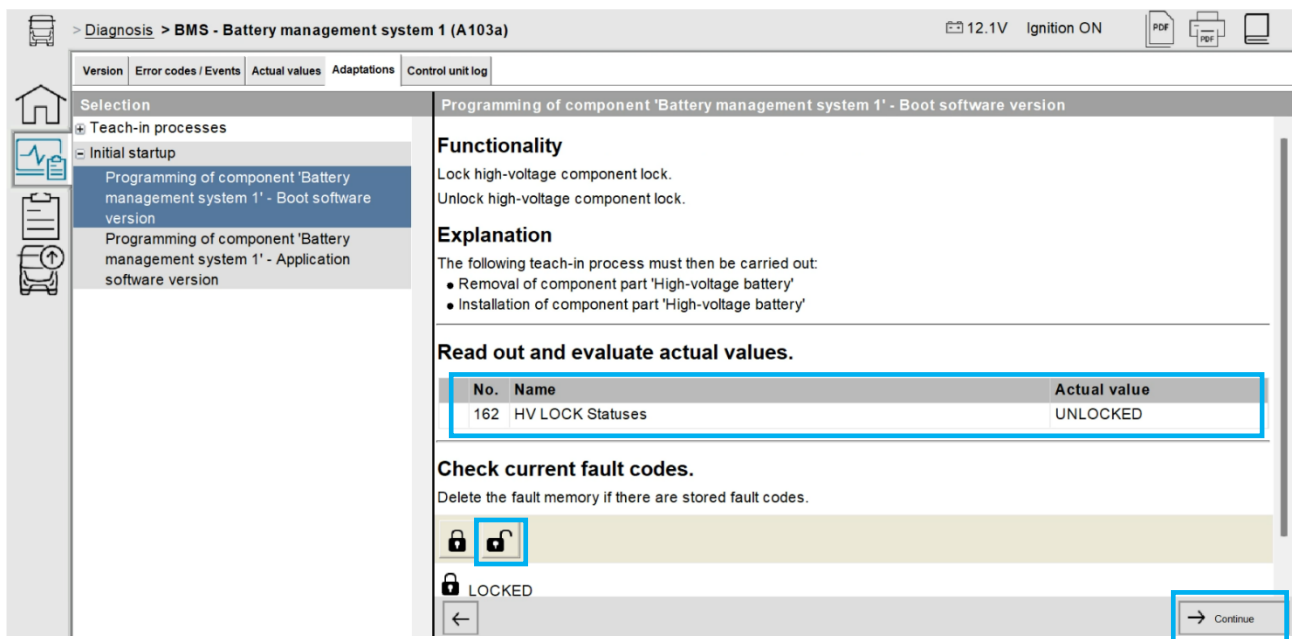
8. Check whether the actual value for the HV lock status is set to “Unlocked” ⇒ “Continue”
 *For “Locked”, click on the unlock symbol ⇒ “Continue”

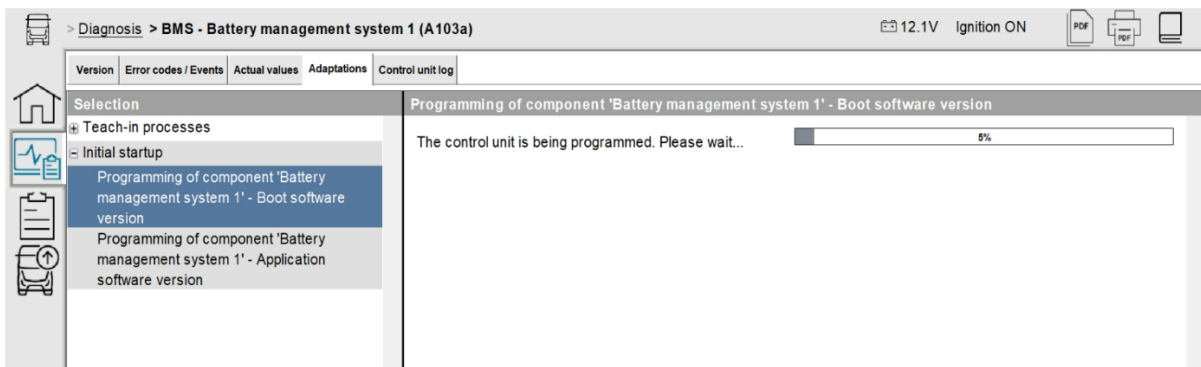
10. Wait for the screen to change because it is being programmed (approximately 2~3 minutes).

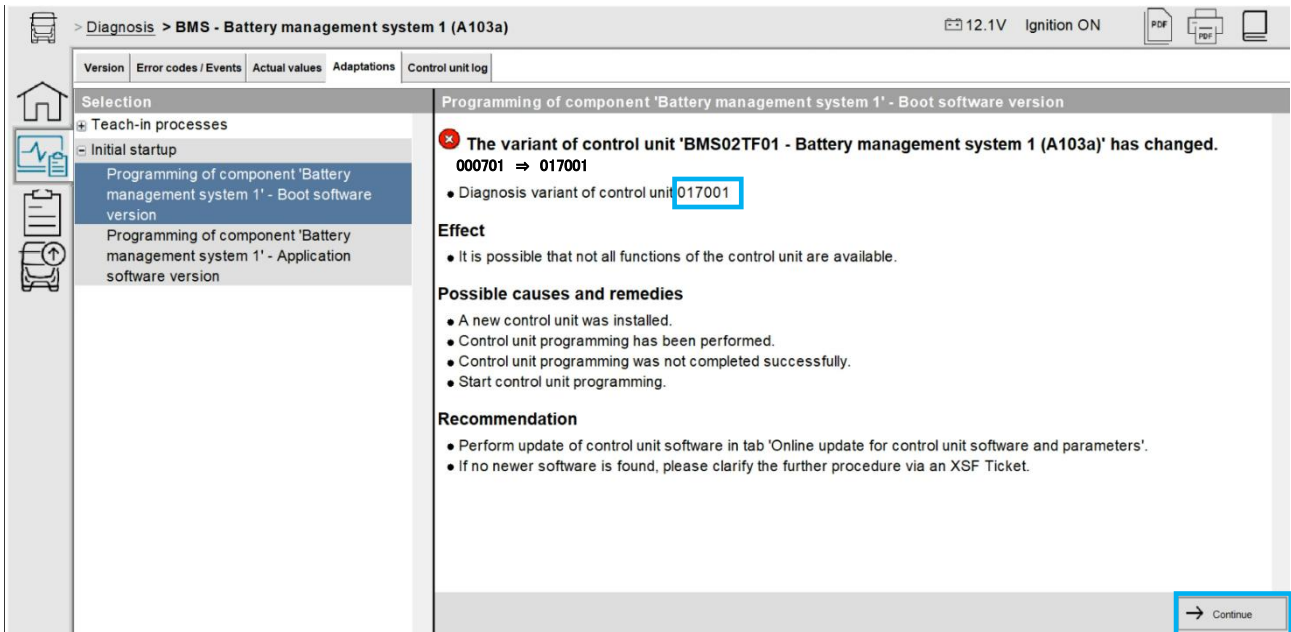
When the conversion is complete, a screen appears informing you that the diagnosis variant has been changed. Click on “Continue”.

⌘During the recovery procedure of VI (even during recovery), the screen may not be displayed. It may also not be displayed during recovery.

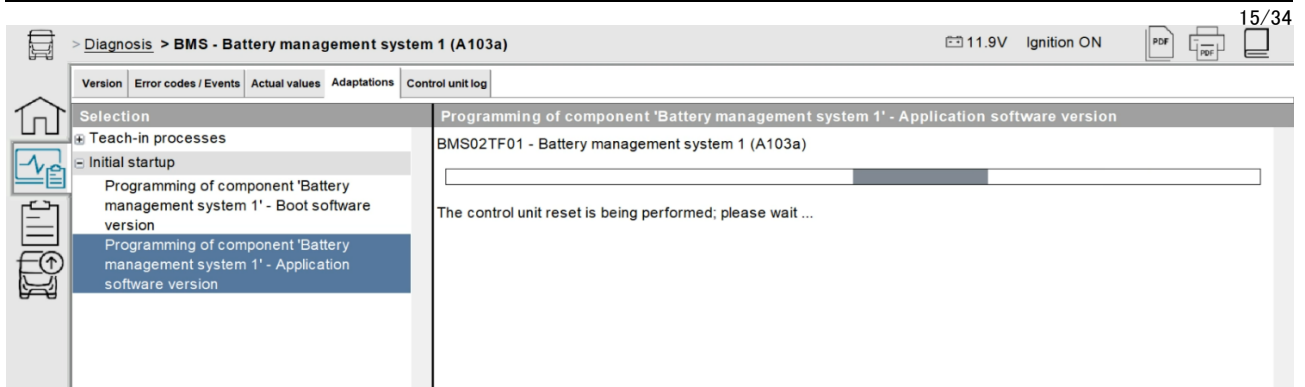
18. Resetting: Waiting (Approximately 30 to 40 minutes)

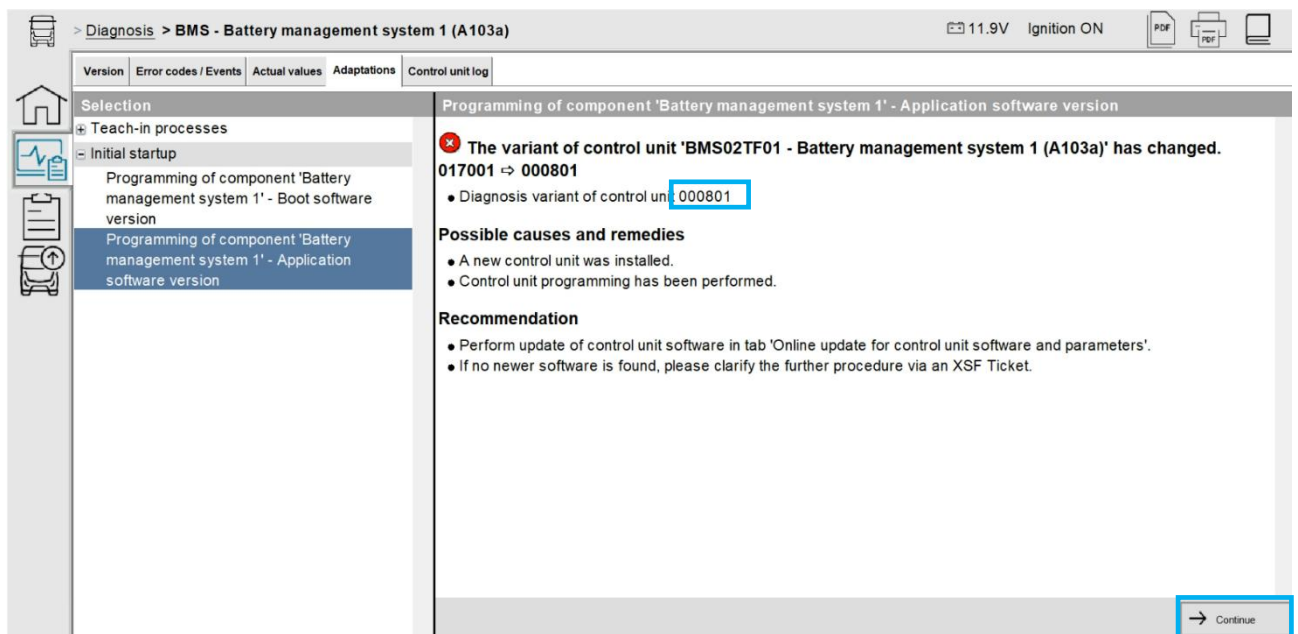
19. Ensure that the diagnosis variant of the control unit is 000801⇒“Continue”
 *This screen may not be displayed.

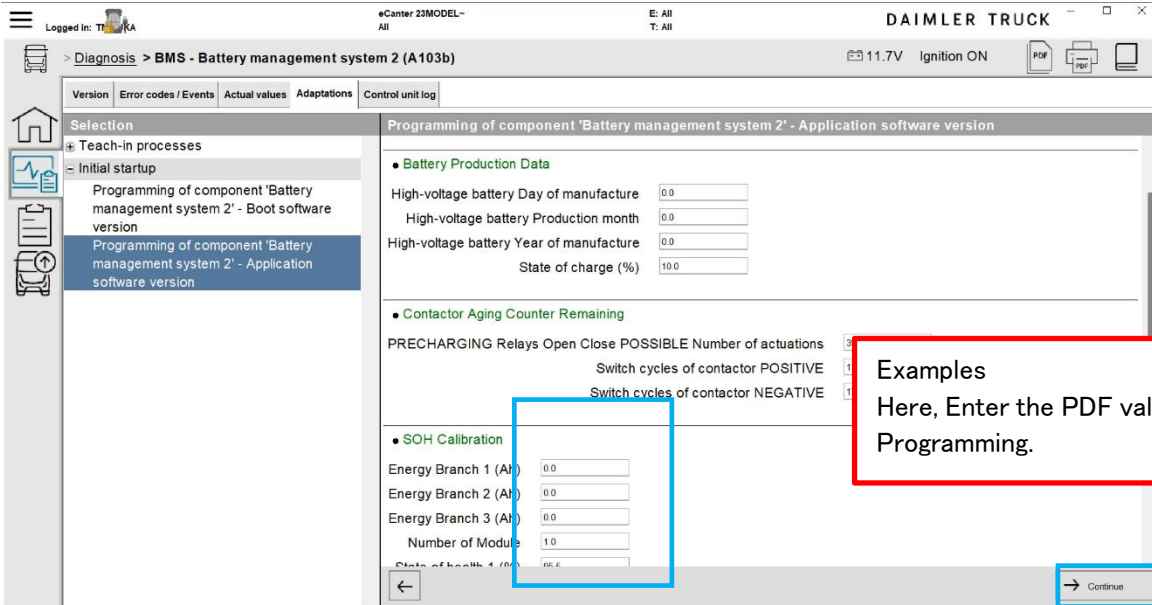
Note: Before and after programming, the charge level and degradation level 1 (%) may fluctuate slightly. If the difference is ± 0.1 , please select “Yes” as like there is no difference. If the difference is greater than ± 0.1 , enter the value below and select “Continue.”

* Even if the displayed PDF after input differs by ± 0.1 , as mentioned above, treat it as it there is no difference and continue.

Examples
Here, Enter the PDF values from before Programming.

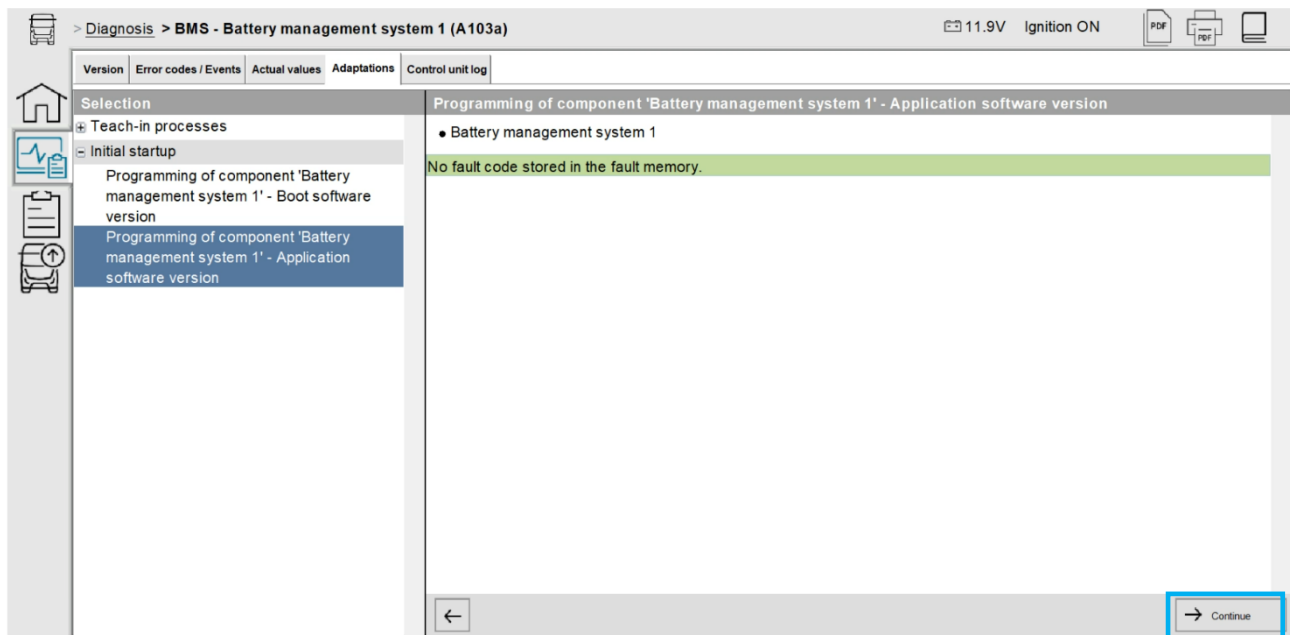
26. If any Error codes present, Then Erase fault code ⇒ 'Continue'

Note:- Check the status of the fault code, and if it is a 'stored Fault,' press 'Continue' to clear it.

If there is a current fault 'Number of installed high-voltage battery modules error,' proceed with the steps from 29 onward (because the number of high-voltage batteries installed in the vehicle differs from what the ECU recognizes).

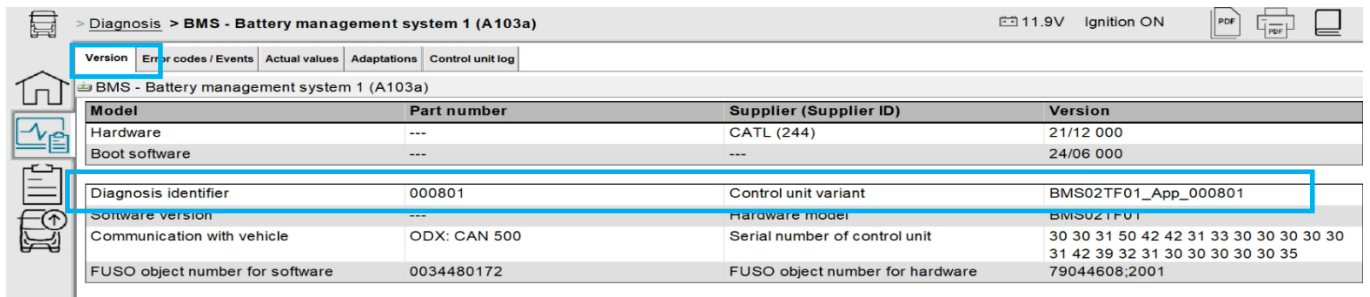
28. Ensure that the diagnosis ID and control unit variant is 000801.

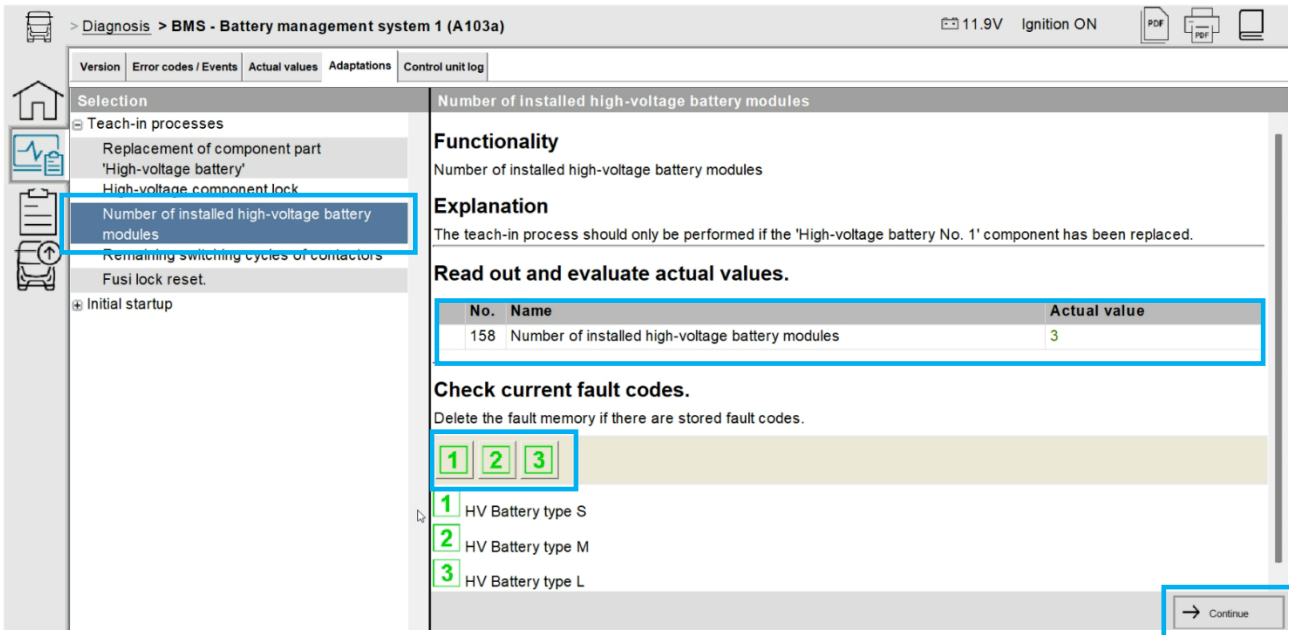
29. Check whether the “Number of installed high–voltage battery modules” matches the actual vehicle.
If different, select the number of modules in the actual vehicle and if the actual value display changes ⇒ “Continue”.
Note:–Wait until the selected number of batteries is displayed in the Actual Value

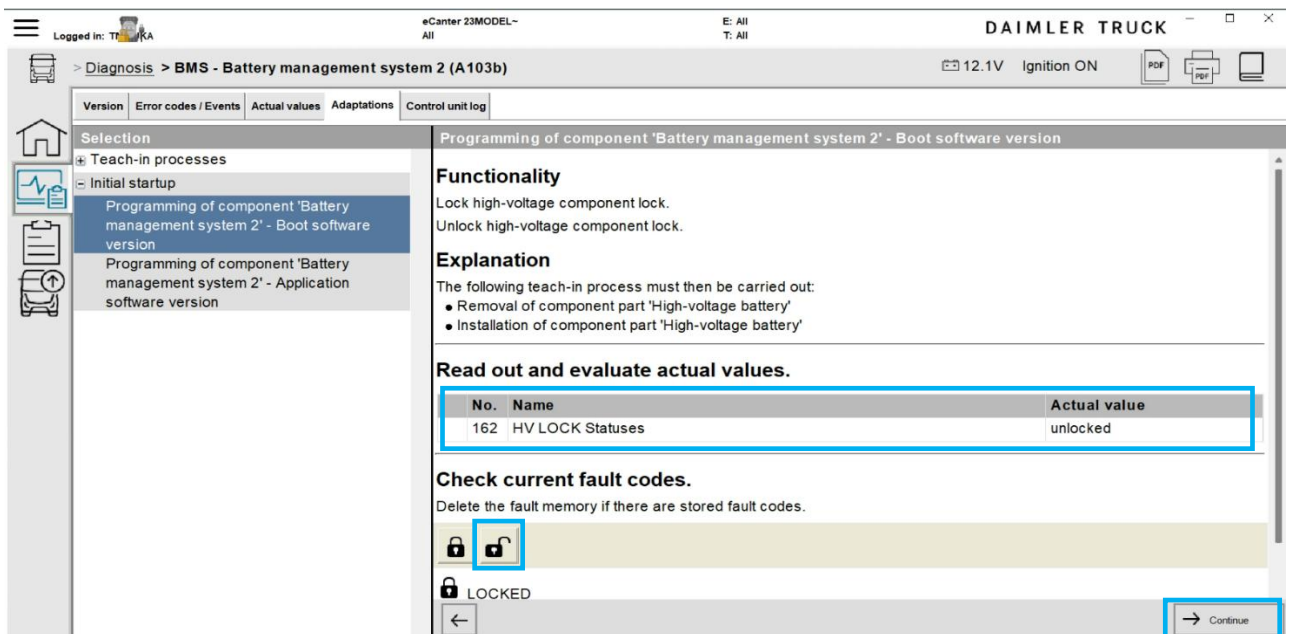
38. Check that the actual value for the HV lock state is set to “unlocked”⇒“Continue”
 *If “locked”, click on the unlock symbol⇒“Continue”

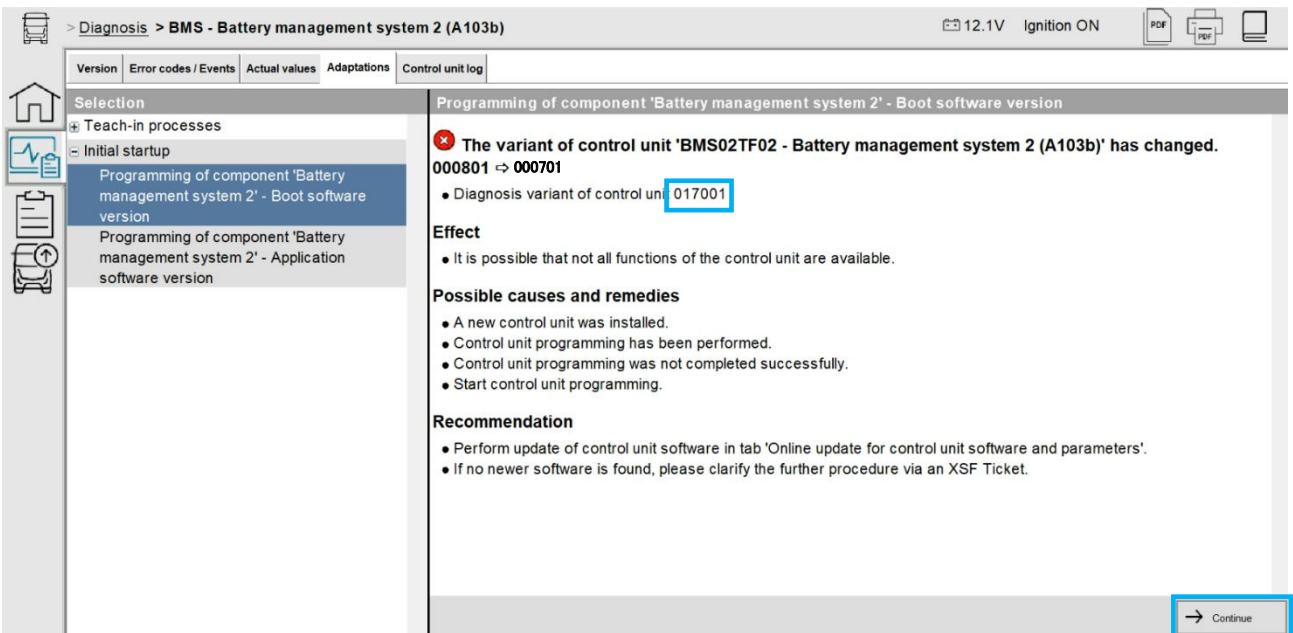
41. Confirm that "Diagnosis variant of control unit" is set to 017001 ⇒ "Continue"

*This screen may not be displayed.

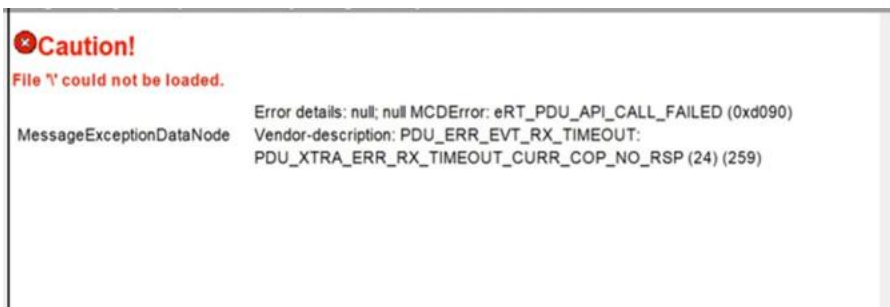
Note: If the following error message appears, press “Continue” and then select “Programming – boot software version of component 'Battery management system 2'” (do not write) and then select “– application software release of component part 'Rechargeable battery management system 2'” again to rewrite the application software.

The screenshot shows the diagnostic software interface for the BMS - Battery management system 2 (A103b). The top bar indicates a voltage of 11.8V and Ignition ON. The left sidebar shows a navigation menu with options like 'Teach-in processes' and 'Initial startup'. The main area is titled 'Programming of component 'Battery management system 2' - Application software version'. A red error message states: 'The variant of control unit 'BMS02TF02 - Battery management system 2 (A103b)' has changed. 017001 ⇒ 000801'. Below this, it lists 'Possible causes and remedies' and 'Recommendation'. A 'Continue' button is visible at the bottom right.

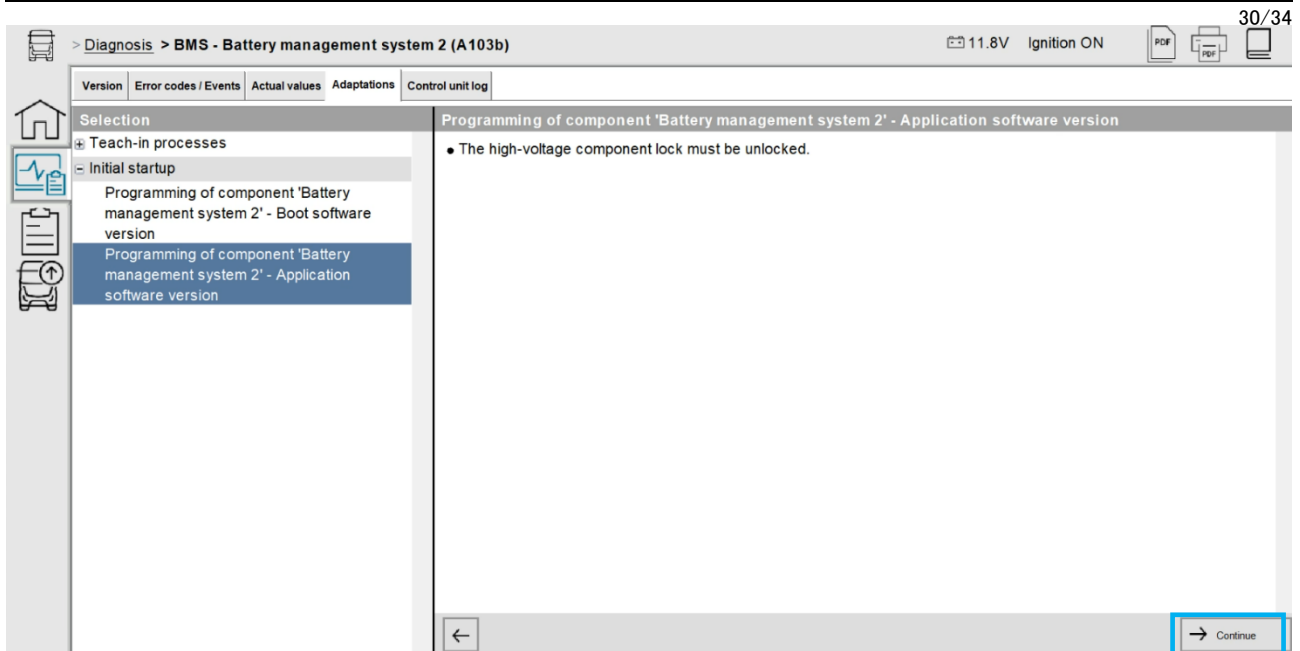
49. “Continue”

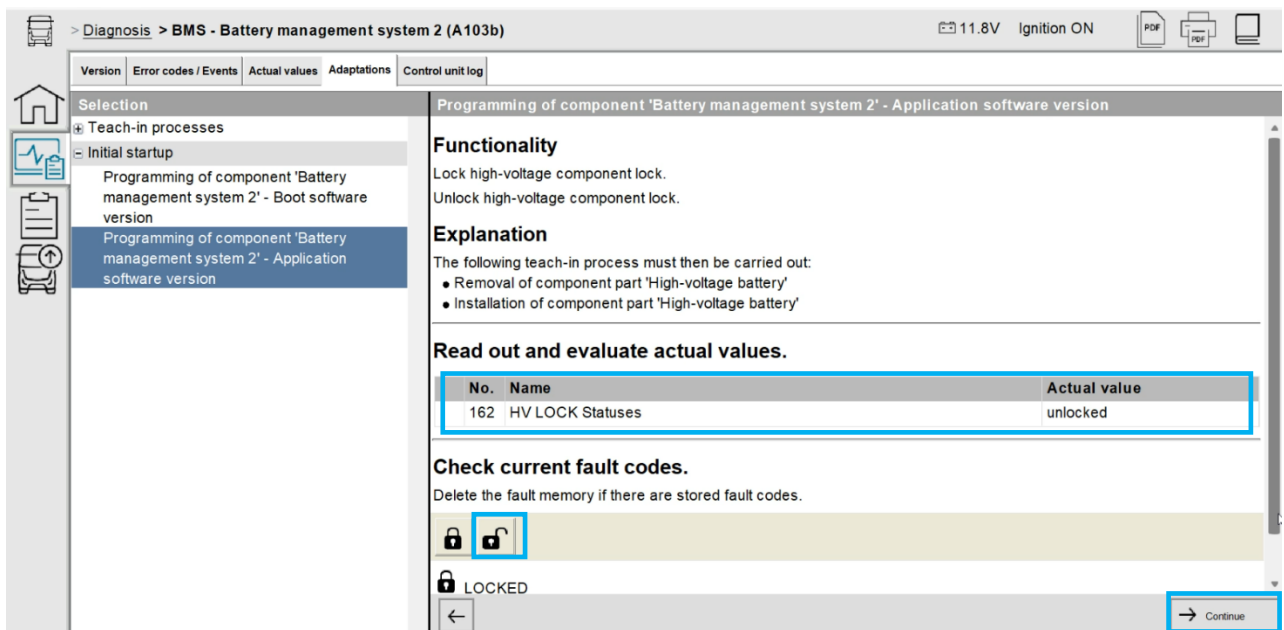
50. "Continue"

51. Check that the actual value for the HV lock state is set to "unlocked" ⇒ "Continue"
 *If "locked", click on the unlock symbol ⇒ "Continue"

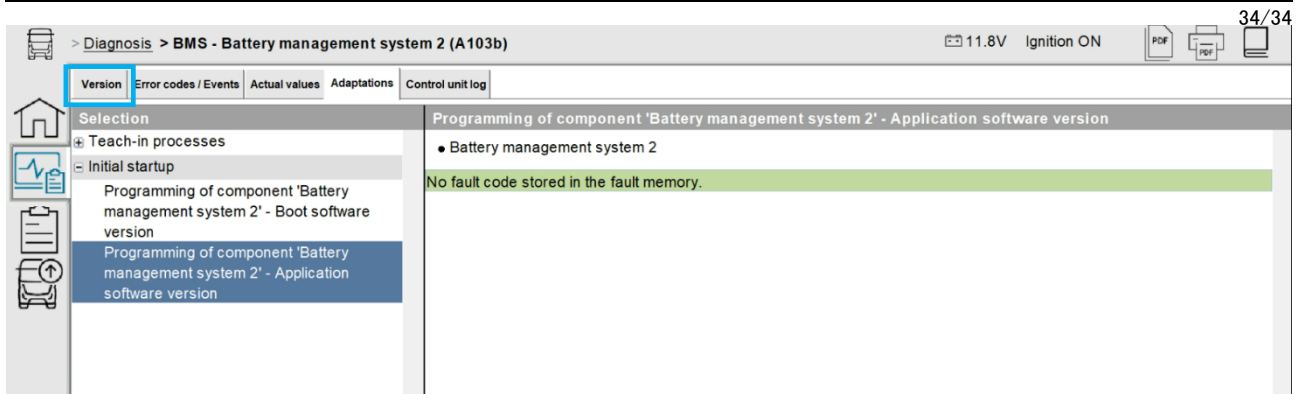
57. Select Version

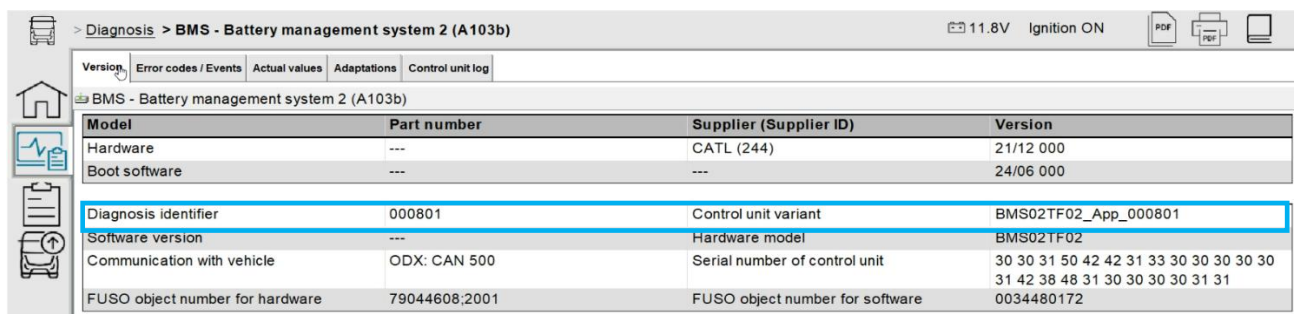
58. Ensure that the diagnosis ID and control unit variant is 000801.

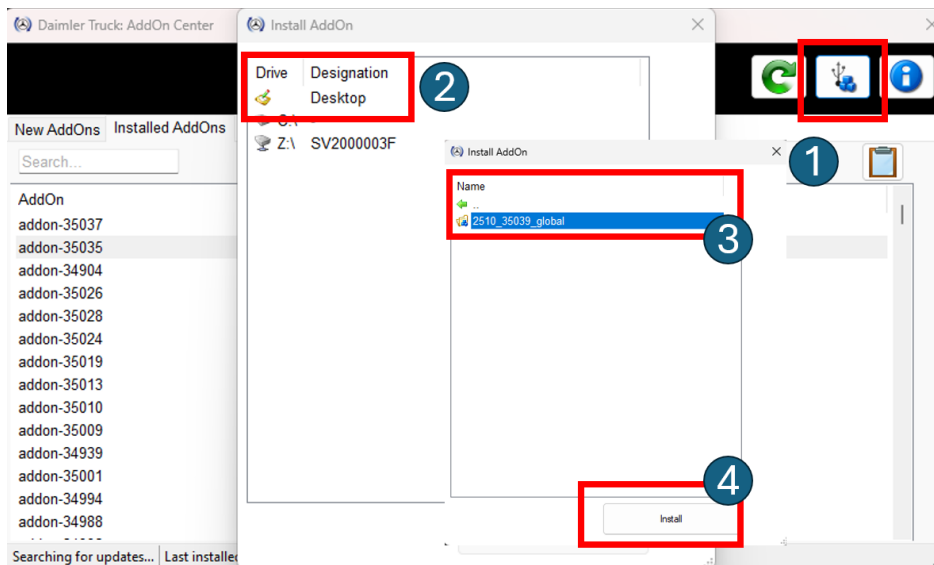
4. **Recovery Procedure If the Adaptations Tab is Not Displayed During Communication with the DCB**
When this screen appears, follow these instructions to install the mail Add-On.

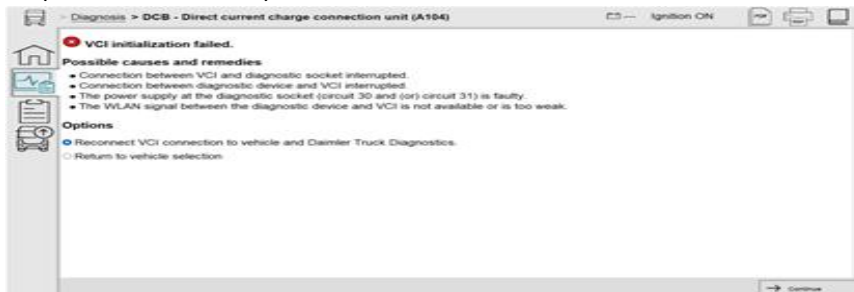
(Main Error Screen)

If any error occurs in the software rewriting of the DCB, follow this procedure to reset the DCB ecu.
Perform a hardware reset.

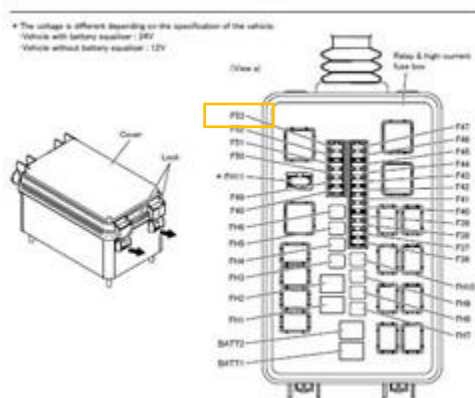
Location of high-current fuse F53 (10 A) to be removed (excerpt from maintenance Manual)

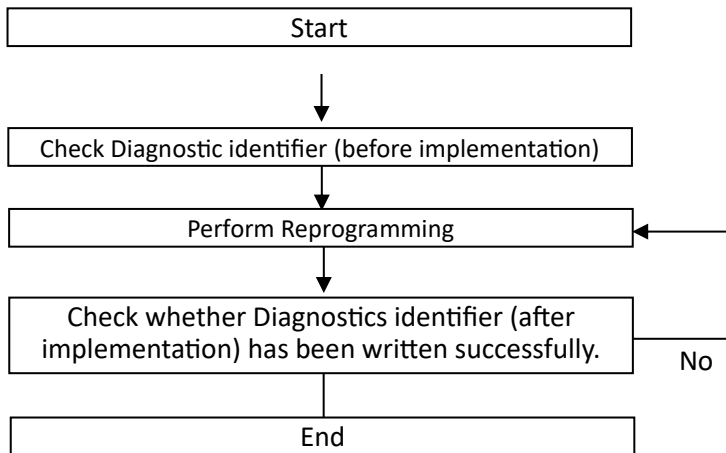
The ECU software can be reprogrammed from the "Initial start-up" - "Reprogramming" screen of the corresponding ECU.

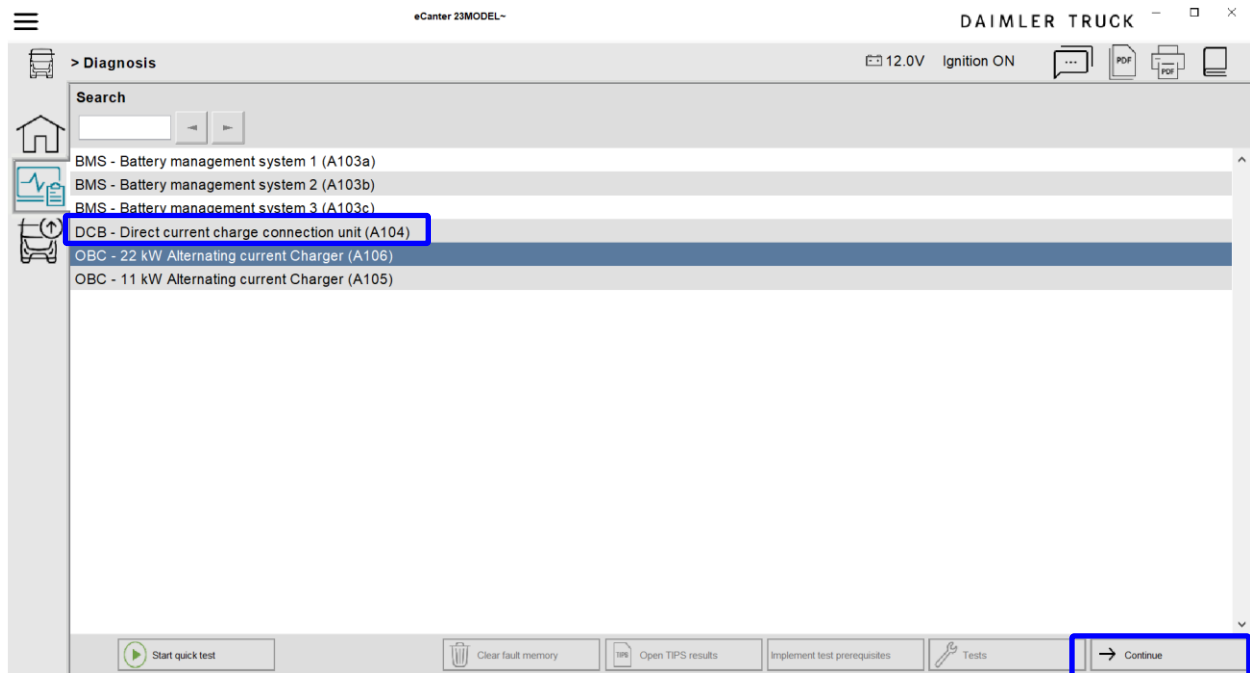
4. Click DCB ECU
5. Click continue.

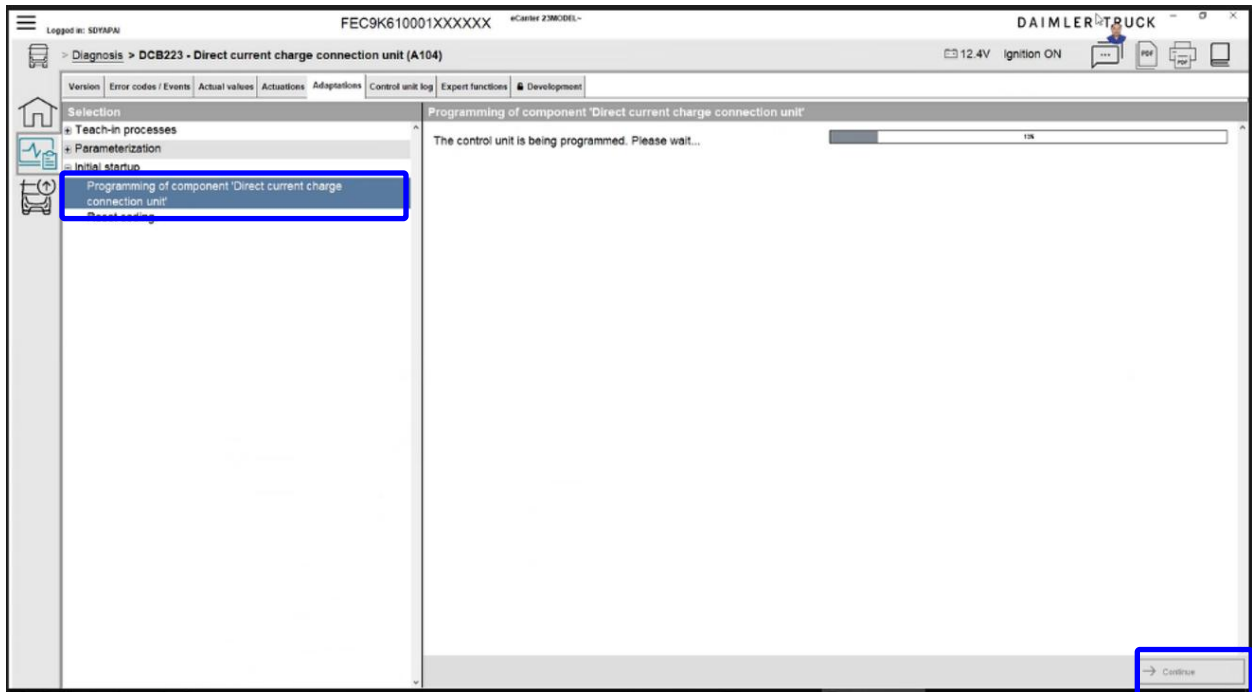
8. Click Programming of component 'Direct current change connection unit' (menu name may have changed due to update of DTD, but select one from the same place)
9. Then click "Continue"

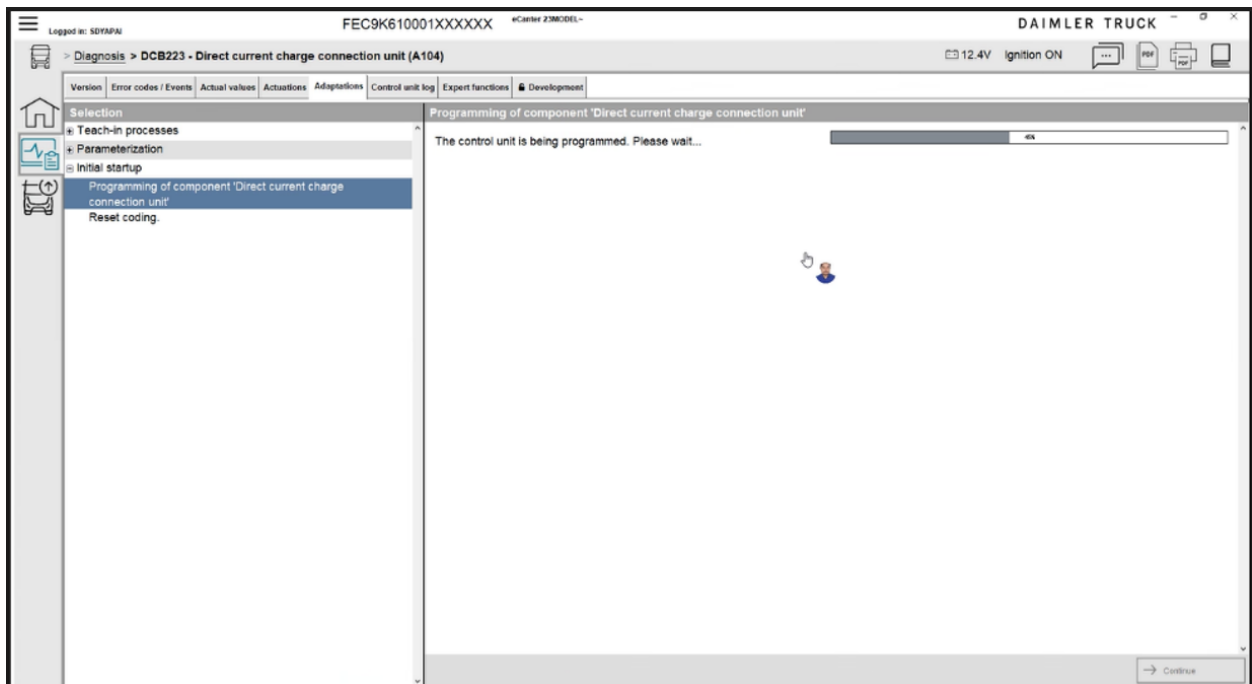
10. Reprogramming in progress. Wait for 100 % completion.

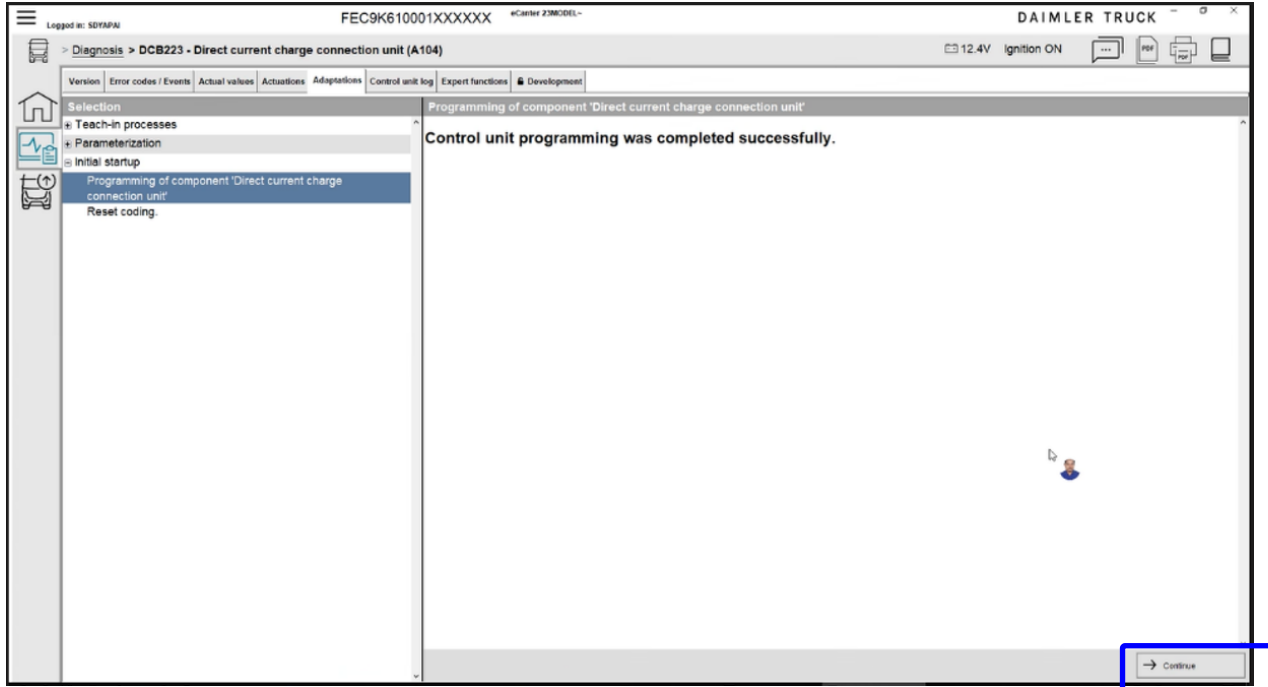
11. When this screen appears, the software rewrite is complete. Select “continue”

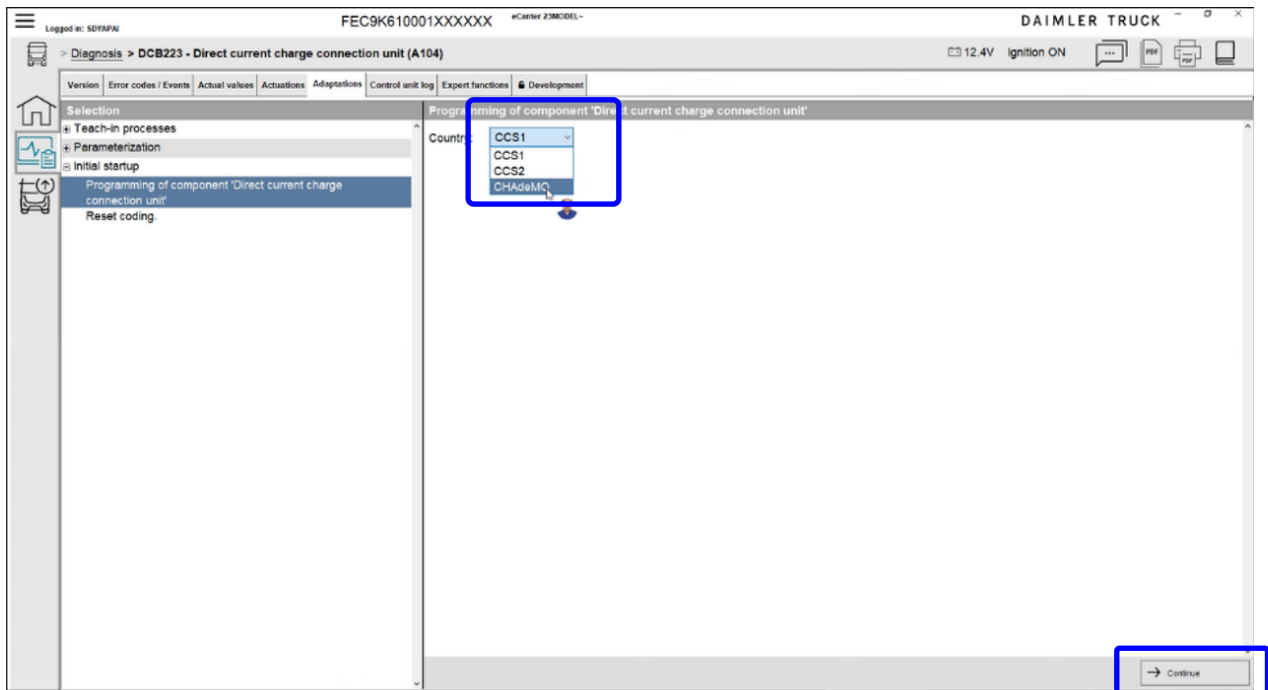
12. Select option as applicable country

Option	Country
CCS1	USA
CCS2	Europe Other country without Japan and USA
CHAdEMO	Japan

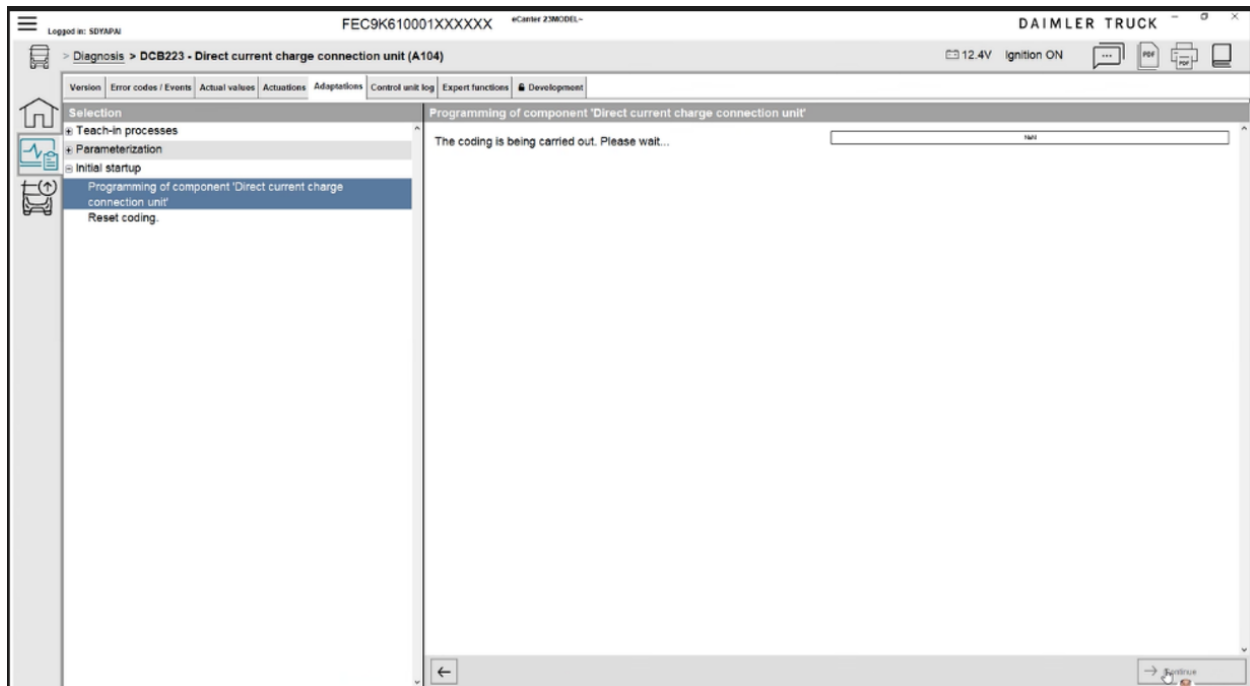
14. Parameter coding in progress

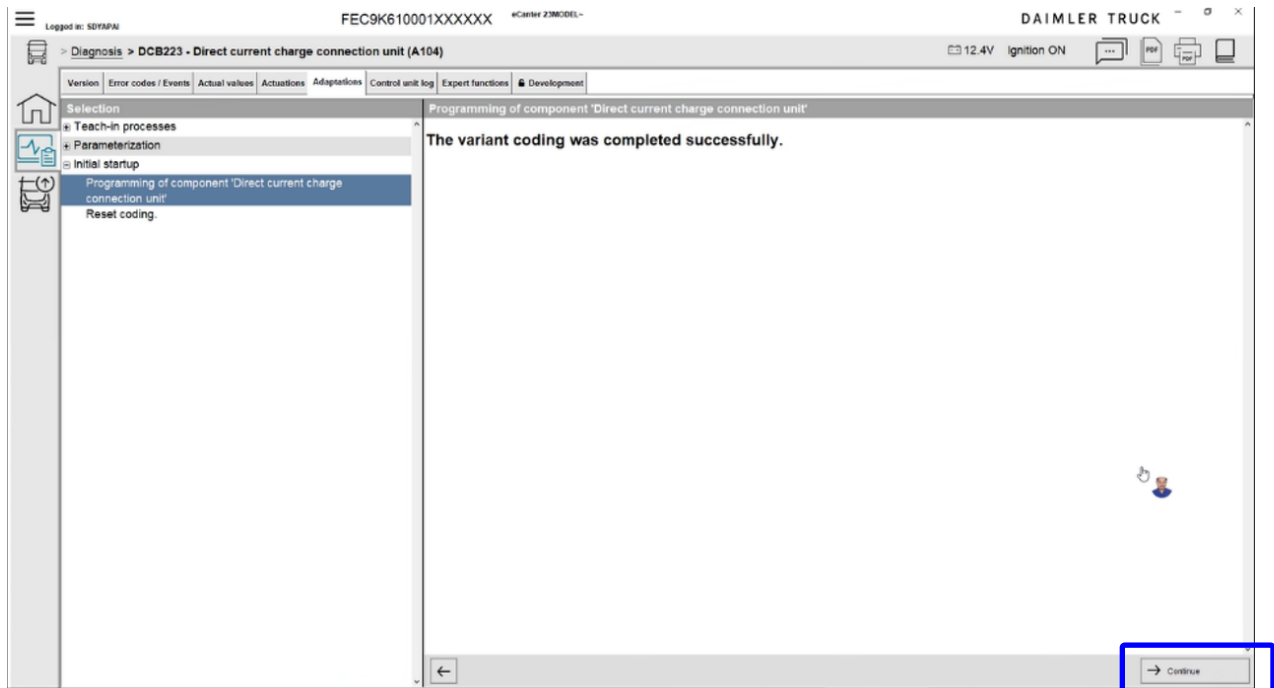
15. Confirm Variant coding completion and then click “continue”

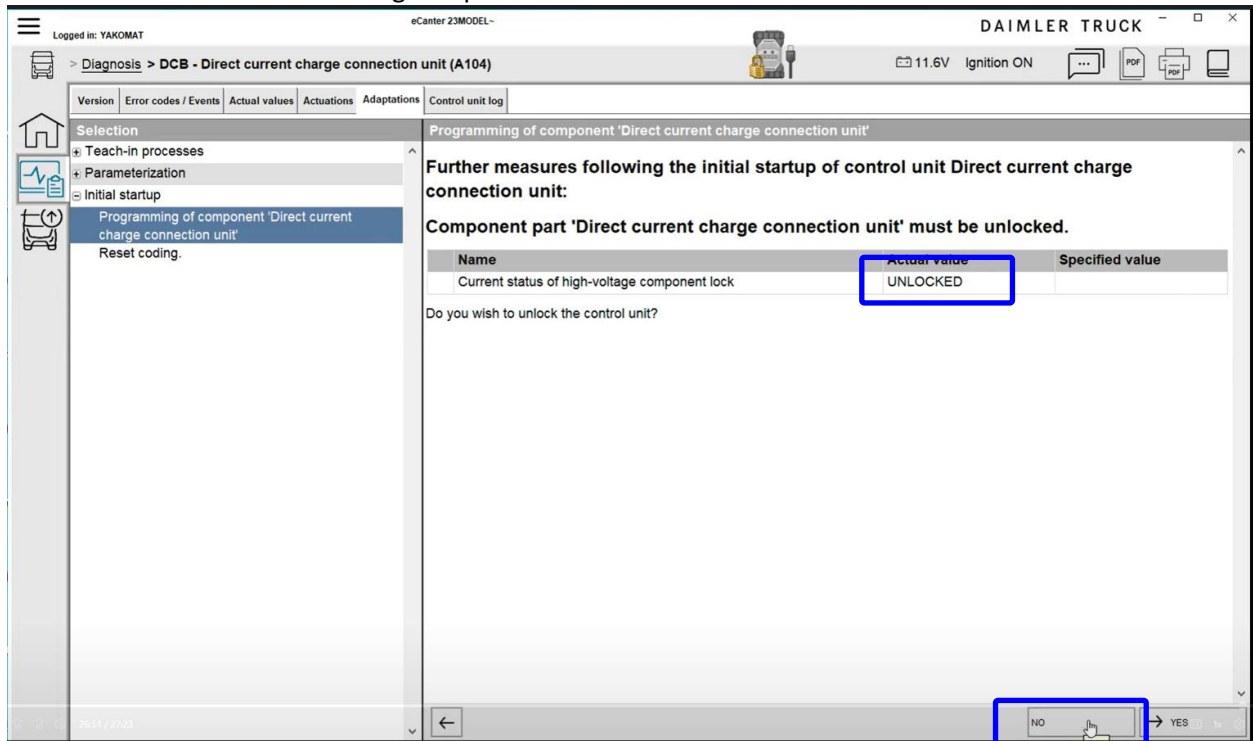
16. Check Current status of High voltage Component lock “UNLOCKED” Status and then click “No”. If Current status is in “LOCKED state, then click “yes”.

- Unlock: Select No
- Lock: Select Yes

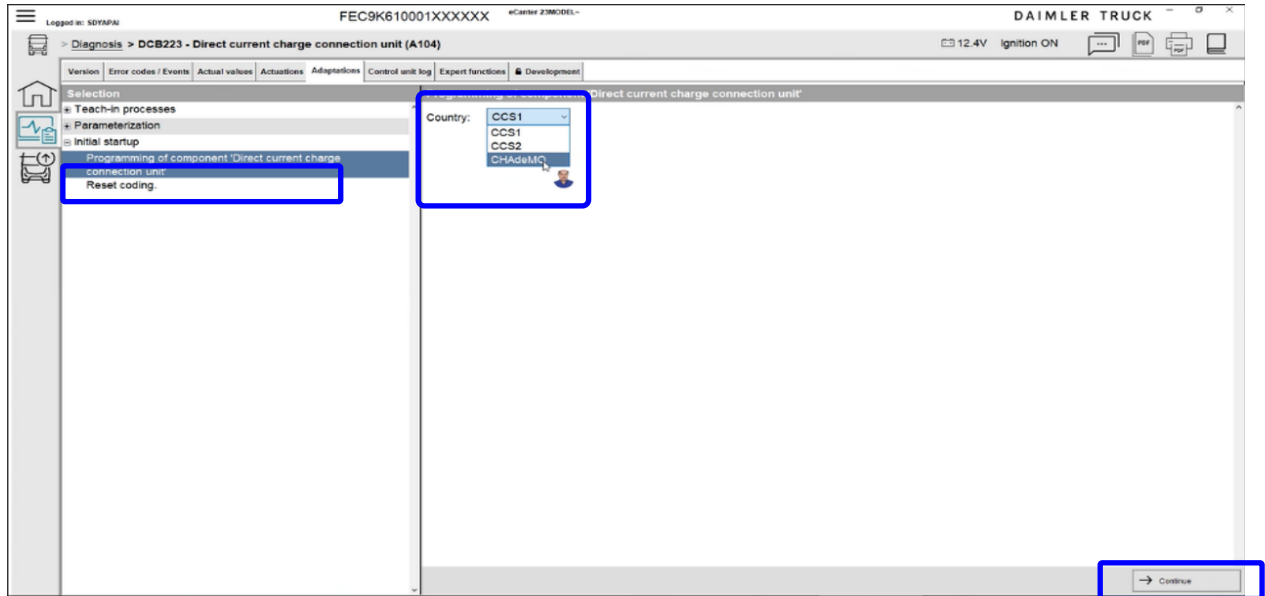
17. Select "Reset of Coding" select country code accordingly from below, and select "continue"

- CCS1: NORTH AMERICA
- CCS2: EUROPE, OTHER COUNTRIES
- CHAdcMO: Japanese
