Recall Information Bulletin

Safety Recall C10136 – HV System 0% State of Charge While Stationary

FEC7K (E16L/E16M), FEC9K (E18L/E18M), FECXK (E18)

eCANTER 23MODEL BMS Software Update Procedure

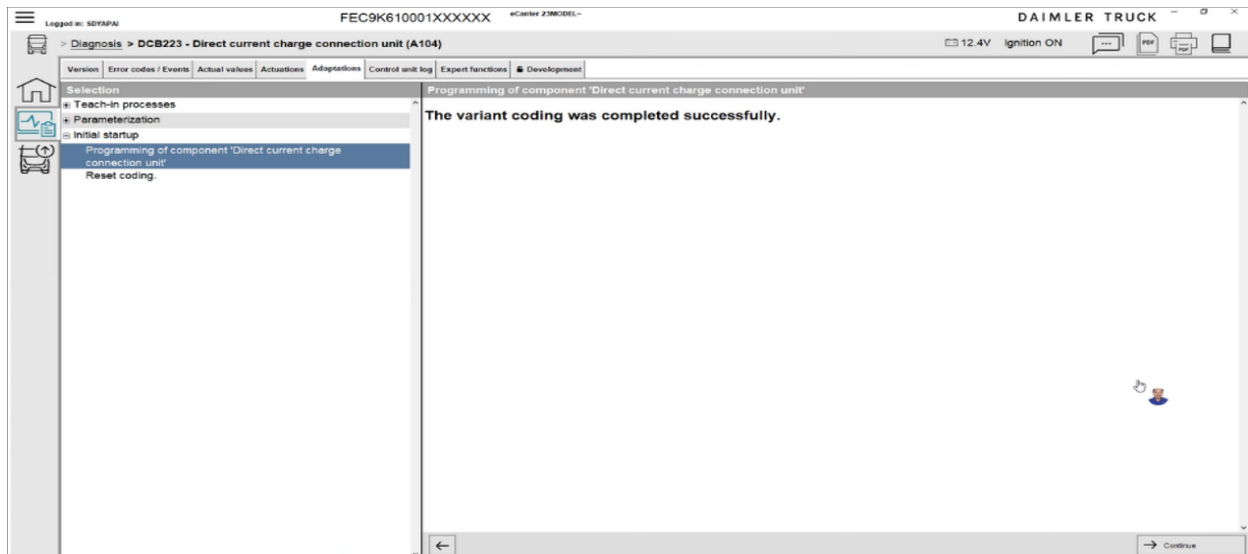
18. Variant coding is completed .

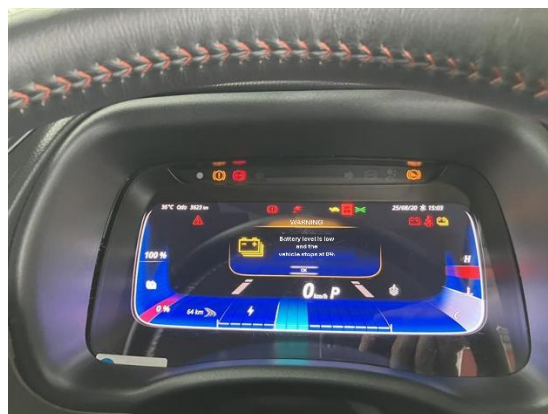
Note: IF THE BATTERY LEVEL ON THE ICUC DISPLAY WAS 0% AFTER COMPLETION OF THE WORK, THE BATTERY DISPLAY RETURNS TO NORMAL BY PERFORMING A RUN-ON TIME OF 1 MINUTE WITH THE KEY OFF.

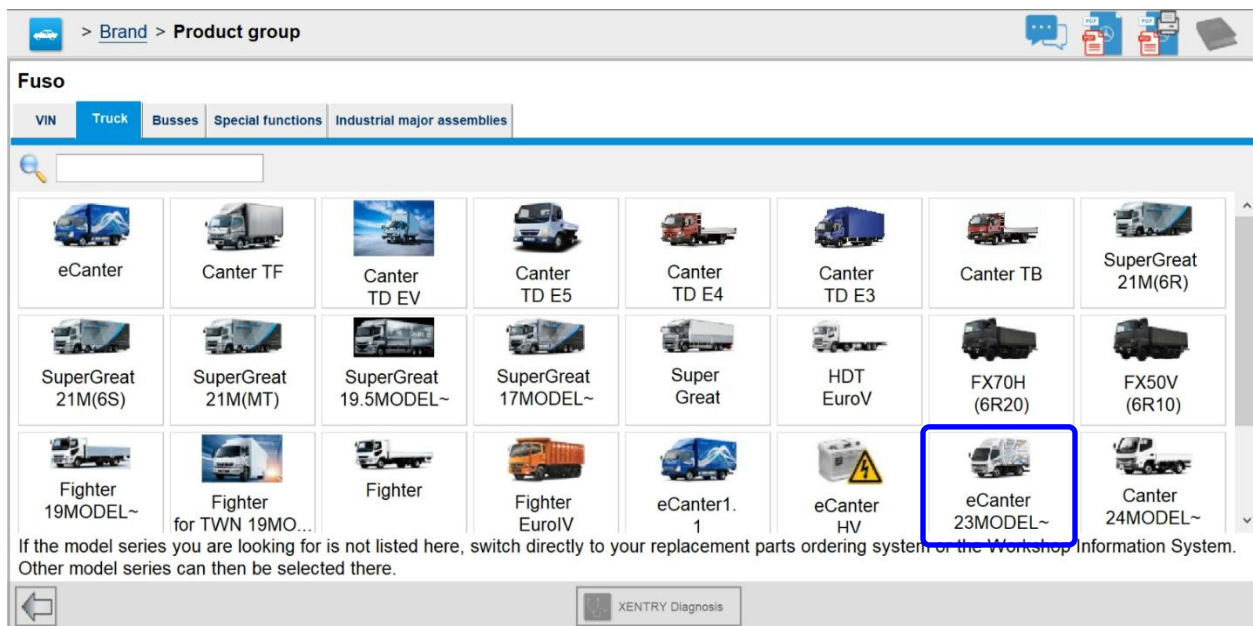
The screenshot shows the Fuso product selection interface. The breadcrumb navigation is "> Brand > Product group". The main heading is "Fuso". Below it, there are tabs for "VIN", "Truck", "Busses", "Special functions", and "Industrial major assemblies". The "Truck" tab is selected. A search bar is present. The main area displays a grid of vehicle models, each with a small image and a label. The models listed are:

1. Select "eCANTER 23MODEL".

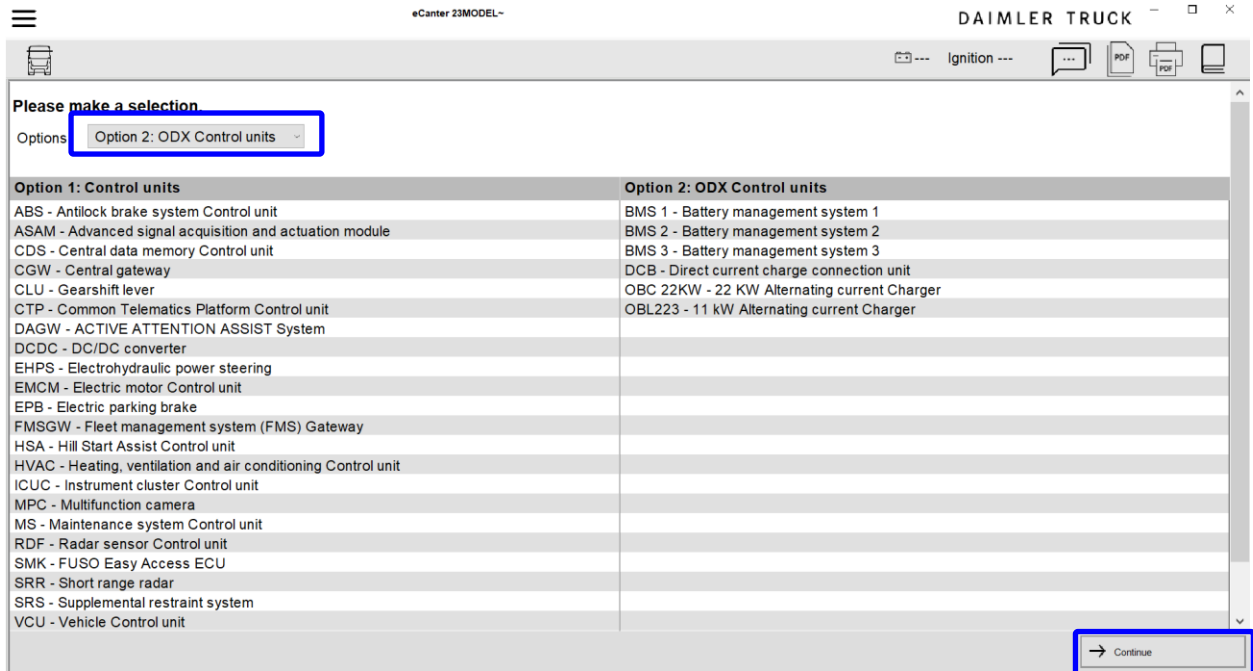
2. Click "Option 2: ODX Control units".
3. Click "Continue" button.

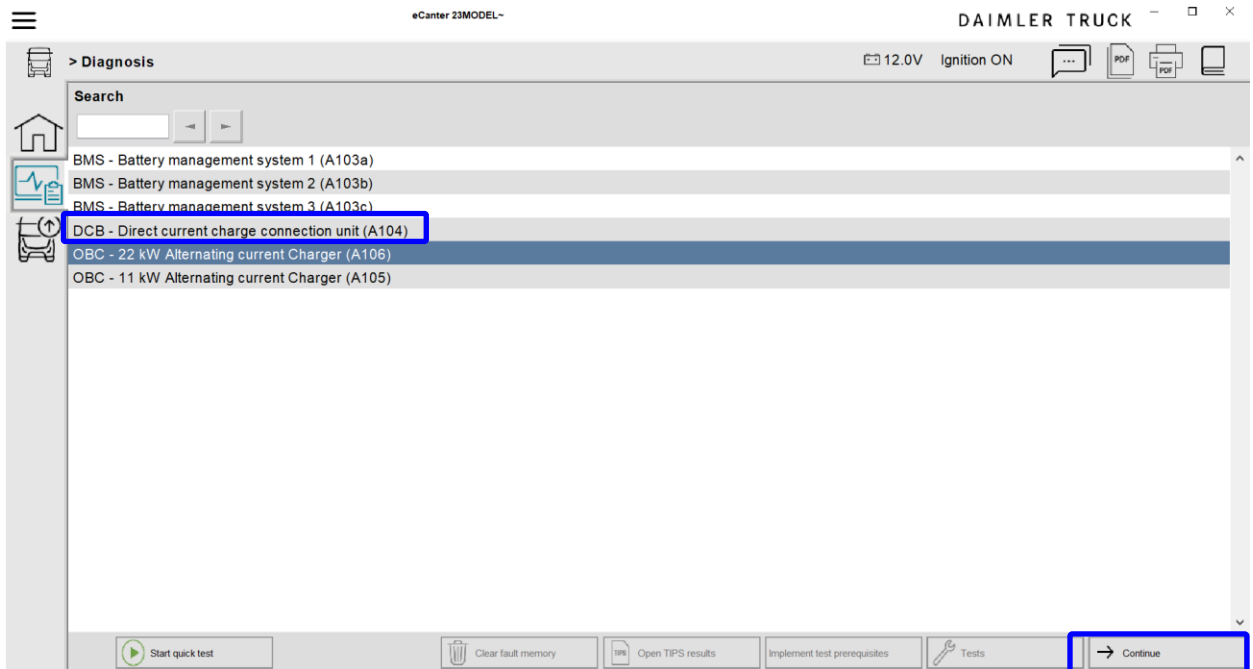
4. Click DCB ECU
5. Click continue.

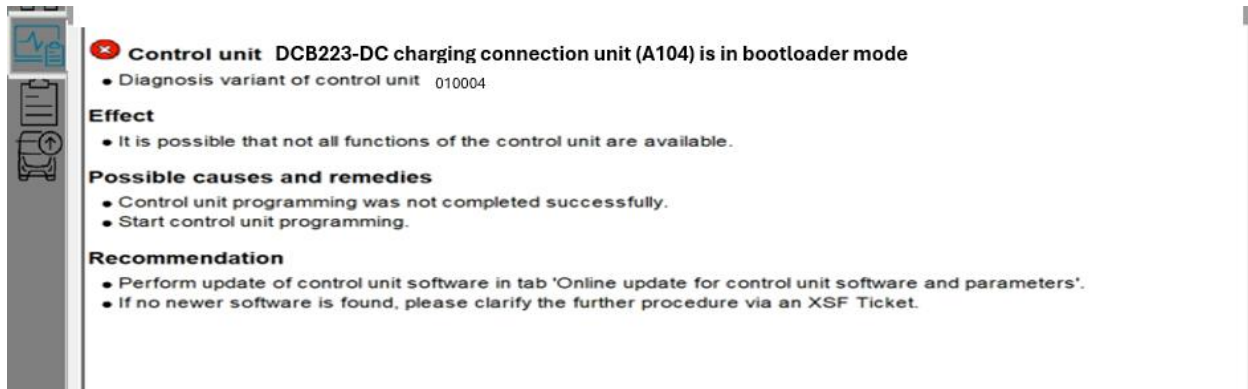
Control unit DCB223-DC charging connection unit (A104) is in bootloader mode

6. Bootloader mode will be displayed in between, Select “continue”

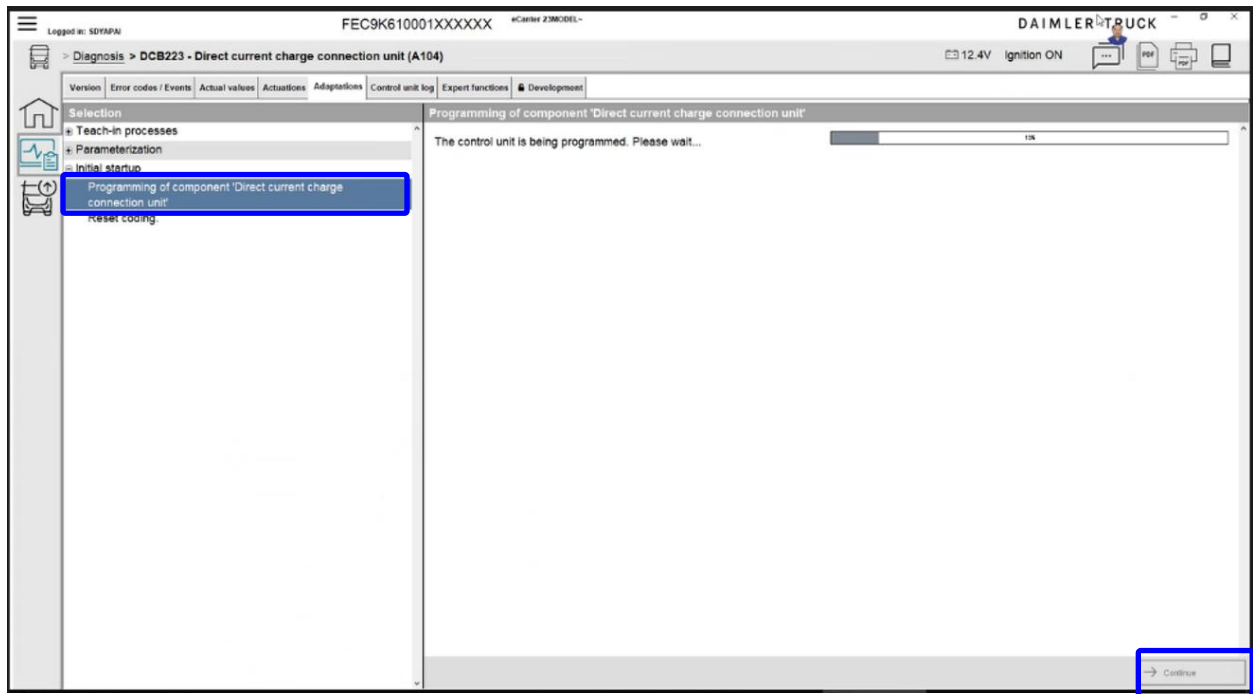
10. Once the DCB data has been loaded, menu will appear on the left side of the screen.

11. Click Programming of component 'Direct current change connection unit' (menu name may have changed due to update of DTD, but select one from the same place) & "Continue"

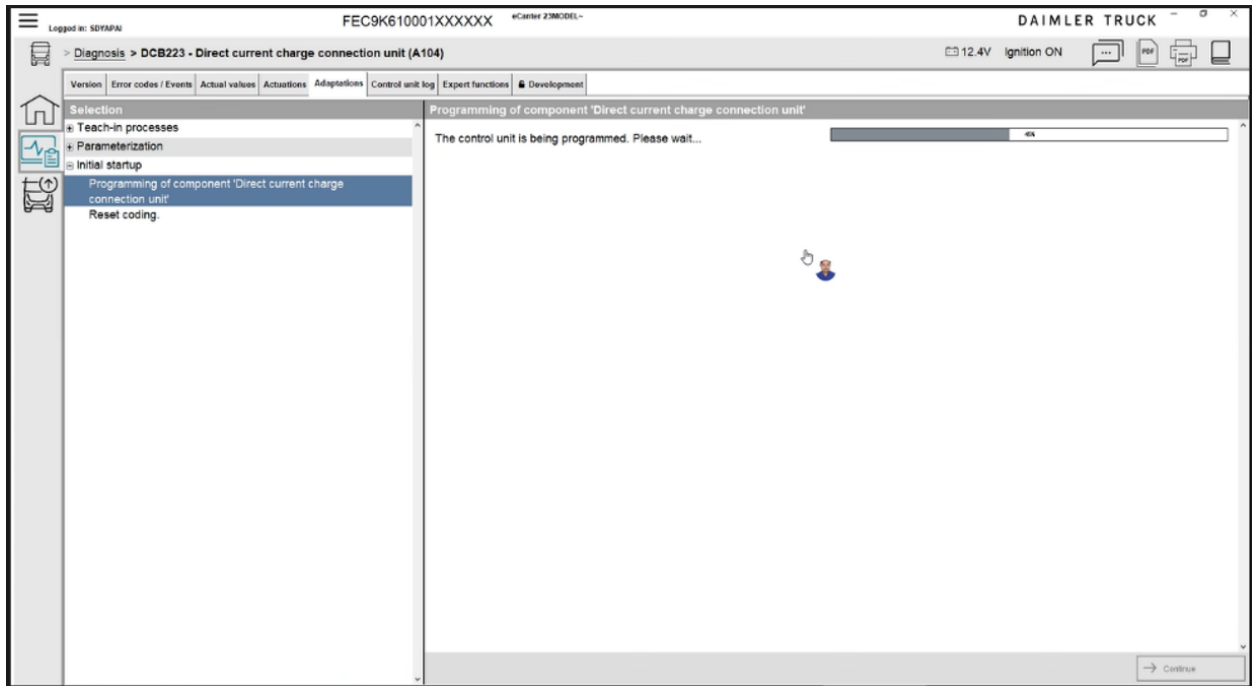
12. Reprogramming in progress. Wait for 100 % completion.

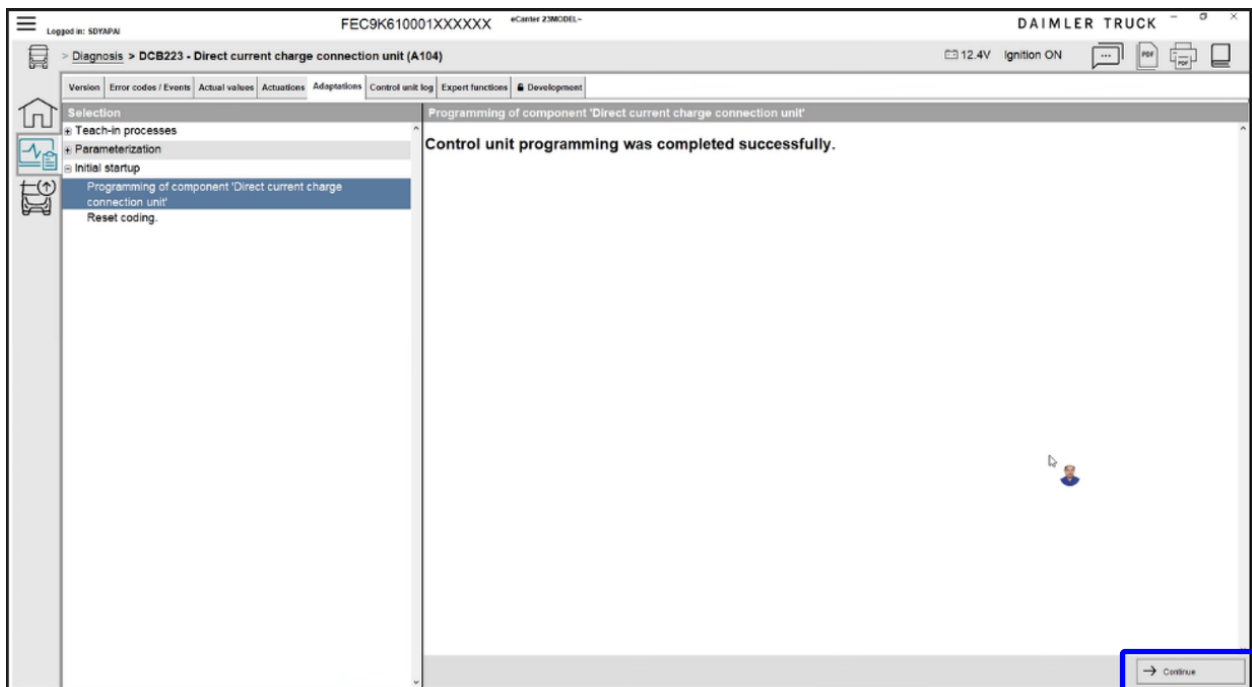
13. When this screen appears, the software rewrite is complete. Select “continue”

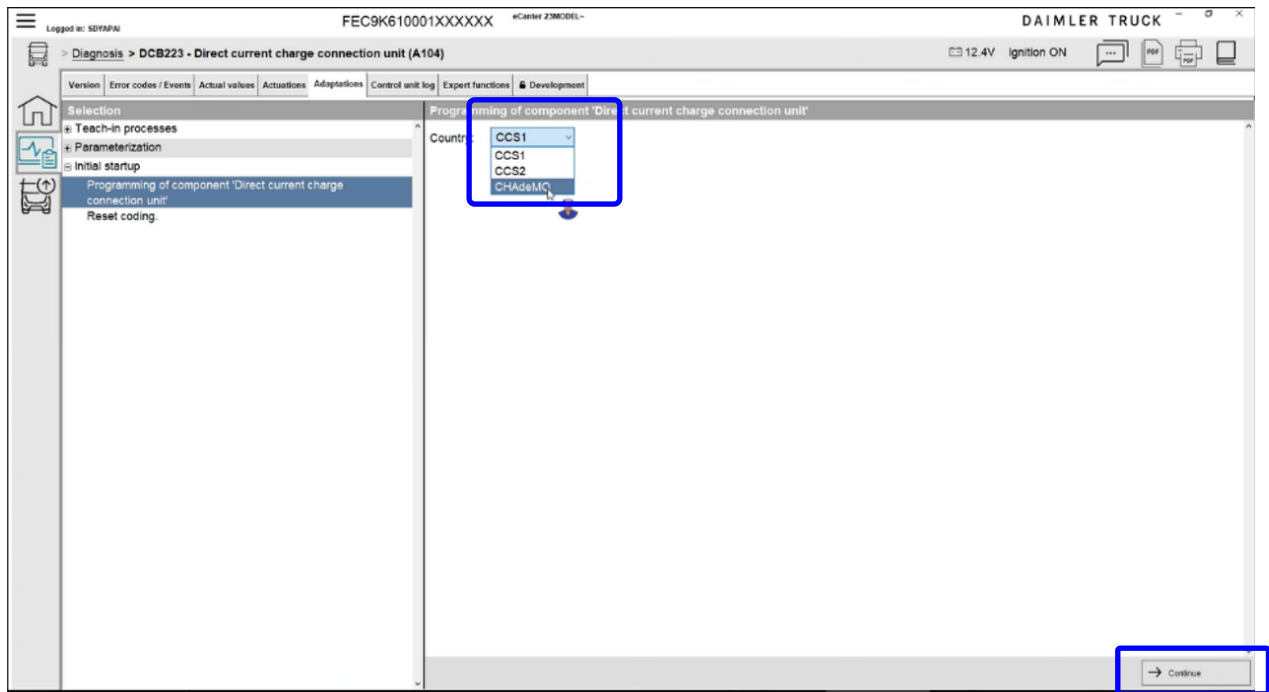
14. Select option as applicable country

Option	Country
CCS1	USA
CCS2	Europe Other country without Japan and USA
CHAdeMO	Japan

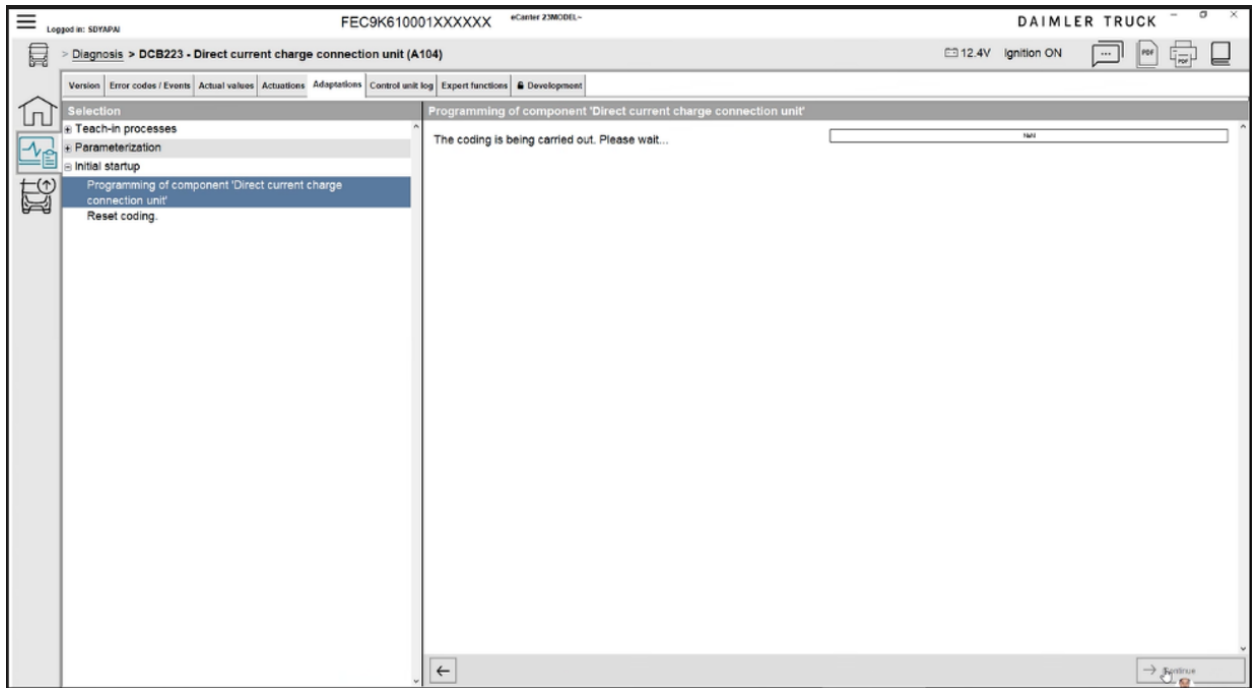
16. Parameter coding in progress

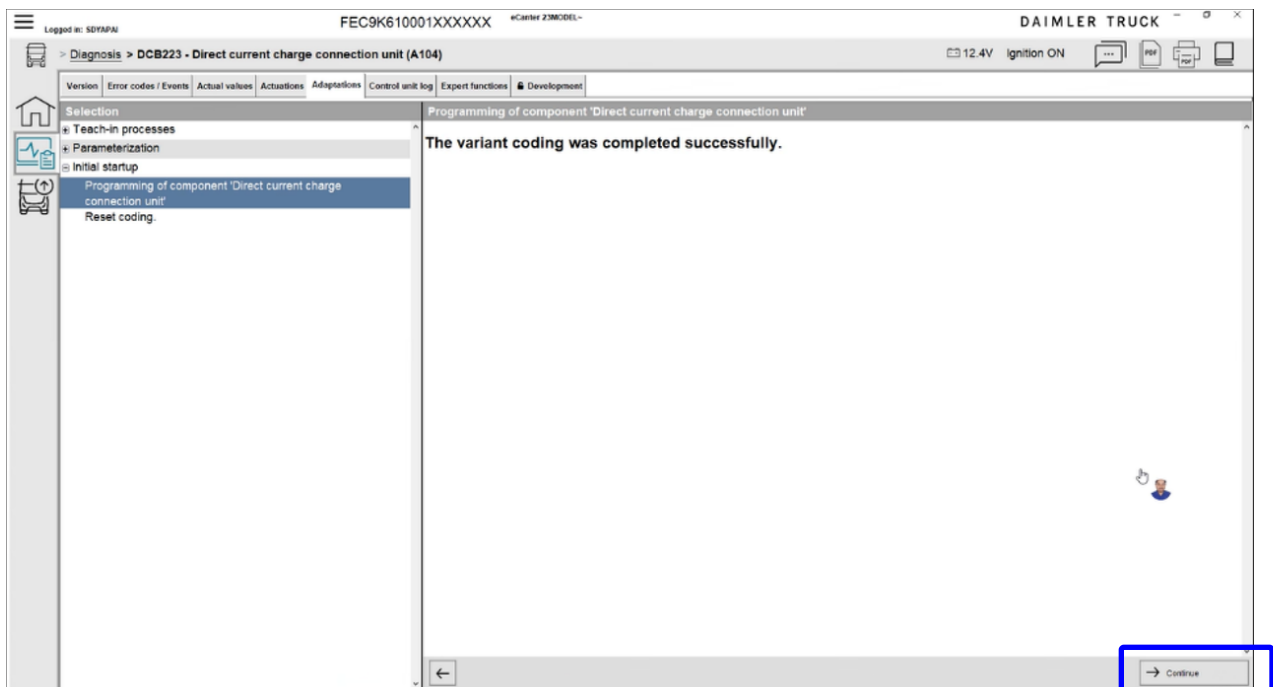
17. Confirm Variant coding completion and then click “continue”

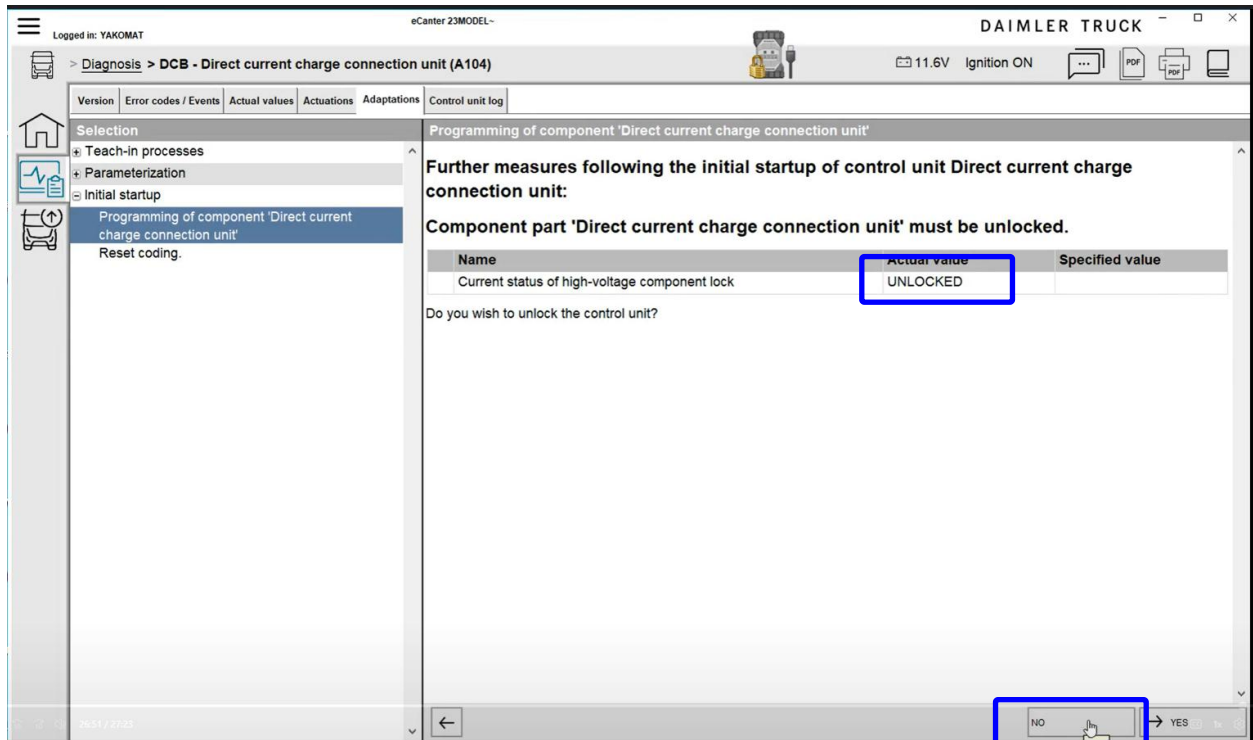
18. Check Current status of High voltage Component lock “UNLOCKED” Status and then click “No”.
If Current status is in “LOCKED state, then click “yes”.

- Unlock: Select No
- Lock: Select Yes

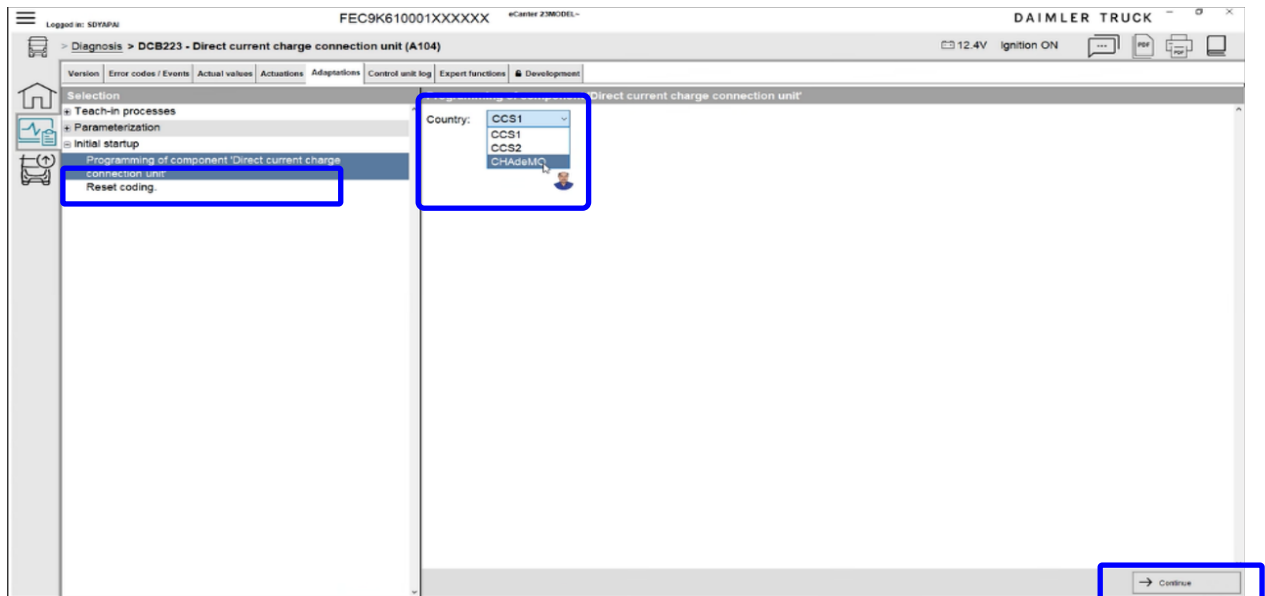
19. Select “Reset of Coding” select country code accordingly from below, and select “continue”

- CCS1: NORTH AMERICA
- CCS2: EUROPE, OTHER COUNTRIES
- CHAdEMO: Japanese

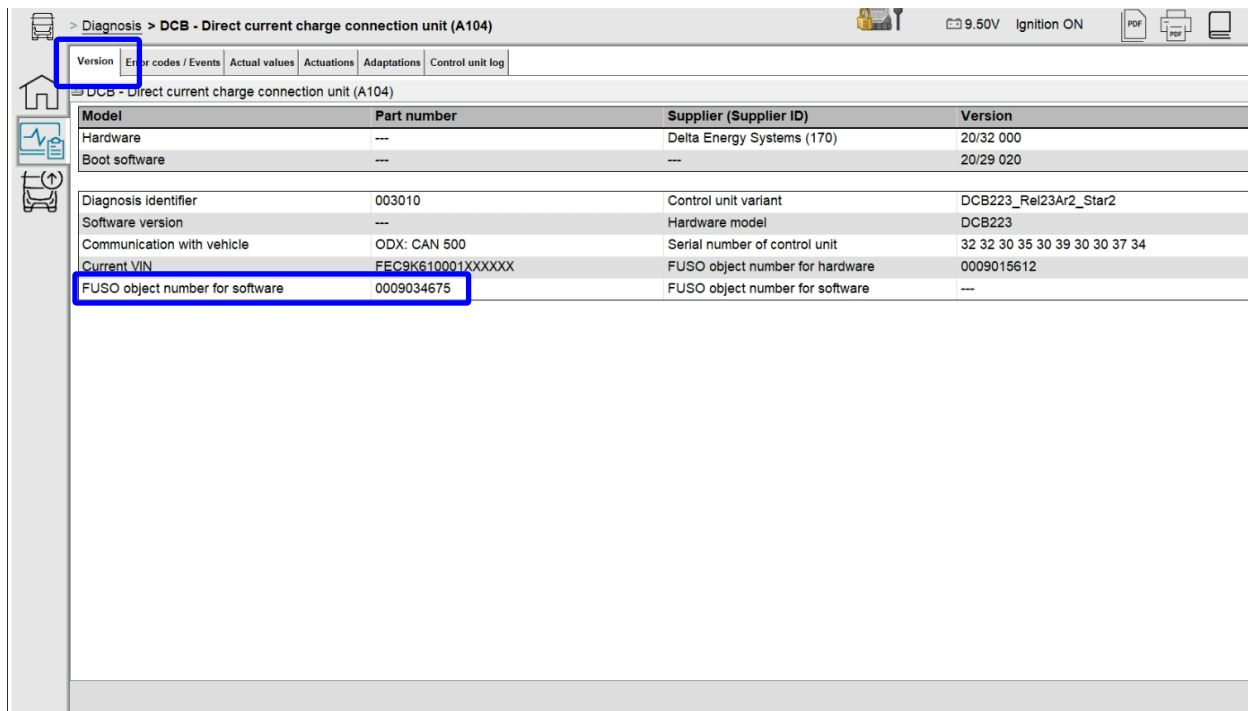
21. Select version tab for software part number check and confirm new Software Part Number.

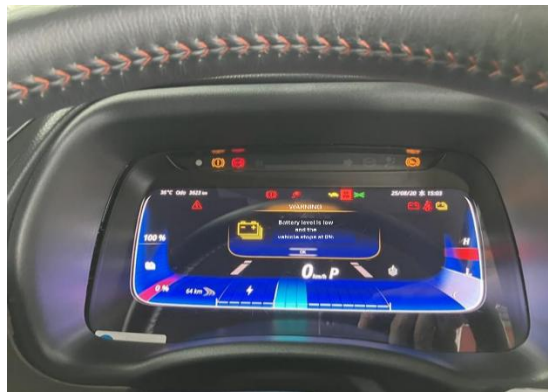
Note: IF THE BATTERY LEVEL ON THE ICUC DISPLAY WAS 0% AFTER COMPLETION OF THE WORK, THE BATTERY DISPLAY RETURNS TO NORMAL BY PERFORMING A RUN-ON TIME OF 1 MINUTE WITH THE KEY OFF.
