# HYUNDAI

## Technical Service Bulletin

GROUP <b>RECALL</b>	NUMBER <b>26-01-031H-1</b>
DATE <b>APRIL 2026</b>	MODEL(S) <b>PALISADE (LX3) PALISADE HYBRID (LX3 HEV)</b>

**SUBJECT:** BDC, POWER SEAT UNIT (PSU) & AVN SOFTWARE UPDATE FOR OPERATION LOGIC IMPROVEMENT (RECALL 296)

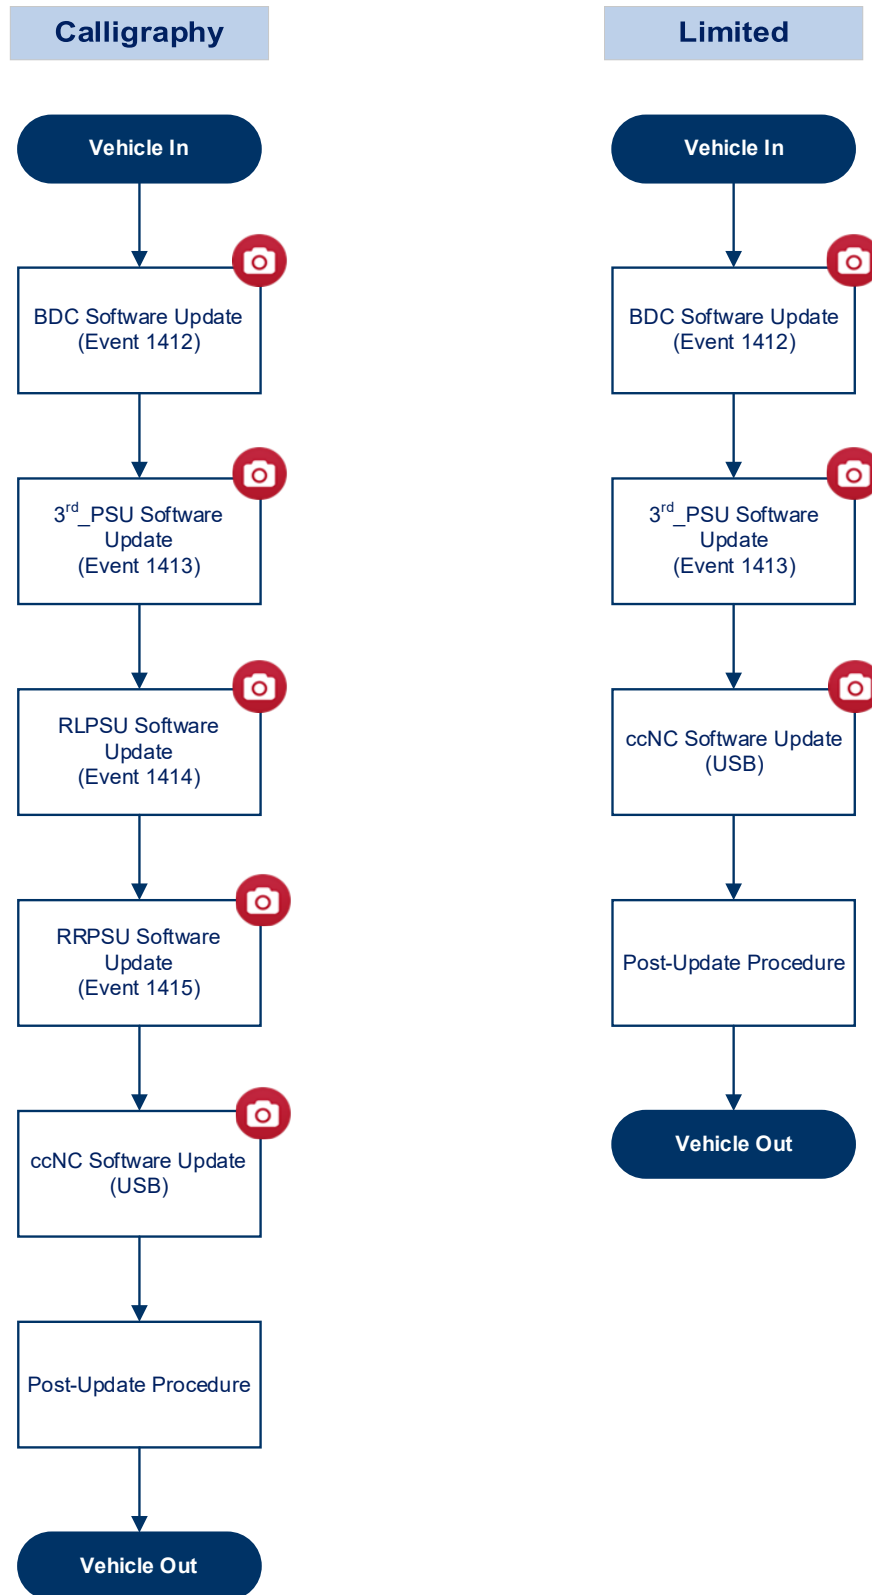
**SUBJECT:**BDC, POWER SEAT UNIT (PSU) & AVN SOFTWARE UPDATE FOR  
OPERATION LOGIC IMPROVEMENT (RECALL 296)**Flowchart:**

**NOTE:** Perform software updates in the order of the flowchart displayed above.

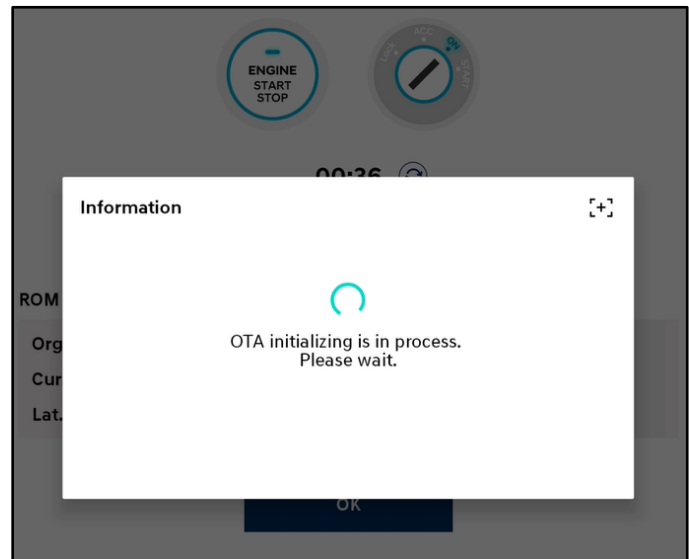
5. The GDS will automatically perform the OTA initializing.

If the GDS does **NOT** automatically perform the OTA initializing, then perform this procedure after **all applicable modules** have been updated successfully.

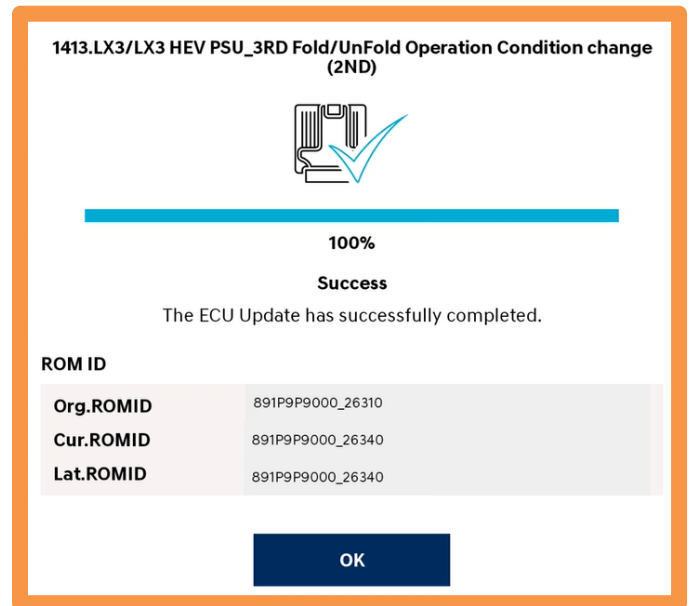
Using the tablet or GDS screen capture function, take a screenshot of the ECU Update “Success” result screen.

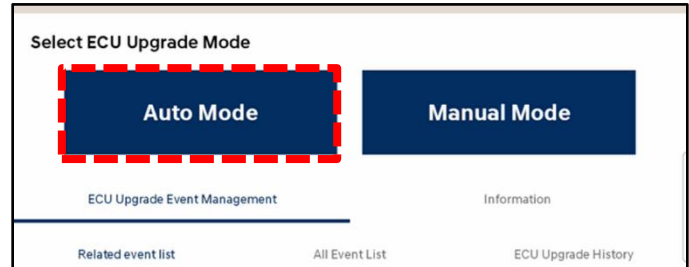
1. Perform the ECU update in **Auto Mode**.

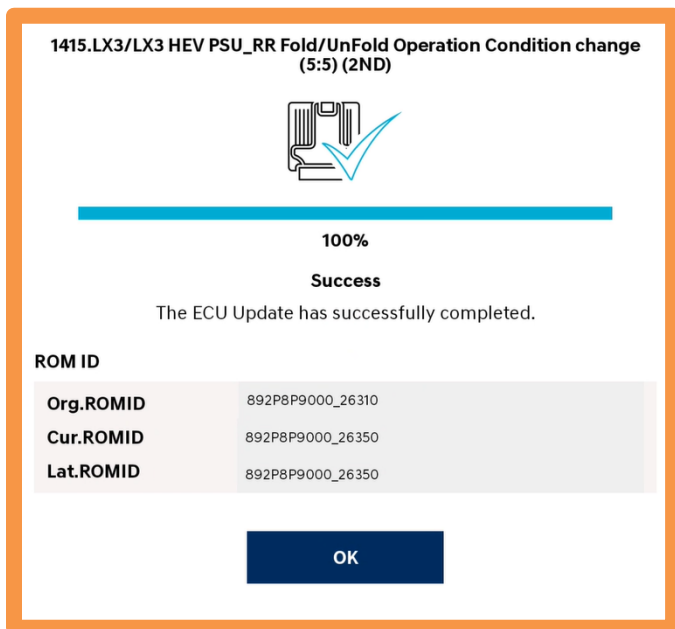
Using the tablet or GDS screen capture function, take a screenshot of the ECU Update "Success" result screen.

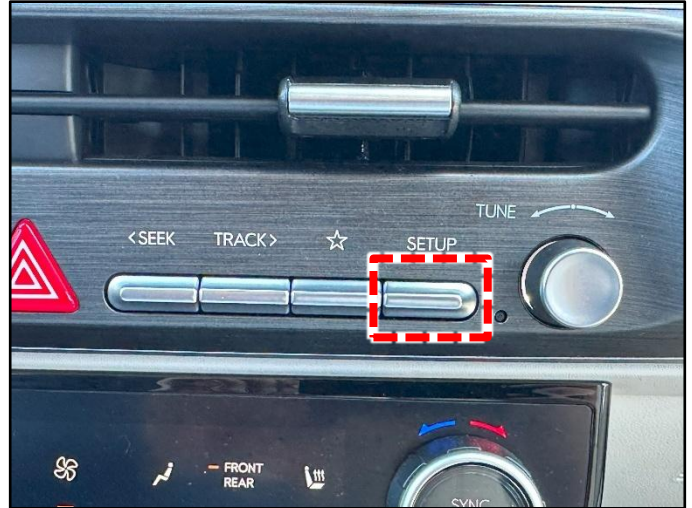
1. With the ignition **ON**, press the **SETUP** button.

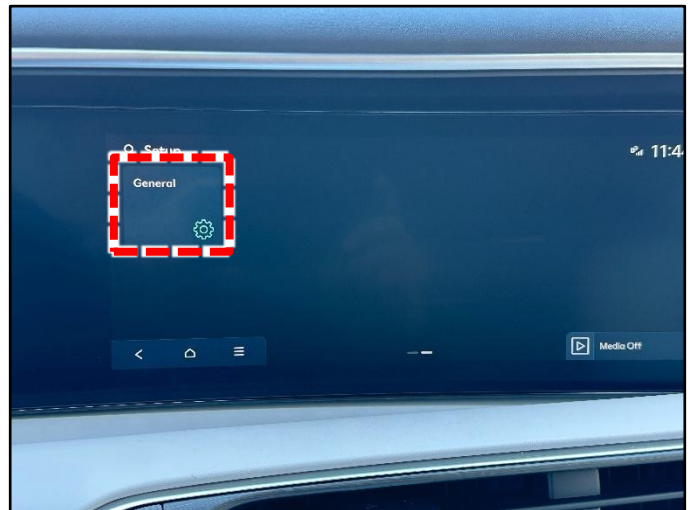
2. Select **General**.

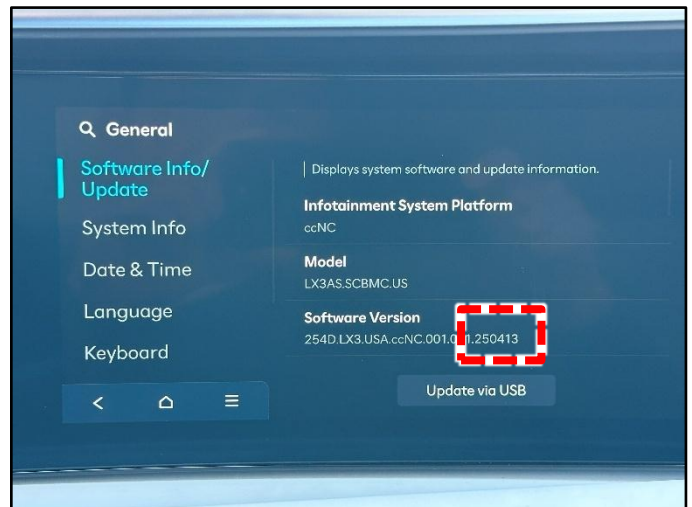
3. Select **Software Info/Update**.

Verify the software version is:

- XXXX.LX3.USA.ccNC.001.001 **260114** or before.

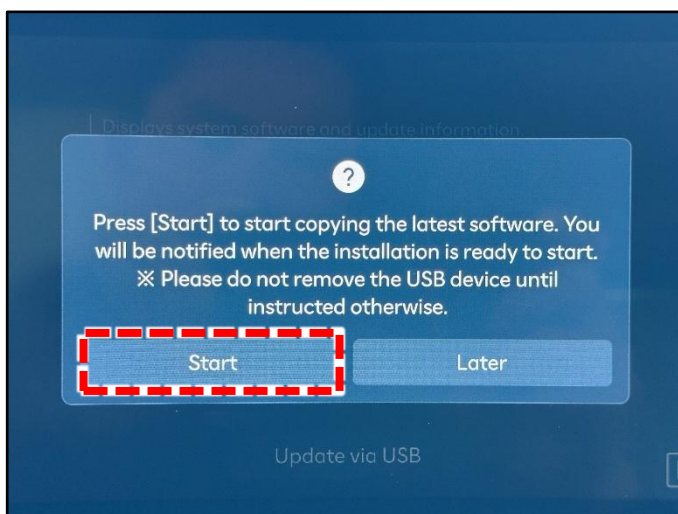
5A. A pop-up message will appear, select **START**.

If the pop-up menu does **NOT** appear, select **USB update** or **Software Info/Update**.

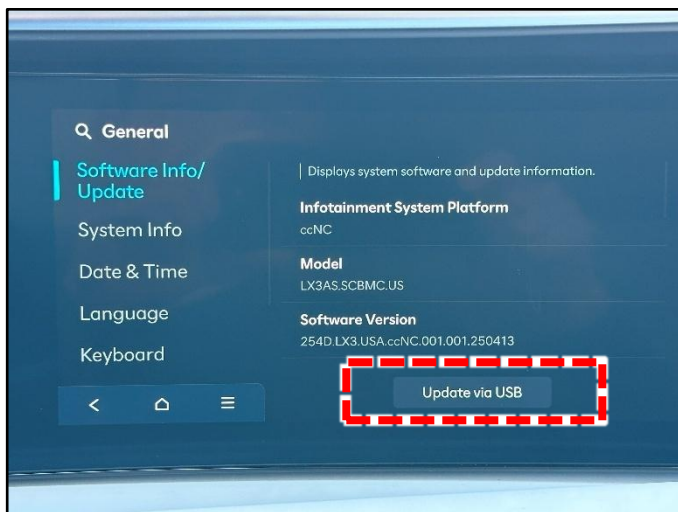
5B.

If the pop-up menu does **NOT** appear, select **USB update** or **Software Info/Update**.

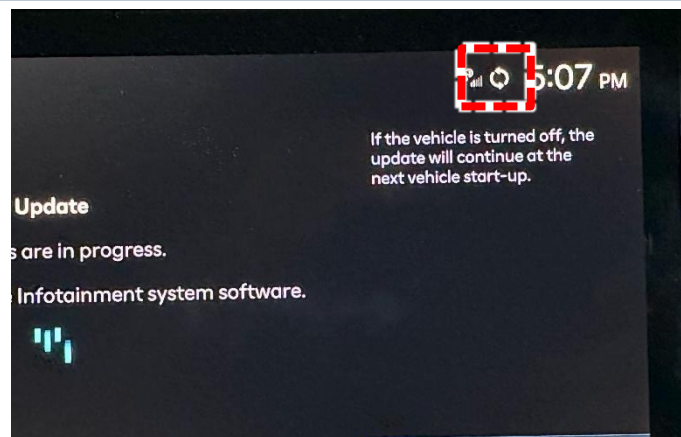
6. Wait for the update to be completed.

The background update icon is at the top-right corner of the menu. The update will take **~40 minutes**.

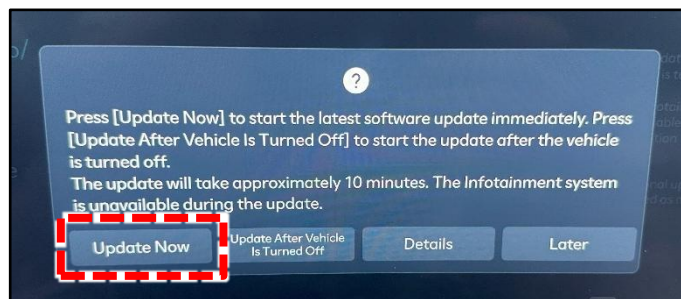
7. Once the pop-up menu appears, select **Update Now**.

If the pop-up menu does **NOT** appear, restart the **IGNITION** then select **Update Now**.

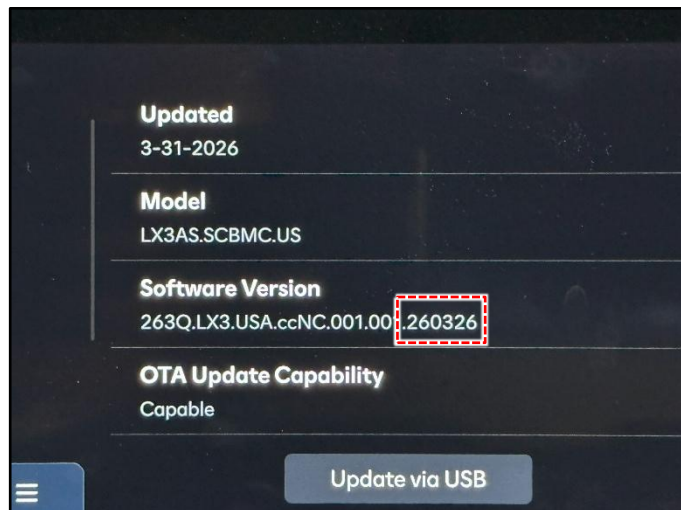
9. Verify the software version is:

- XXXX.LX3.USA.ccNC.001.001.**260326** or later

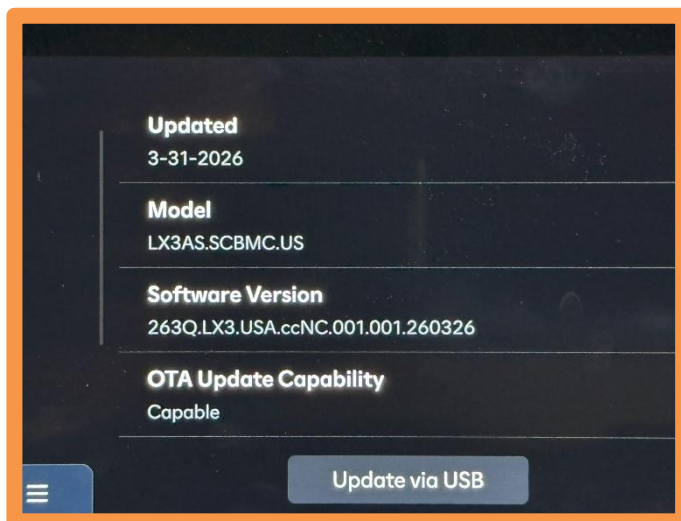
Using the tablet or GDS screen capture function, take a photo of the AVN software version.

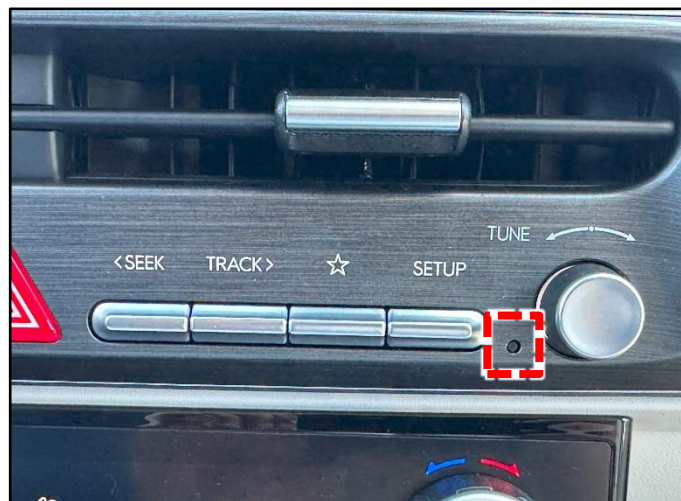
11. Use a small tool to press the pinhole button to reset the AVN system.

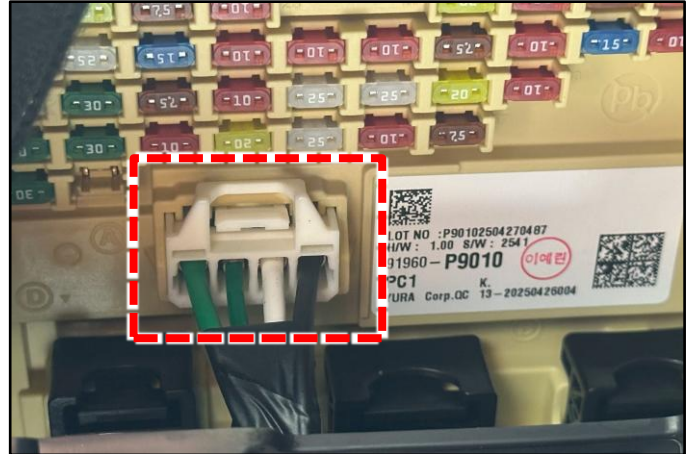
1. Remove the power connector of the indoor fuse box and reconnect after **5 seconds**.
