GROUP	MODEL
Safety Recall Campaign	2027MY Telluride HEV (LQ2 HEV) SX Prestige & X-Line SX Prestige w/Executive Package
NUMBER	DATE
SC366	April 2026

POWER 2ND-ROW SEAT OPERATION LOGIC IMPROVEMENT (SC366)

This bulletin provides information to update the power 2nd-row seat control software to enhance the operating logic of the automatic power-folding (stow) and “one-touch” tilt-and-slide (walk-in) features of the power 2nd-row seats on certain 2027 MY Telluride Hybrid (HEV) SX Prestige and X-Line SX Prestige vehicles equipped with the optional Executive Package and manufactured from February 2, 2026 through March 13, 2026. The power 2nd-row seat assemblies in the subject vehicles, which have an automatic power-folding (stow) and “one-touch” tilt-and-slide (walk-in) features, may not detect obstructions and may continue to move if these features are used while an occupant is in the seat or is entering/exiting the rear of the vehicle, increasing the risk of injury. Follow the procedure outlined in this publication to update the power 2nd-row seat control software on the applicable vehicle.

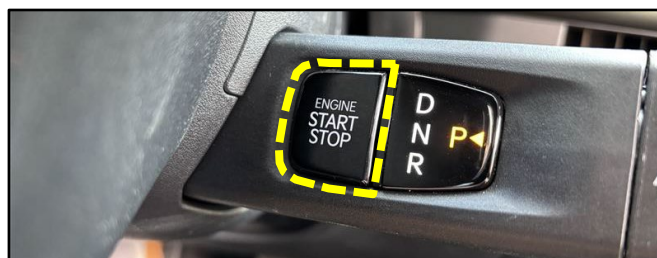
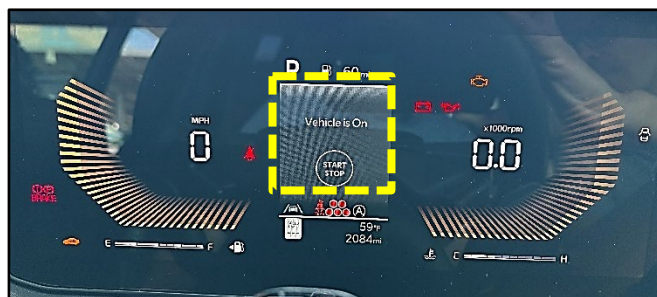
1. Set ignition to **'Vehicle On'** (Engine 'OFF') via ENGINE (START/STOP) button.
2. Perform **'Auto-VIN'** function using KDS to identify the subject vehicle.
3. Enter the **'SW Management'** screen in KDS.
4. Set ignition to vehicle **'OFF'**.
5. Refer to additional instructions on page 6.

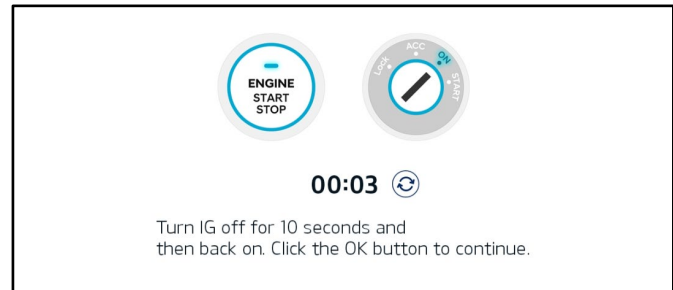
6. Begin 'BDC' SW upgrade, with ignition 'OFF'.

964. LQ2a HEV Power Seat Unit Operation Logic Improvement (BDC)

Note: If the 'pop-up' message shown on the right is displayed, ignore it and select 'OK' as the vehicle ignition is already set 'OFF'.

7. After the 'BDC' software upgrade is complete, set the ignition to '**Vehicle On**' before proceeding with the other two (2) software upgrades.

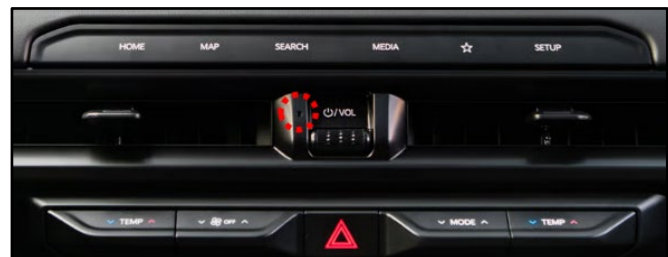
Note: Perform the software updates using KDS first, followed by the AVN update last. If the AVN update is 'mistakenly' performed first, a pinhole reset must be carried out after the controller update using KDS is completed. (Refer to the pinhole location on the image shown to the right).

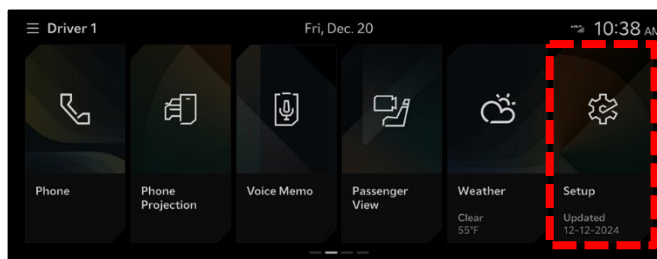
1. Press the **'Start'** button two (2) times to turn the vehicle 'ON' (Engine 'OFF').

Select **'Settings'** on the ccNC screen.

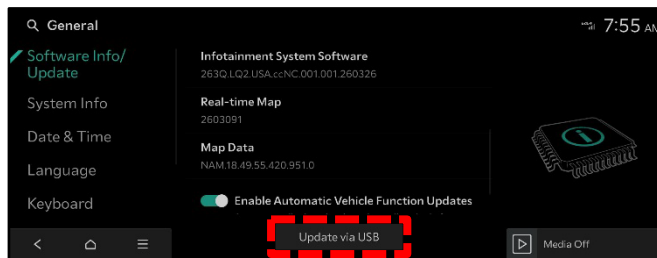
3. Select **'Software Info Update'** → **'System Info'** to verify the existing 'Infotainment System Software' needs to be updated. Refer to the 'USB-C Flash Drive (ccNC)' table on page 4.

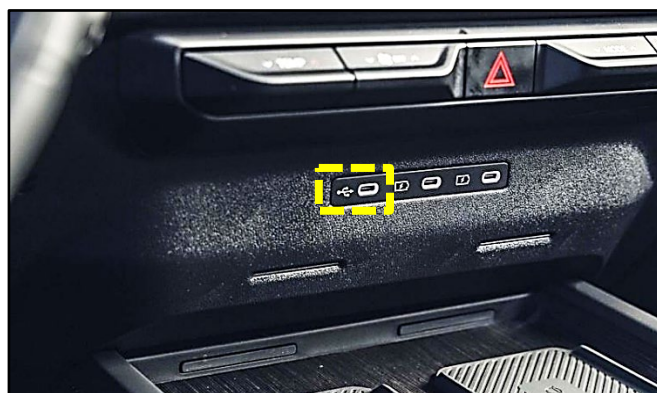
4. Insert the USB-C flash drive into the **USB-C port** located under the HVAC/Media Controller.

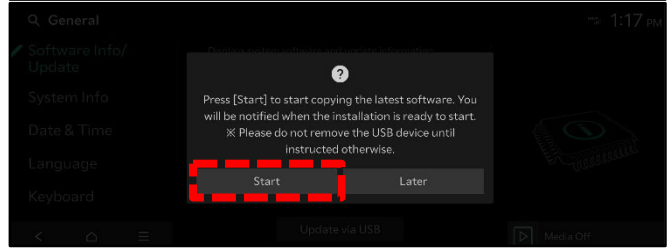
6. Select 'Start'.

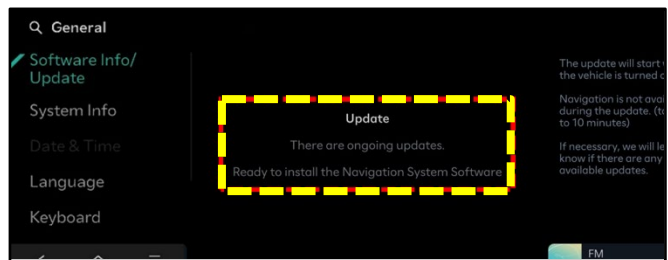
7. Once the software update completes running, the 'Update' pop-up screen will be displayed as shown.

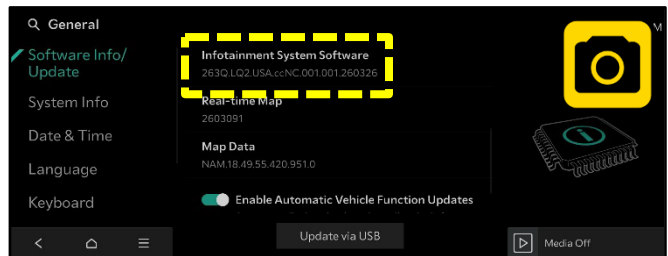
263Q.LQ2.USA.ccNC.001.001.260326
version or later.

12. Take a clear photo of the AVN screen showing the latest software version installed using KDS Warranty Claim Attachment function.
