Technical Service Bulletin

GROUP RECALL	NUMBER 26-01-048H
DATE MAY 2026	MODEL(S) SEE BELOW

SUBJECT: FRONT VIEW CAMERA FORWARD COLLISION AVOIDANCE (FCA) LOGIC IMPROVEMENT (RECALL 302)

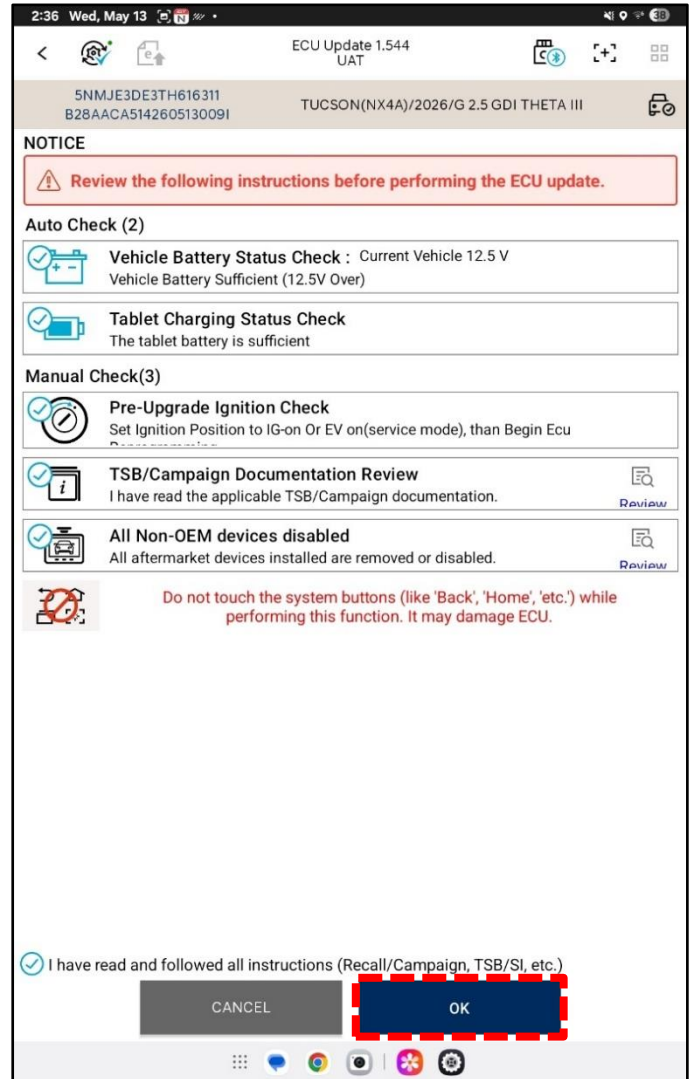
3. Review the instructions before performing the ECU Update. Check off the items in the manual checks, then press **OK**.

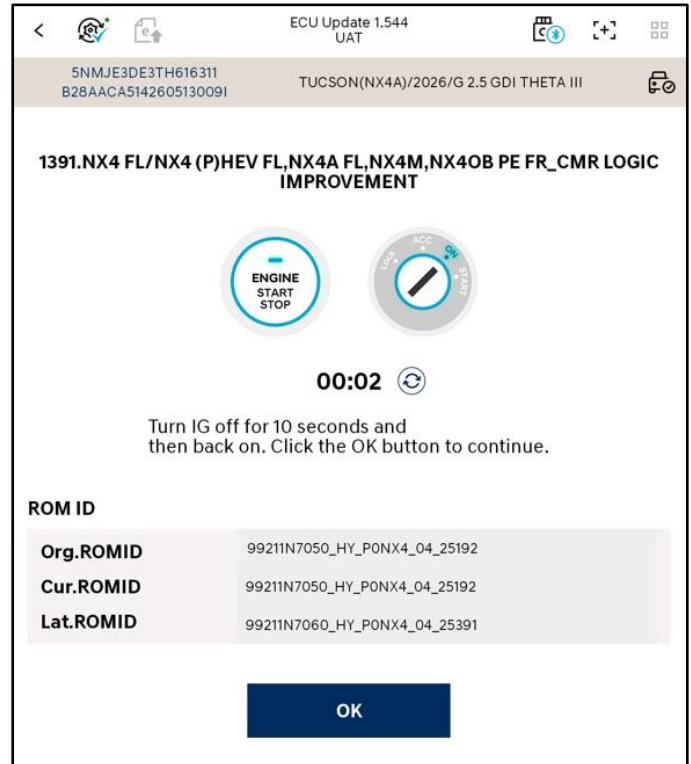
4. After the ECU update process shows 100% complete, follow the prompts on the screen to cycle the ignition **OFF** for at least **10 seconds** to reset the control unit (certain models may take up to **30 seconds**).

Use the **Refresh** button to reset the timer.

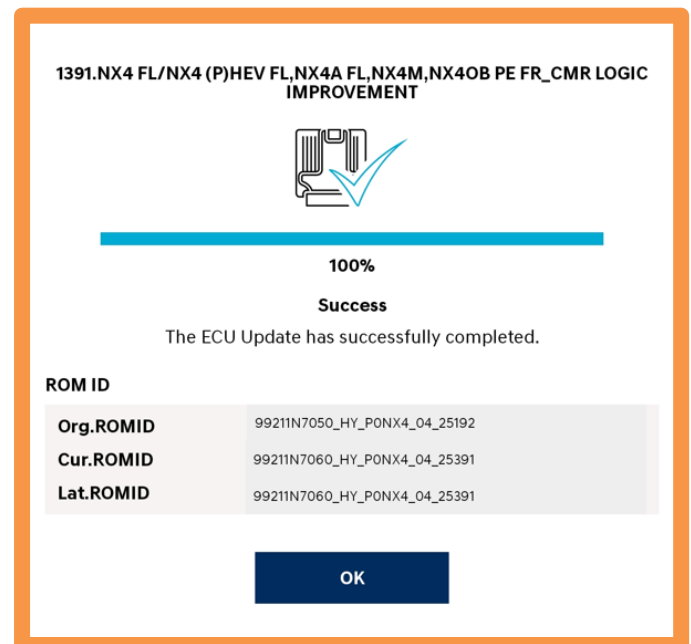
Using the tablet or GDS screen capture function, take a screenshot of the ECU Update "Success" result screen.

Upload the photo to STUI.

NOTE: The VIN/Date/Time/Mileage photo imprint is **NOT** required for GDS screenshots.

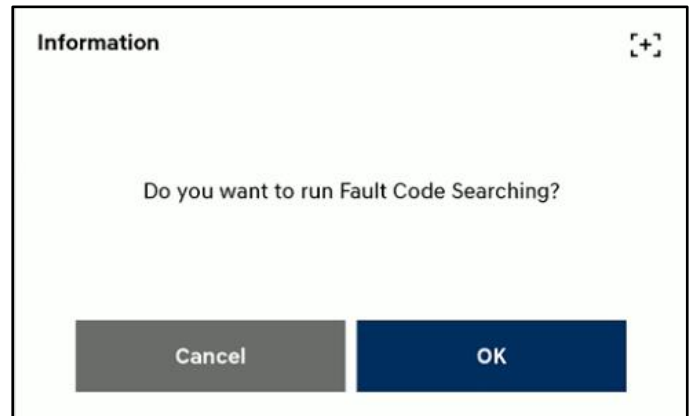
6. Perform an **All Systems Fault Code** search and erase DTC history that had incidentally occurred from the ECU update.
