## Technical Service Bulletin

26-01-054H-2

**SUBJECT:** INSTRUMENT CLUSTER LOGIC UNIT (CLU) SOFTWARE UPDATE  
(RECALL 304)

**Description:** Certain Tucson (NX4, NX4A, and NX4M), Tucson Hybrid (NX4 HEV), and Tucson Plug-in Hybrid (NX4 PHEV) vehicle’s instrument panel (“IP”) display may intermittently reboot during vehicle operation, potentially resulting in a temporary blank display screen due to a software logic issue involving the IP cluster assembly and the Head-Up Display (“HUD”). This bulletin provides instructions to perform software updates for the Instrument Cluster Logic Unit (CLU).

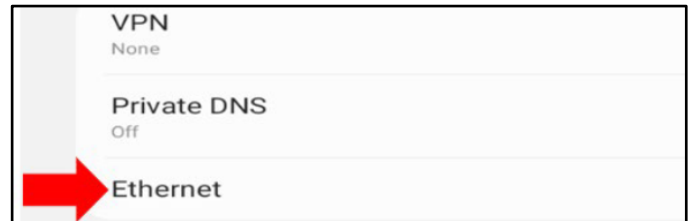
4. Select **Ethernet**.

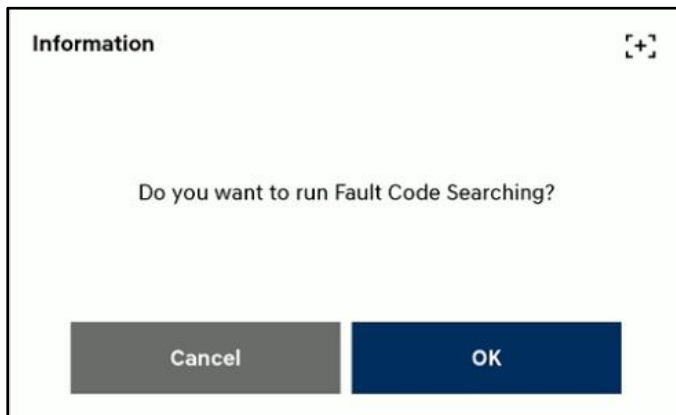
6. Select **Cancel**.

The fault code search will be performed after all the applicable modules have been updated.

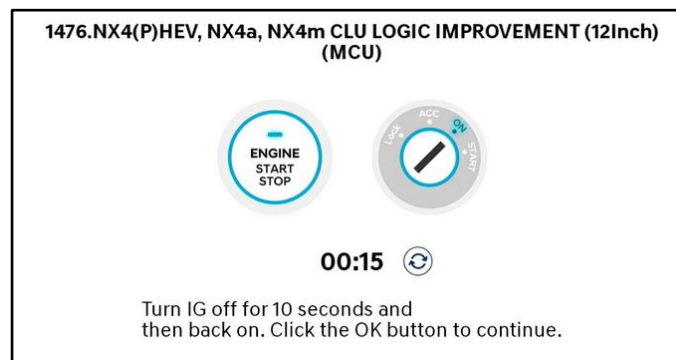
3. After the ECU update process shows 100% complete, follow the prompts on the screen to cycle the ignition **OFF** for at least **10 seconds** to reset the control unit.

Use the **Refresh** button to reset the timer.
