## Technical Service Bulletin

26-01-054H-1

**SUBJECT:** INSTRUMENT CLUSTER LOGIC UNIT (CLU) SOFTWARE UPDATE  
(RECALL 304)

**Description:** Certain Tucson (NX4, NX4A, and NX4M), Tucson Hybrid (NX4 HEV), and Tucson Plug-in Hybrid (NX4 PHEV) vehicle's instrument panel ("IP") display may intermittently reboot during vehicle operation, potentially resulting in a temporary blank display screen due to a software logic issue involving the IP cluster assembly and the Head-Up Display ("HUD"). This bulletin provides instructions to perform software updates for the Instrument Cluster Logic Unit (CLU).

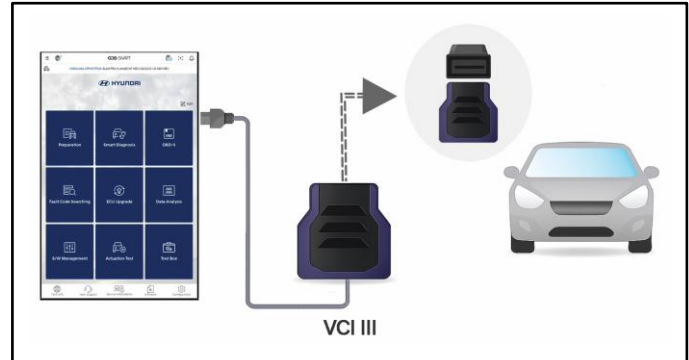
1. Connect the Ethernet Communication Interface (ECI) DLC cable to the OBD connector of the vehicle.
2. Connect the VCI DLC cable to the ECI.
3. Select the appropriate tablet cable (type C, 5-pin) to the ECI.
4. Connect the cable to the tablet PC.

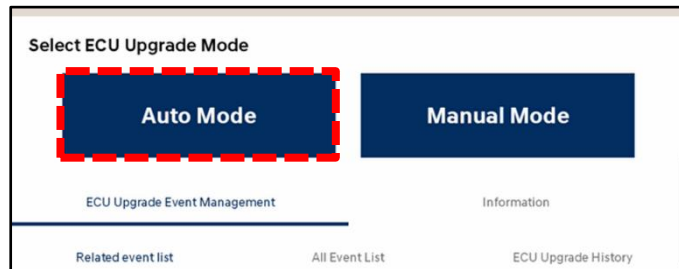
1. Perform the ECU update in **Auto Mode**.

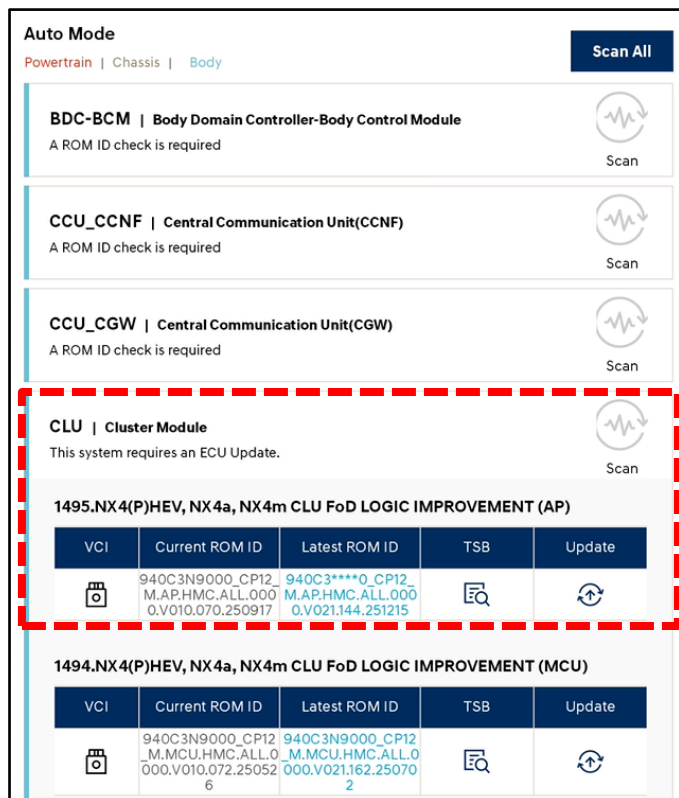
2. Verify the ROM ID by selecting the **FoD** system to scan the vehicle’s current ROM ID.

Check the current ROM ID version and compare it to the [ROM ID Information](#) table before attempting to perform the software update.

If the update fails, remove the power connector from the in-cabin fuse box for at least **5 seconds**. Reassemble and retry the update.

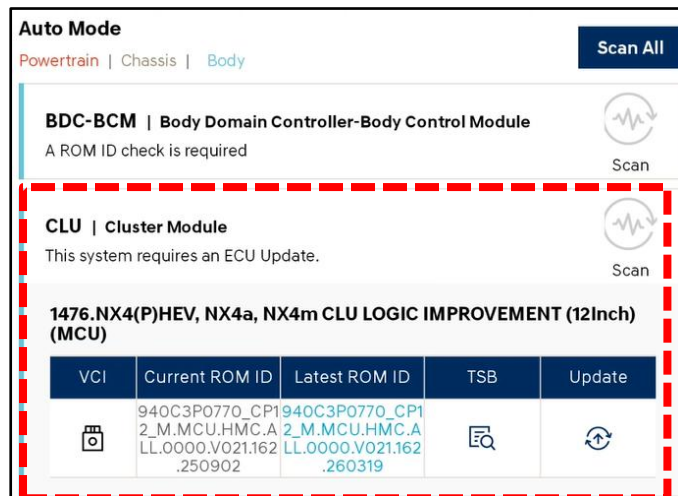
2. Verify the ROM ID by selecting the **CLU** system to scan the vehicle's current ROM ID.

Check the current ROM ID version and compare it to the [ROM ID Information](#) table before attempting to perform the software update.

If the update fails, remove the power connector from the in-cabin fuse box for at least **5 seconds**. Alternatively, disconnect the negative (–) **12V** battery terminal and wait at least **5 seconds**. Reassemble and retry the update.

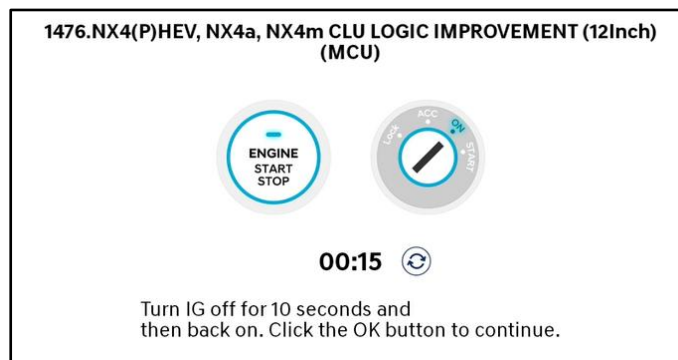
3. After the ECU update process shows 100% complete, follow the prompts on the screen to cycle the ignition **OFF** for at least **10 seconds** to reset the control unit.

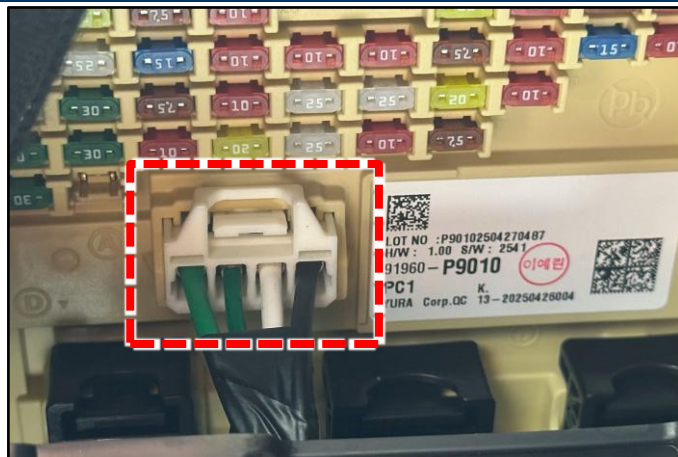
1. Remove the power connector of the indoor fuse box and reconnect after **5 seconds**.

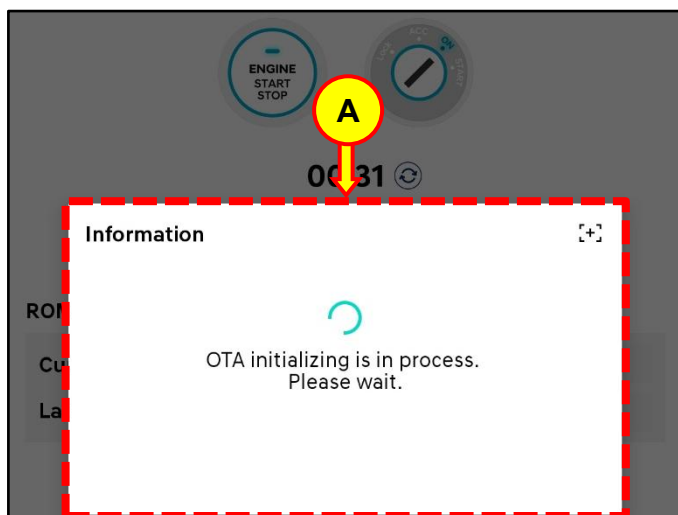
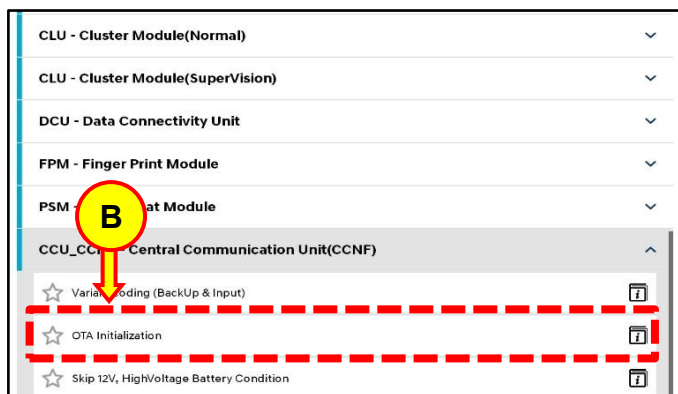
2. Perform an **All Systems Fault Code** search and erase DTC history that had incidentally occurred from the ECU update.
3. OTA initialization (A) should perform automatically after the software update:
  - If OTA initialization performs automatically, then proceed with the service procedure.
  - If the OTA initialization process fails, complete it manually under:  
**S/W Management > CCU\_CCNF - Central Communication Unit (CCNF) > OTA Initialization (B).**
