## Technical Service Bulletin

26-01-054H

**SUBJECT:** INSTRUMENT CLUSTER LOGIC UNIT (CLU) SOFTWARE UPDATE  
(RECALL 304)

**Description:** Certain Tucson (NX4, NX4A, and NX4M), Tucson Hybrid (NX4 HEV), and Tucson Plug-in Hybrid (NX4 PHEV) vehicle’s instrument panel (“IP”) display may intermittently reboot during vehicle operation, potentially resulting in a temporary blank display screen due to a software logic issue involving the IP cluster assembly and the Head-Up Display (“HUD”). This bulletin provides instructions to perform a software update for the Instrument Cluster Logic Unit (CLU).

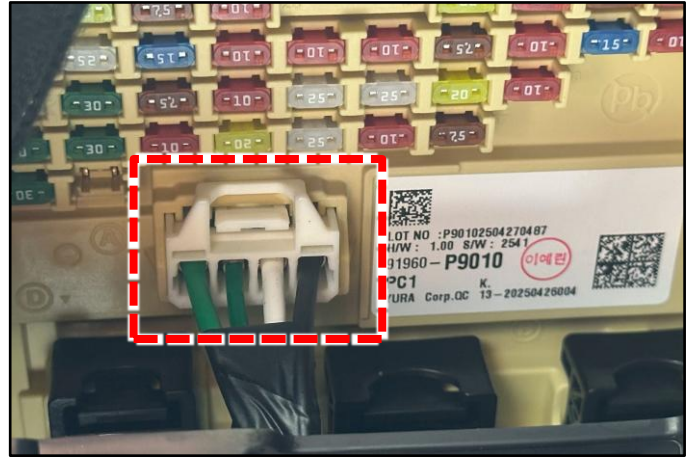
1. Remove the power connector of the indoor fuse box and reconnect after **5 seconds**.
