**February 27, 2026**

Version 2

## Safety Recall: 2024 Prologue Instrument Cluster Center Display Software Update

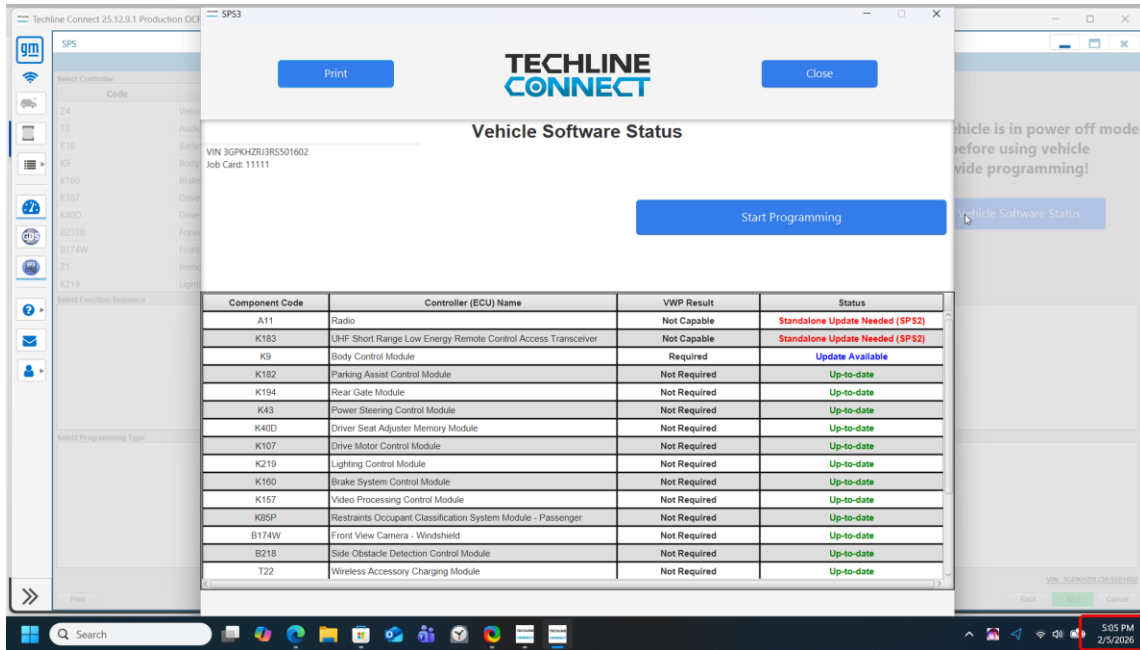
- For vehicles that need software updates, take a screen shot of the Techline Connect screen indicating the VIN and the software(s) that needs to be updated.
- Use the screenshot to determine which software needs an update. Then select the matching add-on labor operation(s) and enter the correct code(s) on the Template B claim form.

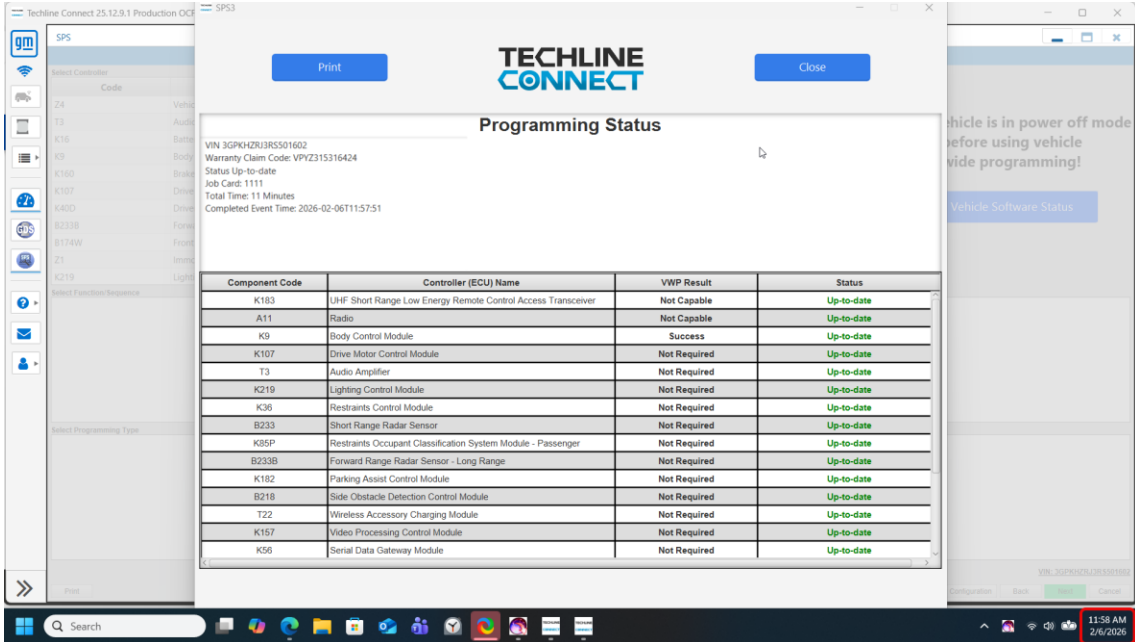
- Upon completion of the updates, take a screen shot of the Techline Connect confirming that all software(s) has been fully updated. **Be sure the date/time on the computer screen can be seen in the screenshot (e.g. lower right corner of the image below).**
