TECHNICAL SERVICE BULLETIN

SUBJECT:		No: TSB-02-13-015REV	
PCM REPROGRAMMING FOR COLD ENGINE MISFIRE (V6 GALANT/ECLIPSE)		DATE: October, 2002	
		MODEL: See below	
CIRCULATE TO:	<input type="checkbox"/> GENERAL MANAGER	<input checked="" type="checkbox"/> PARTS MANAGER	<input checked="" type="checkbox"/> TECHNICIAN
<input checked="" type="checkbox"/> SERVICE ADVISOR	<input checked="" type="checkbox"/> SERVICE MANAGER	<input checked="" type="checkbox"/> WARRANTY PROCESSOR	<input type="checkbox"/> SALES MANAGER

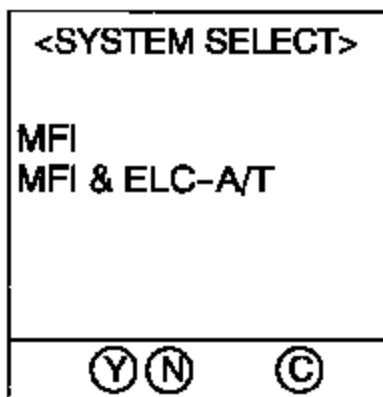
9. For **manual** transmission models, select "MFI".

For **automatic** transmission models, select "MFI & ELC-A/T." Then press "YES".

NOTE: The MUT-II will take a few seconds to verify the ROM-ID.
