### Certain 2013 Model Year Lexus GS350 Vehicles Engine Control Module (ECM) Reflash

#### Customer Satisfaction Campaign

**TECHNICAL INSTRUCTIONS**  
**FOR**  
**CUSTOMER SATISFACTION CAMPAIGN CLA**  
**ENGINE CONTROL MODULE (ECM) REFLASH**  
**CERTAIN 2013 MODEL YEAR GS350**

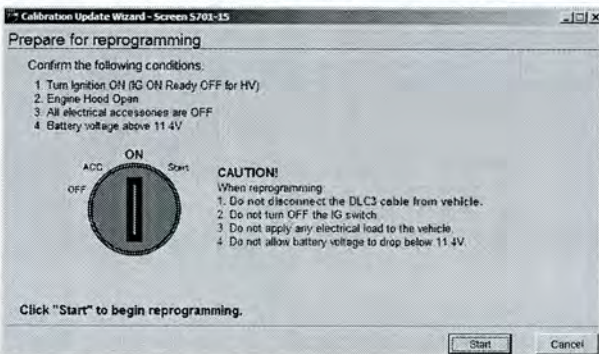
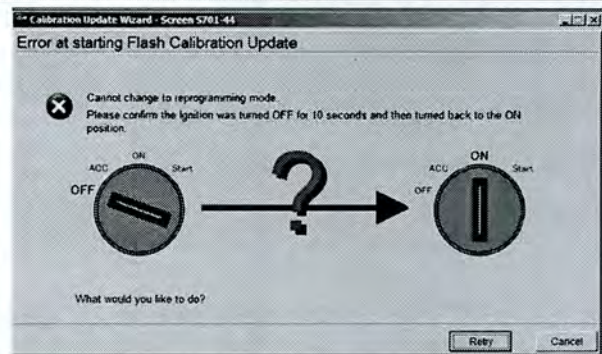
### PAY CLOSE ATTENTION DURING THIS STEP OF THE REFLASH PROCESS

After turning IG ON it may be necessary to wait an additional 25-30 seconds before pressing Start on the CUW.

If Start is pressed on the CUW before allowing enough time to elapse, an error may occur and the CUW will request that you retry the process.

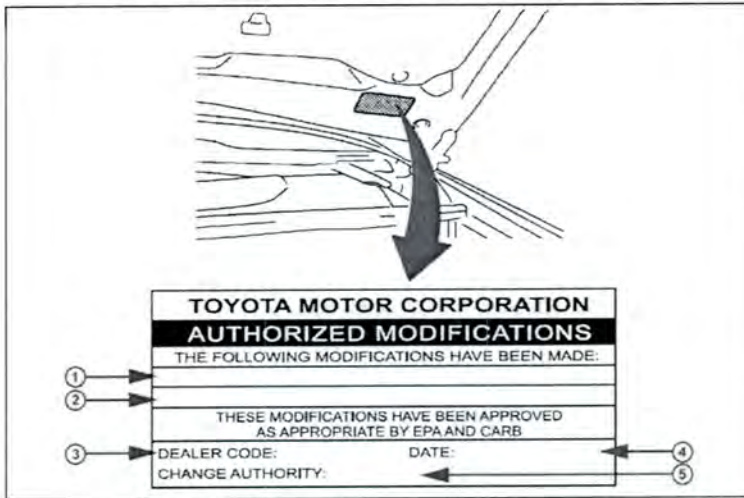
### 3. ATTACH THE AUTHORIZED VEHICLE MODIFICATION LABEL

- a) Fill out the label.
- b) Affix the label to the under-side of the hood.

1	Replacement ECM P/N 2WD – 89661-30U51 4WD – 89661-30U61
2	New Calibration ID 2WD – 330S2100 4WD – 330S3100
3	Dealer Code
4	Date Completed
5	Campaign Code (CLA)
