Audi

Customer Satisfaction Campaign

Code: 24U8

Subject: 2011 - 2012 Audi R8/R8 Spyder
Engine Wiring Harness Overlay & ECM Programming

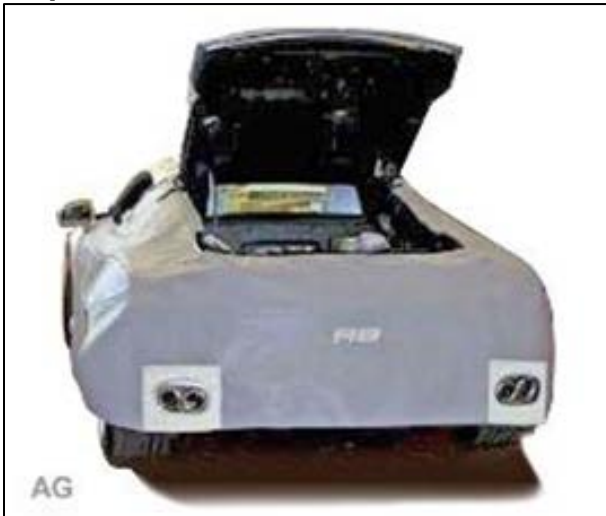
VAS 6411 – Coupe / Spyder Rear End Protector

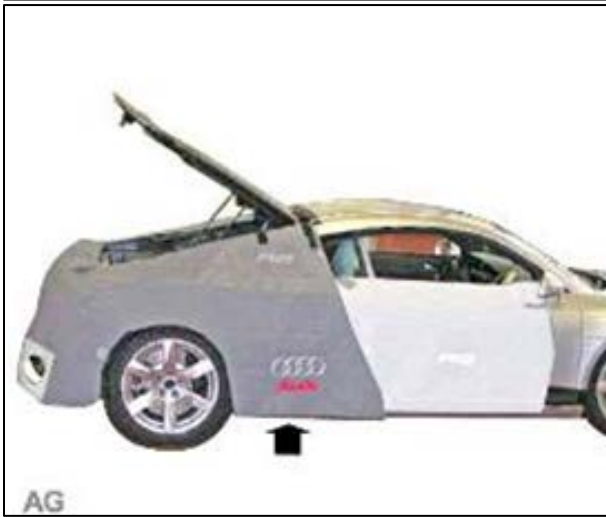
VAS 6412 – Coupe Side Panel Protector

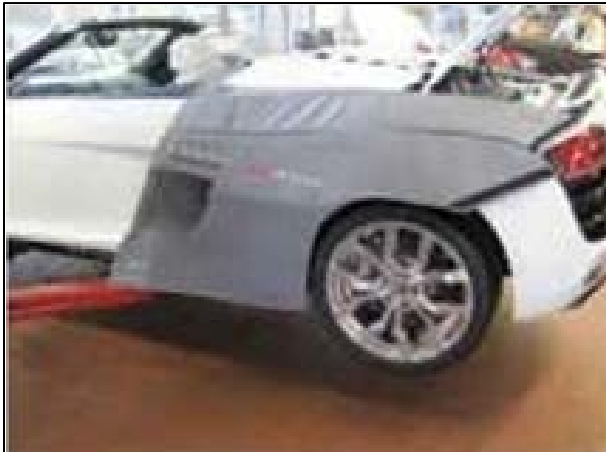
VAS 6428 – Spyder Side Panel Protector

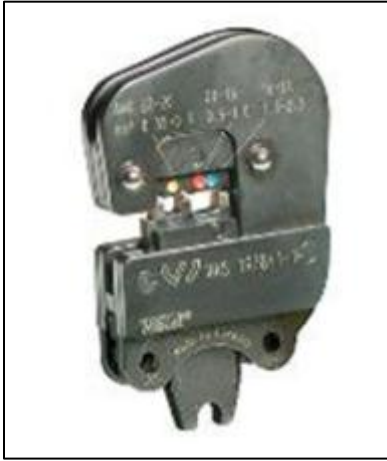
VAS 1978/1-1 – Exchangeable head, 0.35-.50 mm

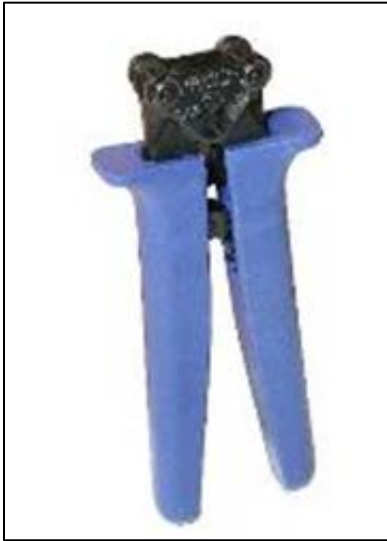
VAS 1978/1-2 – Crimping pliers (base tool)

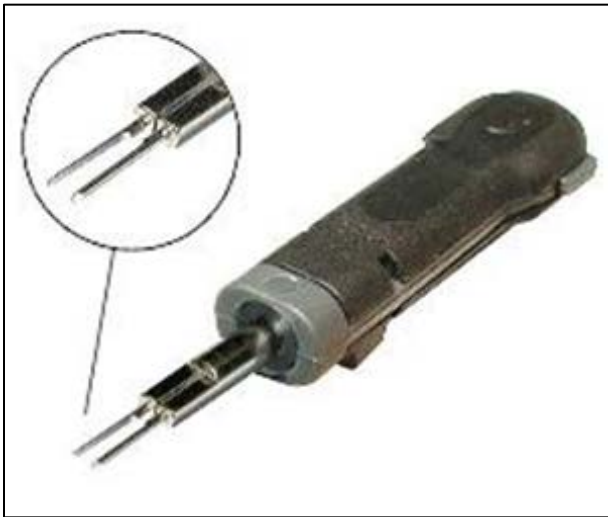
VAS 1978/7A – Terminal removal tool

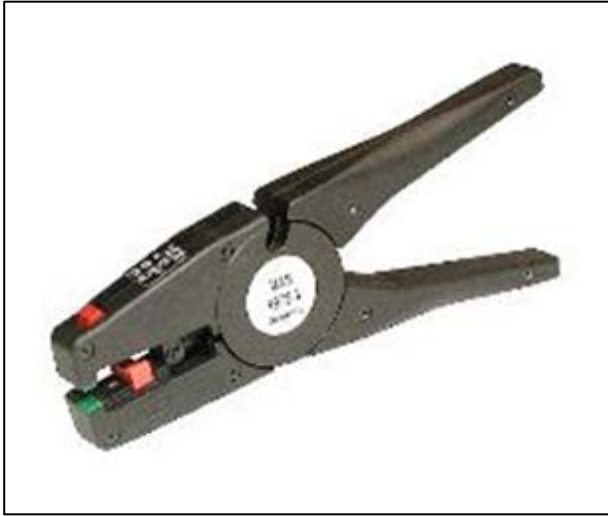
VAS 1978/3 – Wire stripping tool

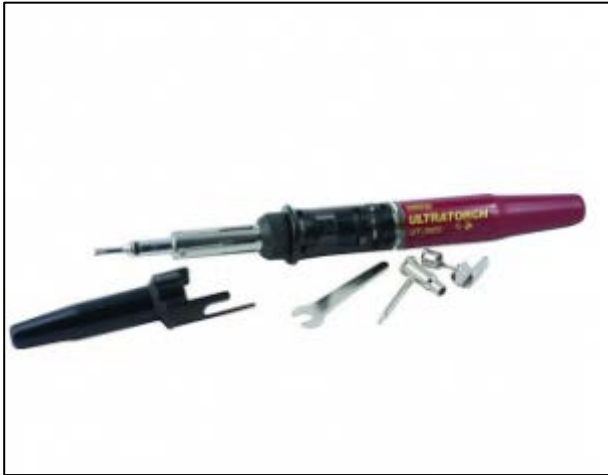
UT-100SI – Ultratorch in VAS 1978 B Tool kit
or suitable heat gun

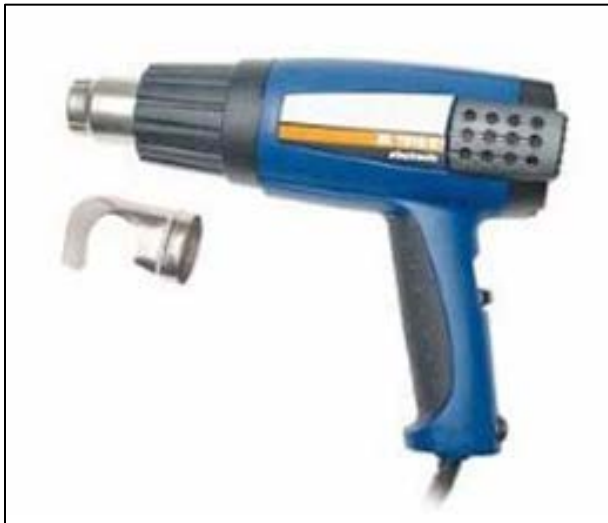
VAS 1978/14A – Hot air blower

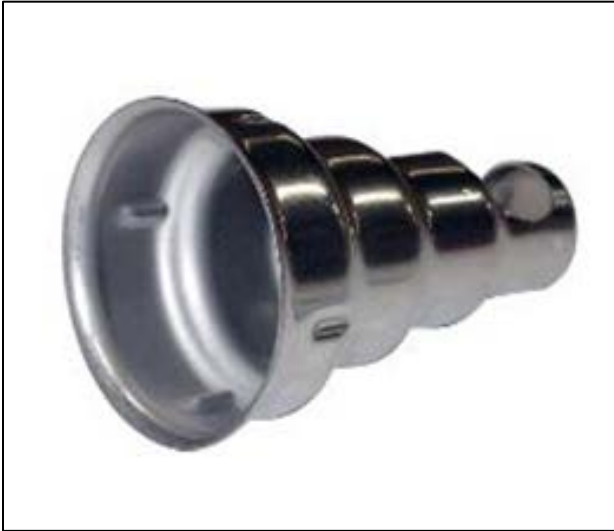
VAS 1978/15A – Shrink element for hot air blower

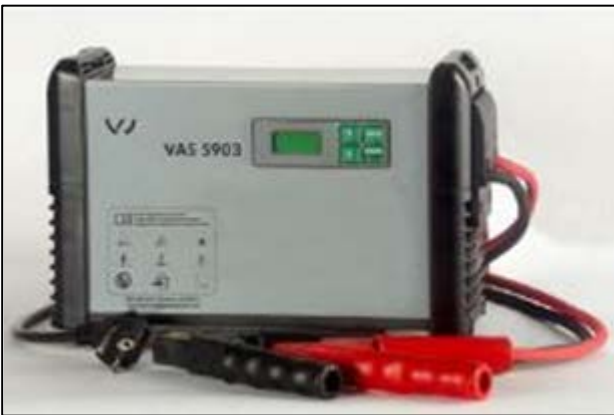
VAS 5903 Battery charger

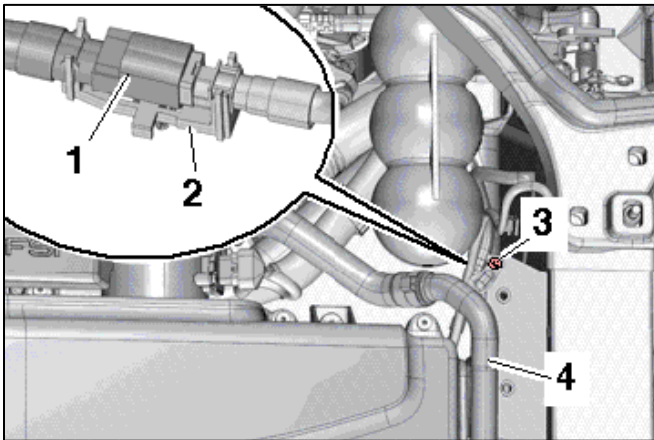
- ⇐ Remove the bolt <3> from the secondary air injection hose <4>.
- ⇐ Remove the connector <1> from the bracket <2> and disconnect it.

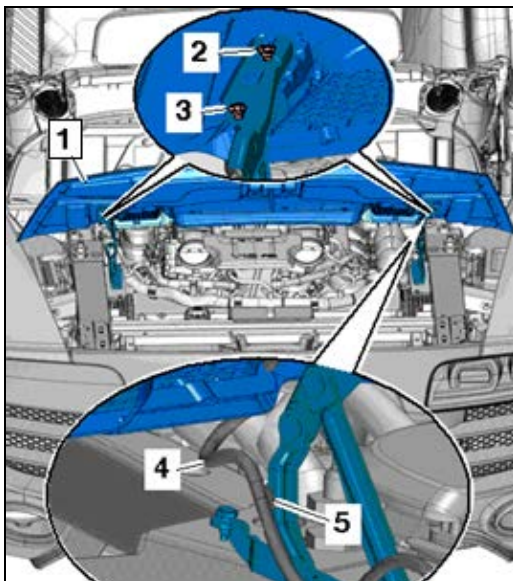
- ⇐ Free up the wiring harness <4> on the right hinge <5>.
- ⇐ Remove the nut <3>.
- ⇐ Loosen the nut <2> two turns.
- Repeat on other side.

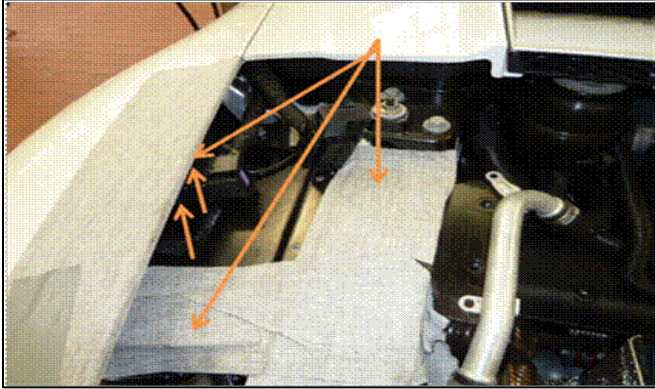
⇐ The space around the ECMs should be additionally protected with suitable tape, especially the edges of the side panels.

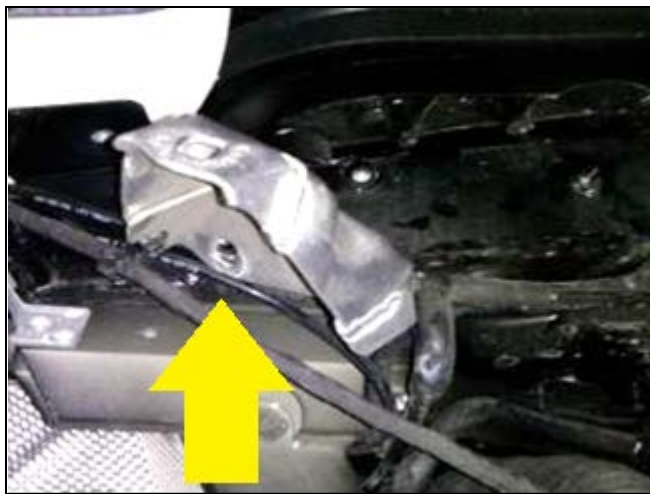
- Remove right side air intake snorkel.
- ⇐ Remove right fender support bracket <arrow>.

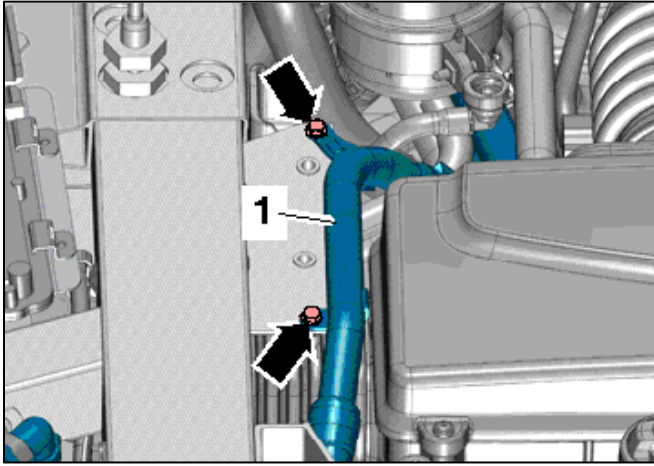
- ⇐ Remove the bolts <arrows> and press the left secondary air injection pipe <1> to the side.
- Repeat on right side of vehicle.

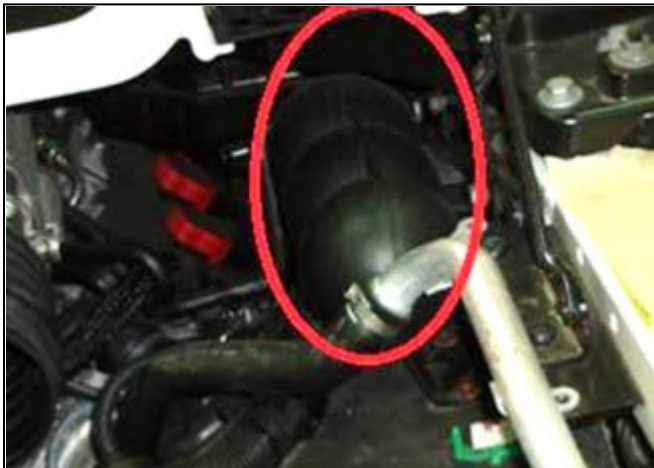
- ⇐ Remove vacuum reservoir <circle> hold-down bolts on right side of engine compartment to gain better access to wiring harness.

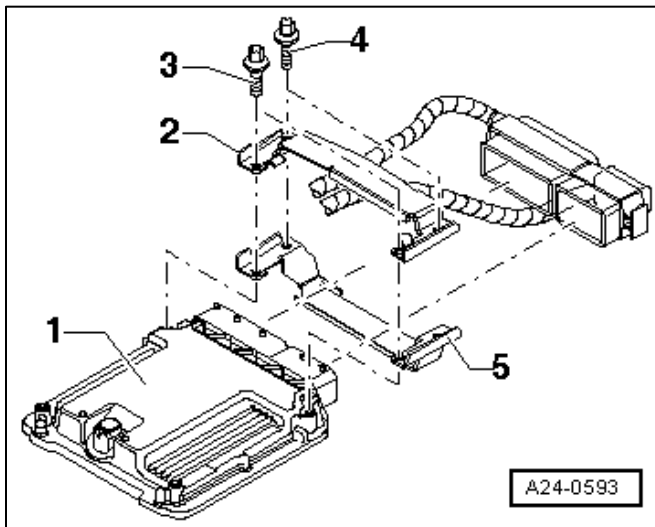
- ⇐ The ECM <1> is secured in a protective housing <5> and shear bolts <3 and 4> to make it more difficult to access.
- ⇐ The threads of the shear bolts <4> (that are not installed in ECM) are coated with locking compound and must be heated to remove.

The threads of both shear bolts <3> (that are installed in the ECM) are not coated with locking compound. The threads in the ECM housing must *not* be heated (unintentional heating the ECM).

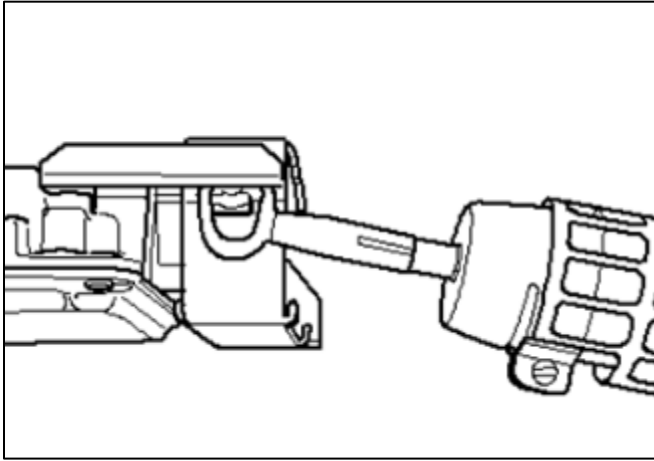
⇐ Heat threads on connector-side shear bolts for approximately 25 to 30 seconds with VAS 1978/15A or equivalent.

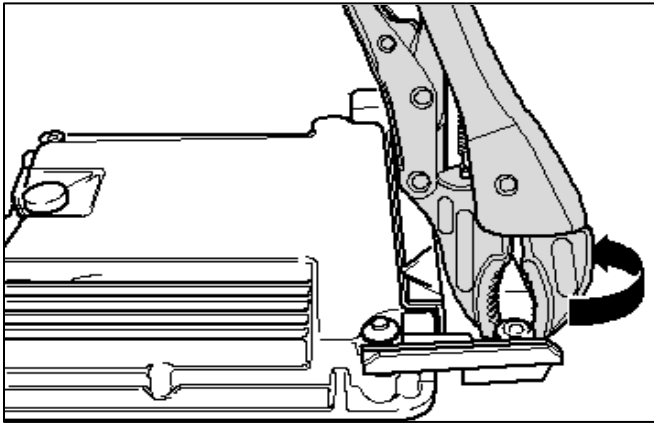
⇐ Remove shear bolts with locking pliers (see direction of <arrow>).

ⓘ Note: The shear bolts installed in the ECM do not need to be heated for removal. They should be removed without heat.

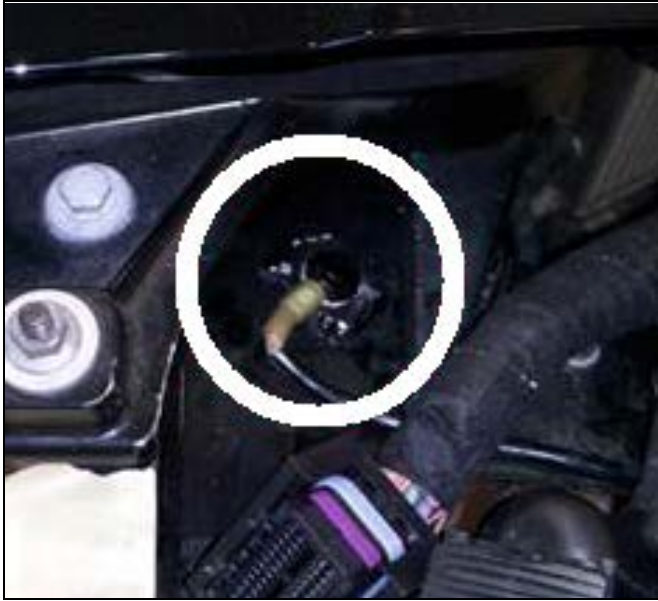
⇐ Remove ground wire <circle> at ECM 1 (J623, passenger's side).

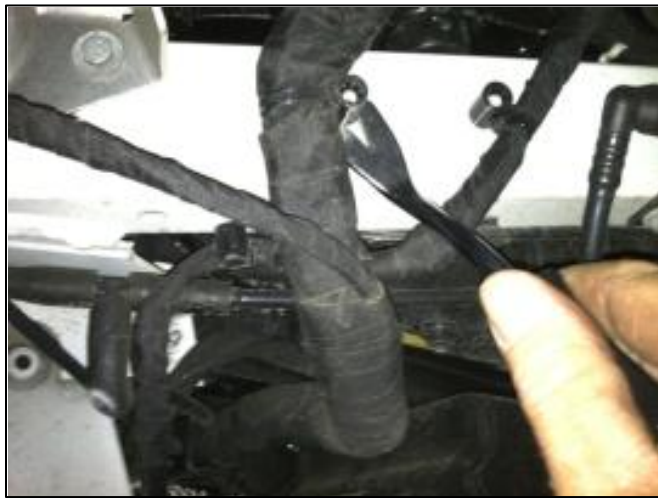
⇐ Release harness holder from frame in right fender well.

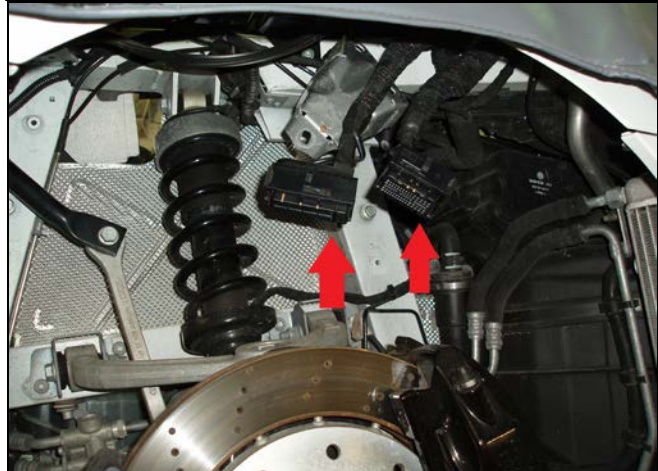
⇐ Pull the harness <arrows> down through the frame opening, into the wheel well, to provide working room for new harness installation.

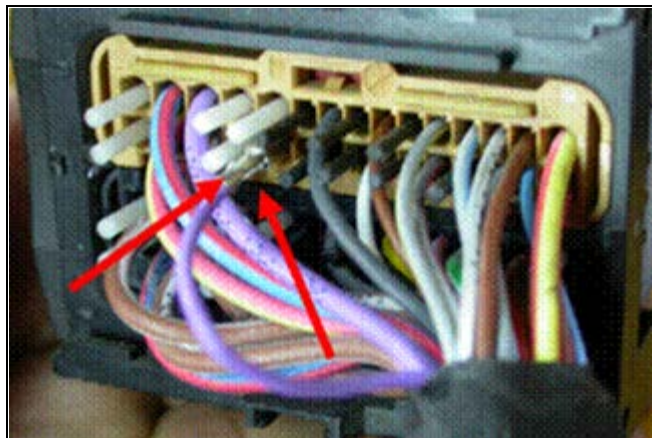
- ⇐ The terminal of the engine speed signal (purple wire) is in the brown housing element, located in **chamber 36**. Release the terminal using VAS1978/7A from the front side of the connector block, and gently remove wire.
- Repeat on the right side of vehicle: pull the purple wire from **chamber 36** of the T60 connector on ECM 1.

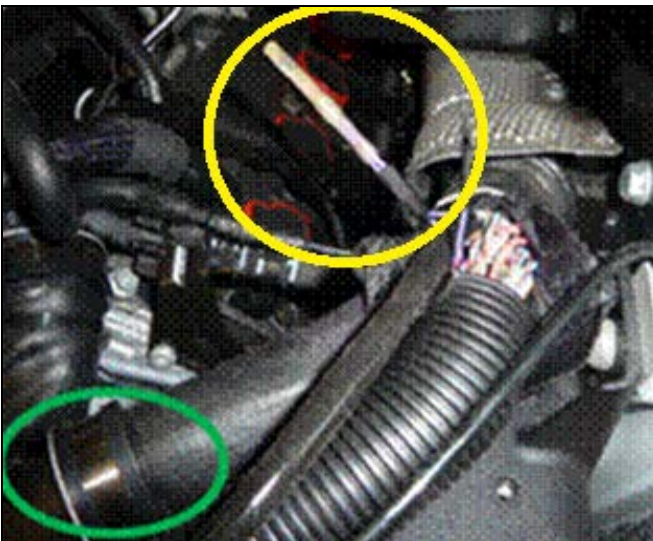
- ⇐ Remove hold down bolt for the harness holder <green circle>. Make sure that the other wires do *not* get damaged.
- ⇐ Locate purple overlay harness wire and cut it off 5 cm from D90 connection point <yellow circle>. Discard the overlay harness; it will no longer be used.

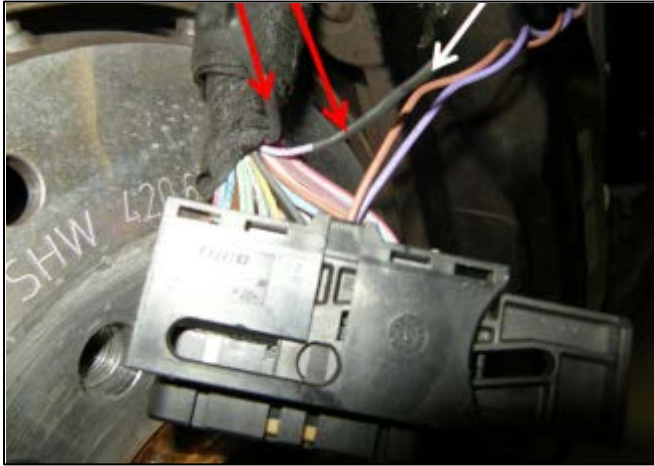
⇐ If the version 1 wiring harness was not installed: cut off wire terminal end and apply shrink tubing <red arrow> to wire from chamber 36 on both ECM1 & 2. Shrink tubing with UT-100SI Ultratorch (or equivalent). Pinch the end of the tubing closed <white arrow> and tape wire back in direction of the harness.

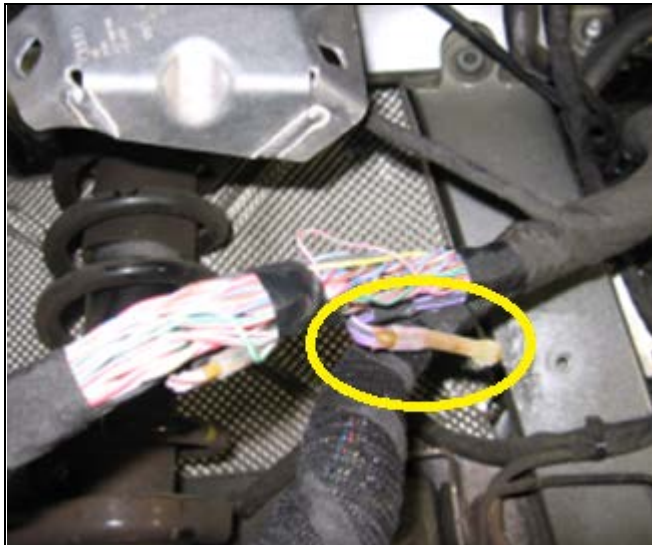
- Remove the brown wire for the G28 engine speed signal to the T60 connector on *ECM 1 (J623, passenger's side)* from **chamber 51** using VAS 1978/7A.
- ⇐ Cut off wire terminals and apply shrink tubing <red arrow> on each wire. Then, heat tubing with UT-100SI Ultratorch (or equivalent) and pinch the end of the tubing closed. Tape wires back in direction of the harness.
- ⇐ Strip the harness at the right side inside the wheel well, where the harness branches, and locate the D141 connection <yellow circle>.

- Locate the D141 connection in engine wiring harness near the harness junction where the harness branches to the T60 and T94 ECM connector plugs. The D141 connection has five lilac (purple) and one wire that is black or gray. Do not confuse with any other connection in harness.

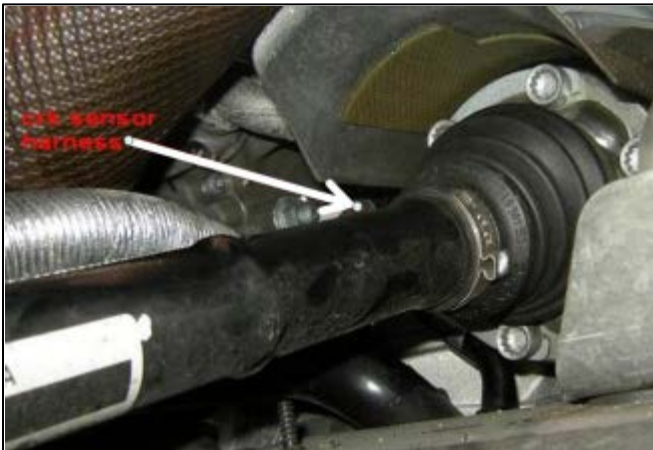
- ⇐ Disconnect the connector <arrow> to the G28 engine speed sensor on the left side of the transmission bell housing and cut off the connector end as straight as possible. The original wiring to the sensor is no longer required.

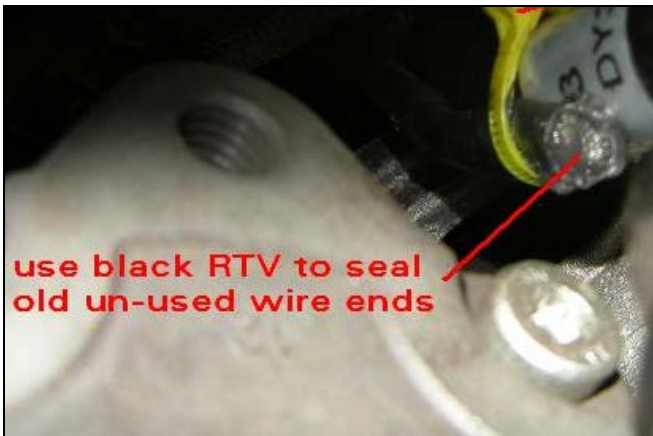
- ⇐ Seal the G28 cable opening with silicone sealant.

- Put the G28 plug of the repair harness on the engine speed sensor and tie wrap (N 909 377 02) following the original G28 harness. Keep harness away from sharp objects and the exhaust.

- Put the G28 plug of the repair harness on the engine speed sensor and tie wrap (N 909 377 02) following the original G28 harness. Keep harness away from sharp objects and the exhaust.
- The overlay harness should be routed along the main engine harness.

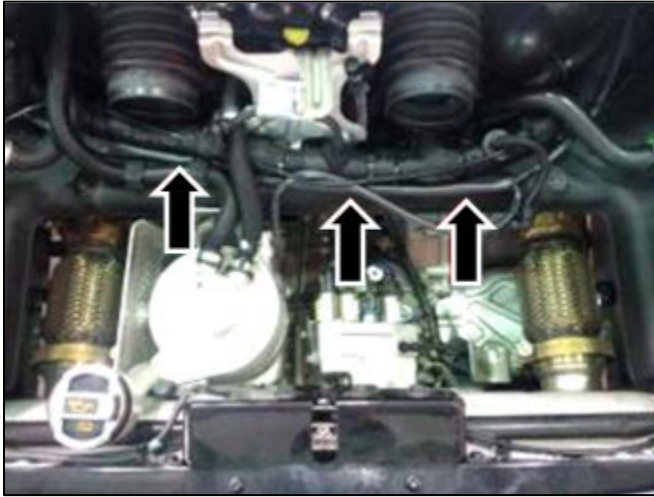
⇐ The overlay harness should be routed along the main engine harness <arrows>.

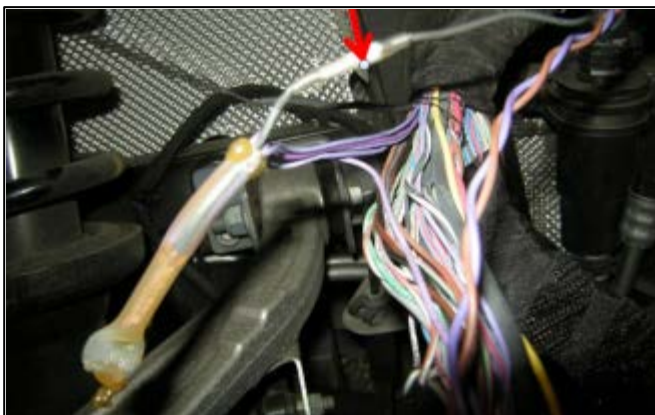
⇐ Crimp the black wire <arrow> from the D141 connection to the new wire from the overlay harness. Use crimping pliers VAS 1978/1-2 with exchangeable head VAS 1978/1-1. Use yellow crimping slot 0.35-2.5mm and crimp connector (000 979 940). Heat connector with UT-100SI Ultratorch (or equivalent).

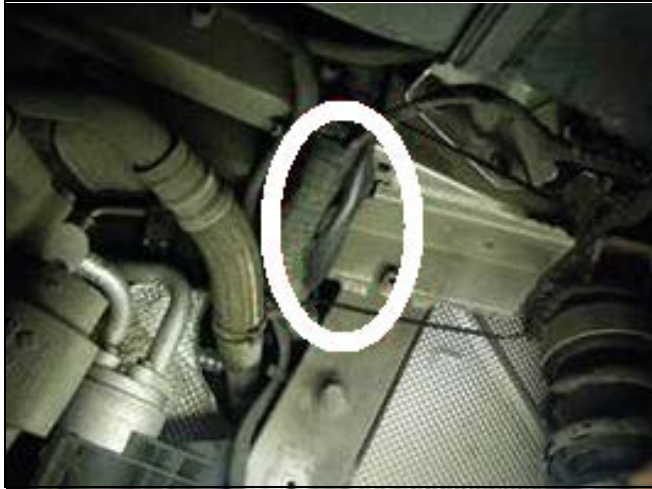
⇐ Route the overlay <circle> to ECM 2. Follow the harness through the splash shield into the wheel house.

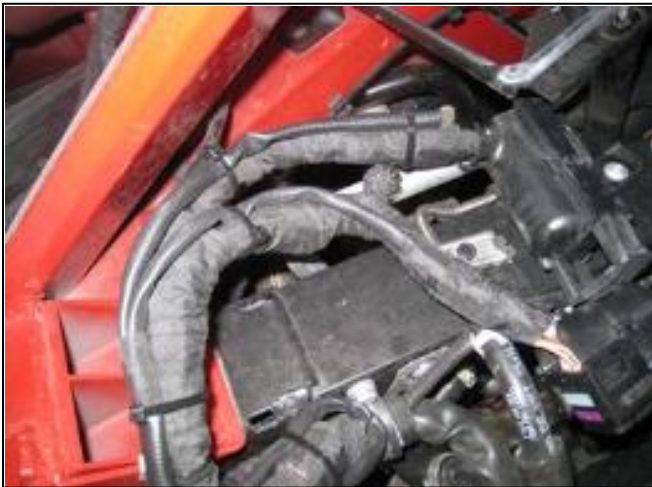
- For *ECM 2 (J624, driver's side)*, put the purple wire into **chamber 36** of the T60 plug. Pull on the wire to ensure that it is locked into the connector.
- Install terminal locking tab.
- Tape harness with cloth tape (000 979 950).
- Reinstall connector cover.
- Install tie wrap (N 909 377 02).

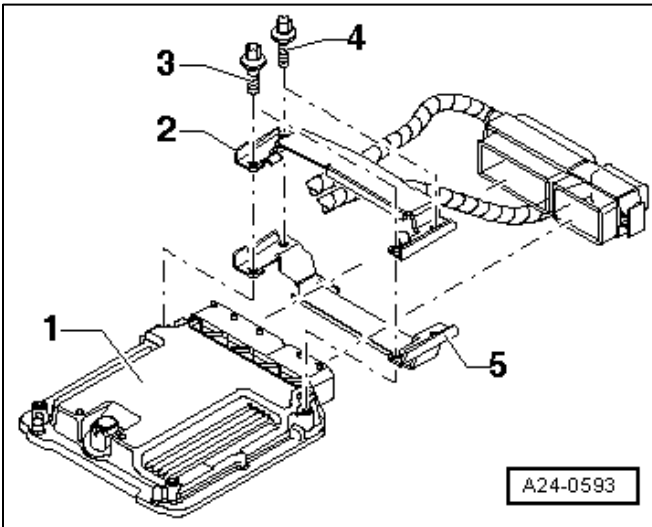
- Install tie wraps (N 909 377 02) every 8 inches following main engine harness. Do not overtighten.
- ⇐ Connect ECM 1 to both wiring harnesses. Reconnect ECM holders <2> and <5> with new shear bolts <3> (N 910 238 02) and <4> (N 909 803 04 with locking compound), then reinstall.

Be sure to install shear bolts <4> with locking compound into the correct position. Put the shear bolts <3> without locking compound into the ECM.

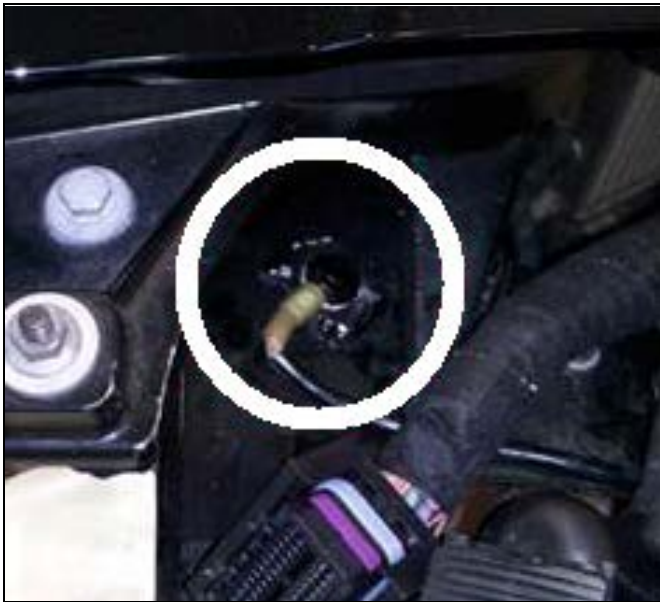
⇐ Reconnect ground <circle> from ECM 1.

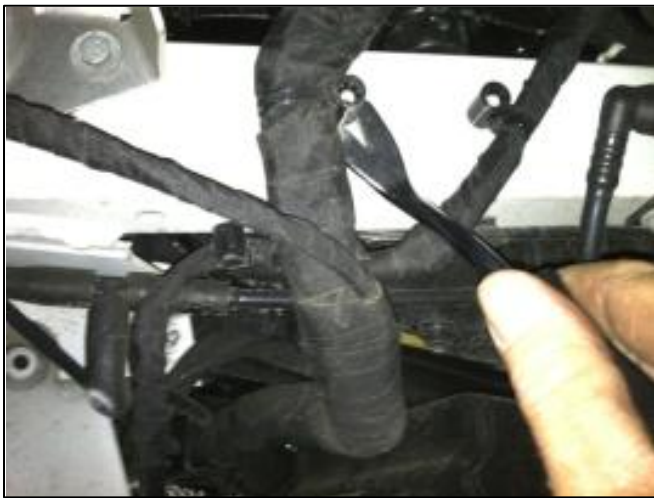
- Uncover the oil fill opening and put the oil cap back into position.
- ⇐ Put harness holder back on frame (picture shows removal).

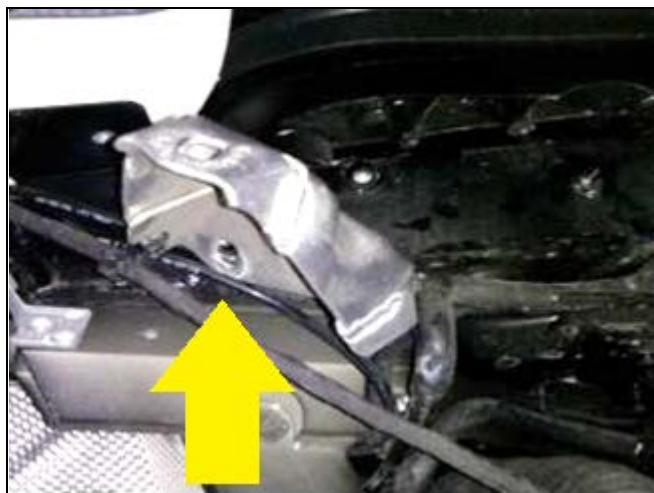
- Reinstall fender support bracket <arrow>

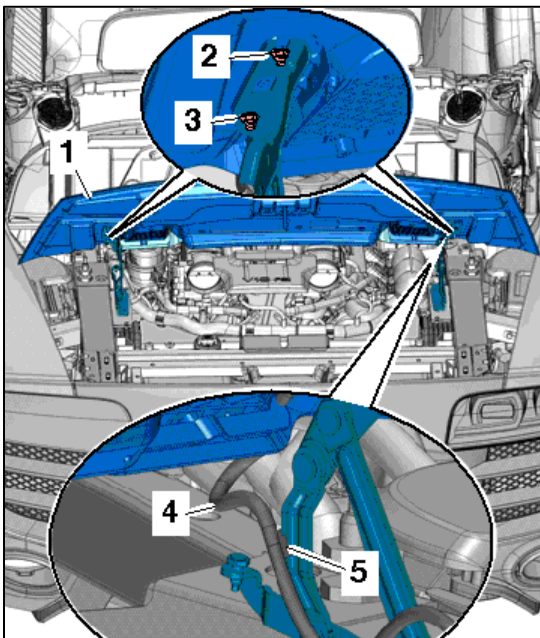
- Reinstall wheels and torque wheel bolts to 120 Nm.
- ⇐ Reinstall servicing door with help from a second technician. Position the door on the hinges using the masking tape markings you made during removal. Torque the nuts <2> and <3> to 23 Nm.
- Reinstall gas filled struts and ensure clip is engaged.
- ⇐ Reattach wiring harness <4> to hinge <5>.
- Remove all protective tape from both sides.

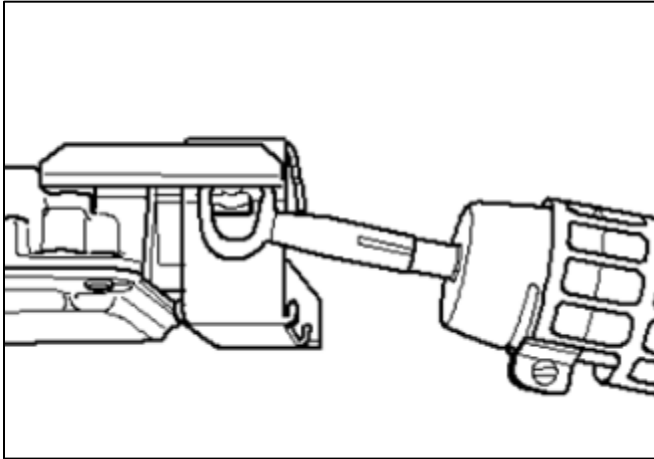
⇐ Heat threads on connector-side shear bolts for approximately 25 to 30 seconds with VAS 1978/15A.

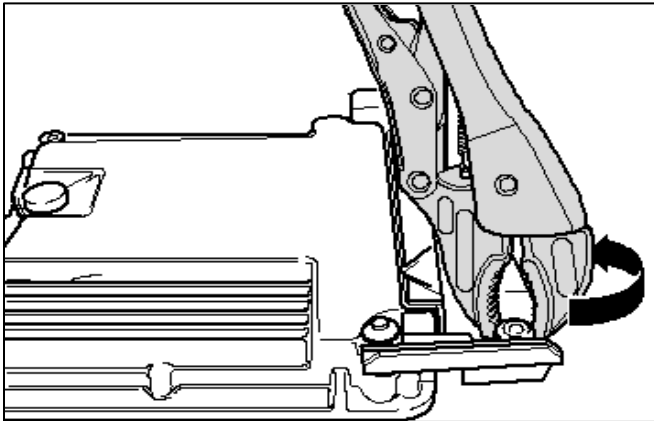
⇐ Remove shear bolts with locking pliers (see direction of <arrow>).

ⓘ Note: The shear bolts installed in the ECM do not need to be heated for removal. They should be removed without heat.

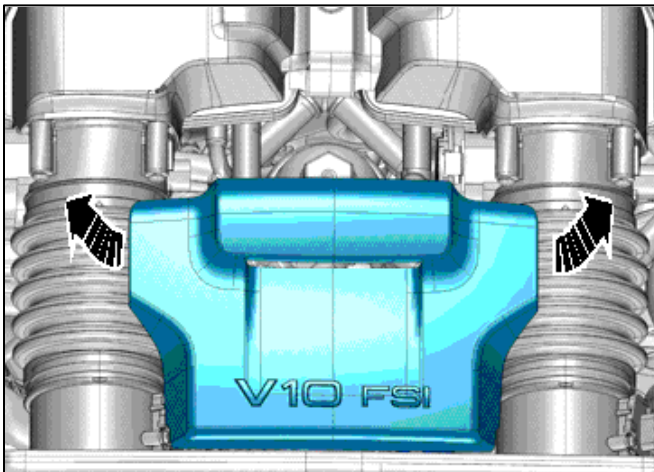
⇐ Remove the engine cover <arrows>. Do not jerk or pull it to one side.

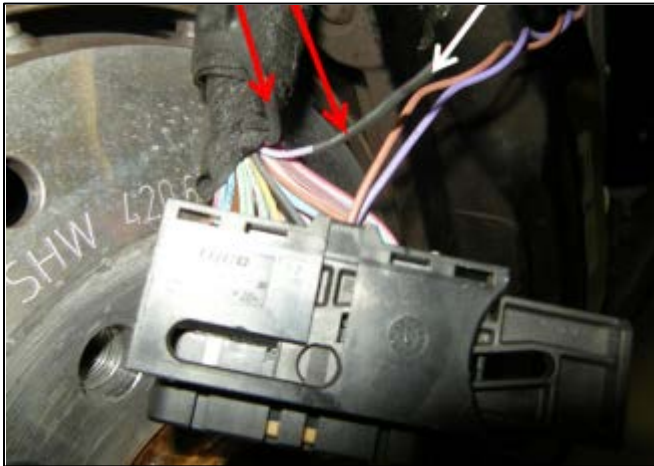
- ⇐ If the version 1 wiring harness was not installed: cut off wire terminal end and apply shrink tubing <red arrow> to wire from chamber 36 on both ECM1 & 2. Shrink tubing with UT-100SI Ultratorch (or equivalent). Pinch the end of the tubing closed <white arrow> and tape wire back in direction of the harness.

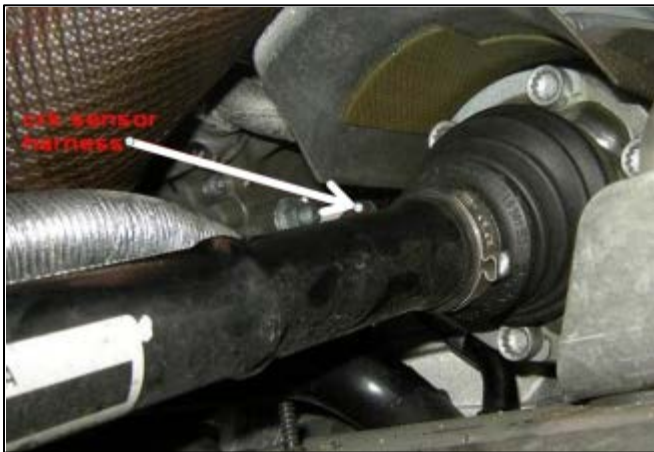
- ⇐ Disconnect the connector <arrow> to the G28 engine speed sensor on the left side of the transmission bell housing and cut off the connector end as straight as possible. The original wiring to the sensor is no longer required.

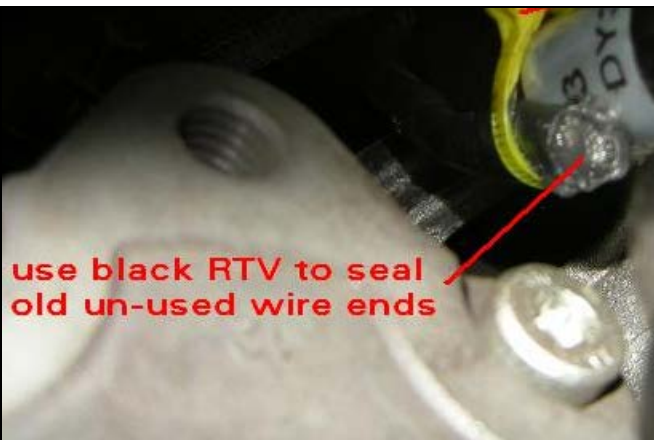
- ⇐ Seal the G28 cable opening with silicone sealant.

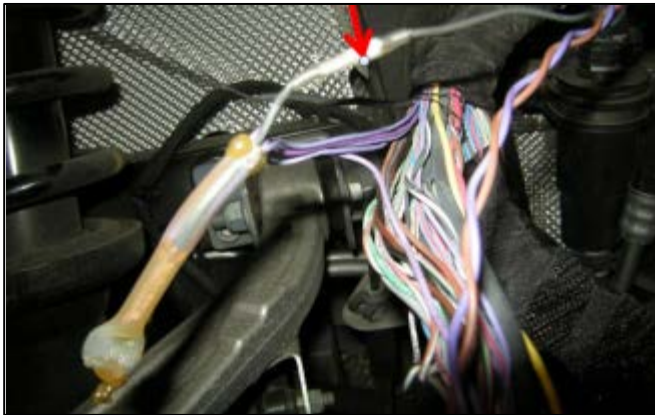
⇐ Crimp the black wire <arrow> from the D141 connection to the new wire from the overlay harness. Use crimping pliers VAS 1978/1-2 with exchangeable head VAS 1978/1-1. Use yellow crimping slot 0.35-2.5mm and crimp connector (000 979 940). Heat connector with UT-100SI Ultratorch (or equivalent).

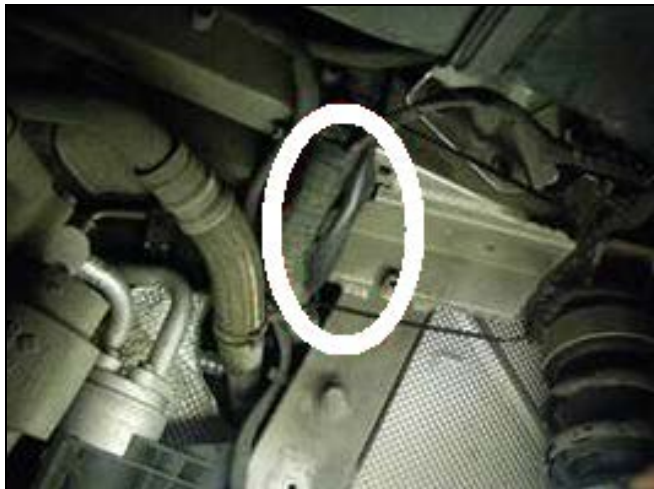
⇐ Route the overlay <circle> to ECM 2. Follow the harness through the splash shield into the wheel house.

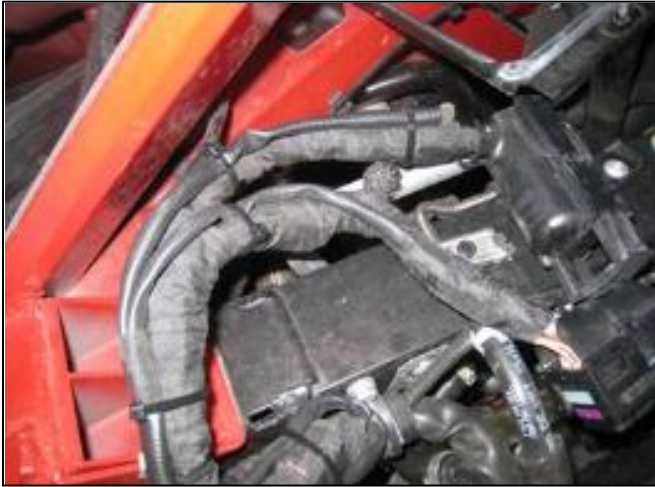
- For ECM 2 (J624, driver's side), put the purple wire into **chamber 36** of the T60 plug. Pull on the wire to ensure that it is locked into the connector
- Install terminal locking tab.
- Tape harness with cloth tape (000 979 950).
- Reinstall connector cover.
- Install tie wrap (N 909 377 02).

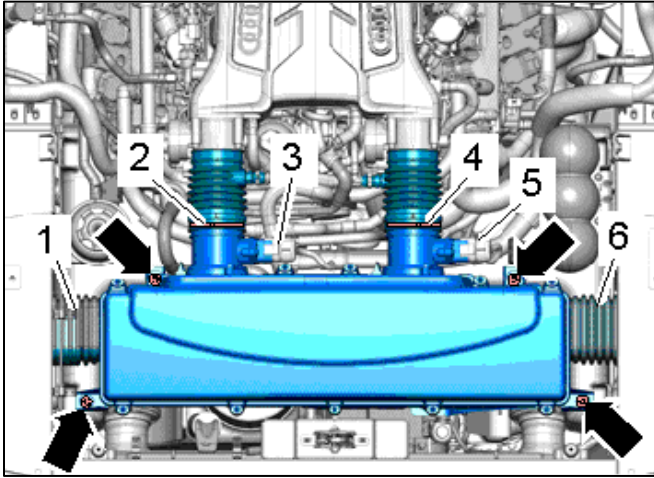
- ⇐ Carefully reinstall air filter housing with MAF. Secure with bolts <arrows> and torque to 8 Nm.
- ⇐ Reconnect air snorkels <1 and 6>.
- ⇐ Reconnect and tighten hose clamps <2 and 4>.
- ⇐ Make electrical connections to MAFs <3 and 5>.
