Audi

Customer Satisfaction Campaign

Code: 24U8

Subject: 2011 - 2012 Audi R8/R8 Spyder
Engine Wiring Harness Overlay & ECM Programming

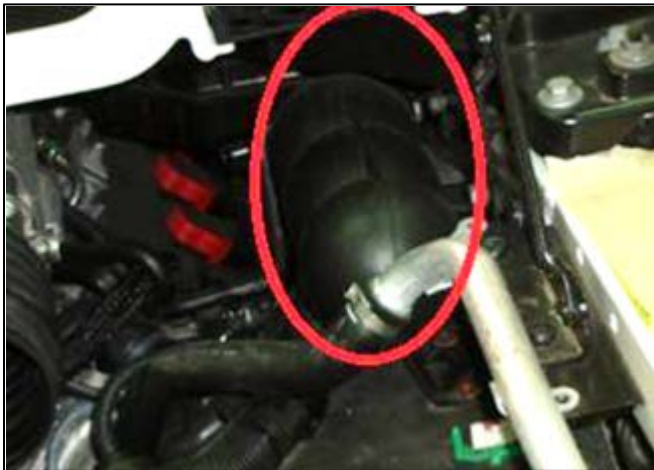
- ⇐ Remove vacuum reservoir <circle> hold-down bolts on right side of engine compartment to gain better access to wiring harness.

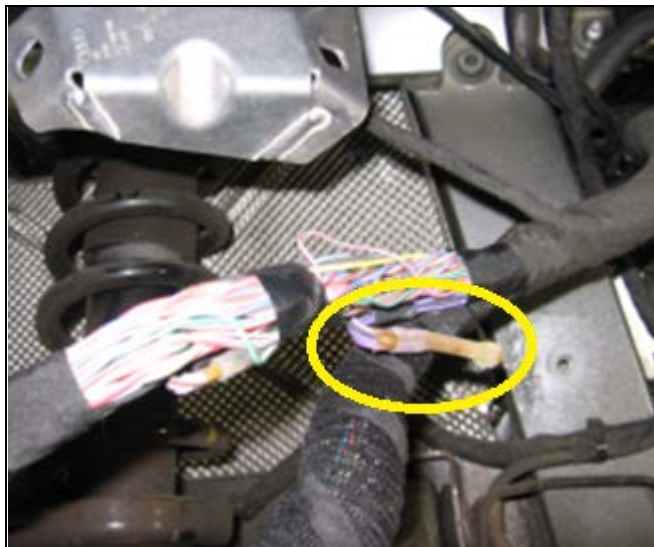
- Remove the brown wire for the G28 engine speed signal to the T60 connector on *ECM 1 (J623, passenger's side)* from **chamber 51** using VAS 1978/7A.
- ⇐ Cut off wire terminals and apply shrink tubing <red arrow> on each wire. Then, heat tubing with UT-100SI Ultratorch (or equivalent) and pinch the end of the tubing closed. Tape wires back in direction of the harness.
- ⇐ Strip the harness at the right side inside the wheel well, where the harness branches, and locate the D141 connection <yellow circle>.

- Locate the D141 connection in engine wiring harness near the harness junction where the harness branches to the T60 and T94 ECM connector plugs. The D141 connection has five lilac (purple) and one wire that is black or gray. Do not confuse with any other connection in harness.

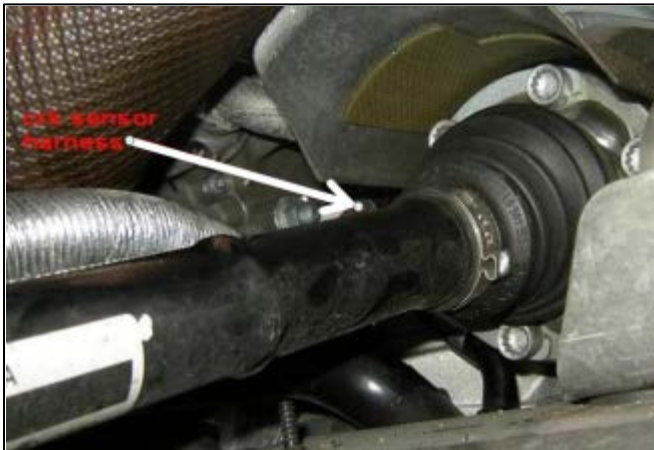
- ⇐ Disconnect the connector <arrow> to the G28 engine speed sensor on the left side of the transmission bell housing and cut off the connector end as straight as possible. The original wiring to the sensor is no longer required.

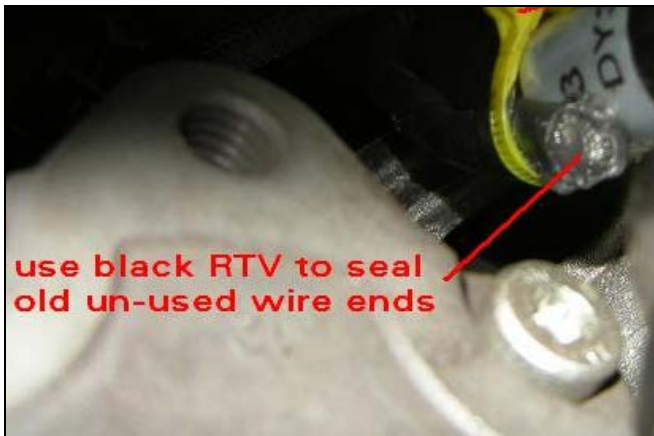
- ⇐ Seal the G28 cable opening with silicone sealant.

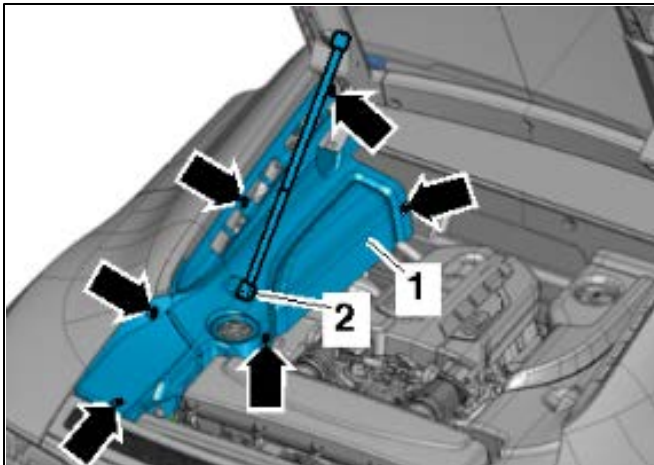
- ⇐ Remove quick release fasteners <arrows> and cap from power steering fluid reservoir.
- ⇐ Release gas-filled strut <2> by pulling clip with small screwdriver while having a second technician support the lid.
- ⇐ Raise the back of the engine compartment trim <1> and guide the front of it out at the lid hinge.
- Press the strut back onto the ball stud.
- Put cap from power steering fluid reservoir back into position.
- Repeat on other side.
- Remove the oil cap and cover the oil fill opening. This will help prevent damage to the oil cap while assembling and disassembling the air box.

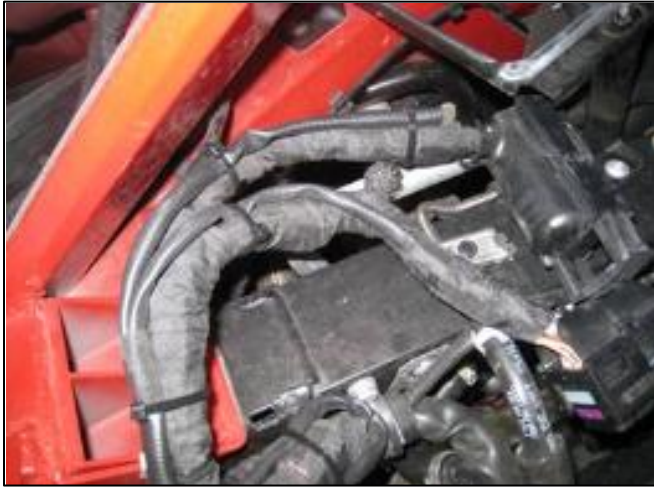
- For ECM 2 (J624, driver's side), put the purple wire into **chamber 36** of the T60 plug. Pull on the wire to ensure that it is locked into the connector
- Install terminal locking tab.
- Tape harness with cloth tape (000 979 950).
- Reinstall connector cover.
- Install tie wrap (N 909 377 02).
