WB40 - Re-coding Instrument Cluster (Workshop Campaign)

Vehicle Type: **Panamera/Panamera 4
Panamera S/Panamera 4S/Panamera S Hybrid
Panamera Turbo/Panamera Turbo S**

Model Year: **As of 2010 up to 2013**

Concerns: **Coding values for the instrument cluster**

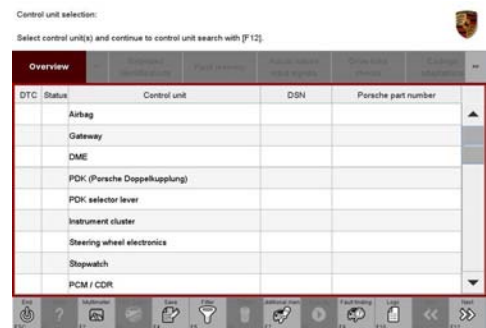
Control unit selection

- 3.2 Once the instrument cluster has been found and is displayed in the list, select the ⇒ **'Codings/adaptations'** menu .
