October 03, 2012

48K4 Update - Power Steering Control Unit (NVLW)

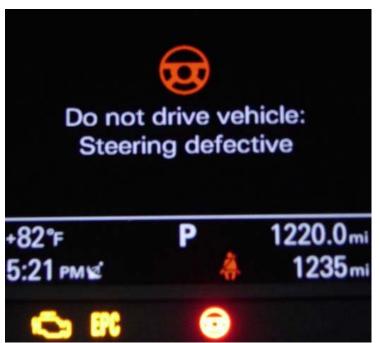
- 1. If the red warning lamp for the steering is displayed in the instrument cluster, the software update must not be performed. Please repair the steering and then perform the software update.
- 2. Follow all instructions in the attached TSB 2011732 00 Software Version Management (SVM), operating instructions.
- 3. Update the power steering control module (J500) using the SVM action code as listed in the table below if necessary.
