NUMBER: 08-065-12

GROUP: Electrical

RHR Navigation Map Enhancements

This bulletin involves updating the RHR radios navigation map database software.

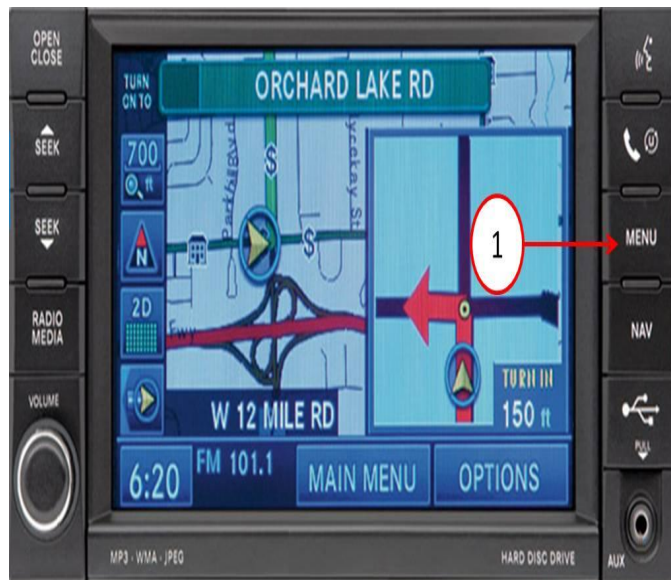
Fig. 1 Radio Face Plate

1 - MENU Key

1. Turn ignition to the RUN position
2. Turn the Radio on.
3. Press the MENU key (Fig. 1).

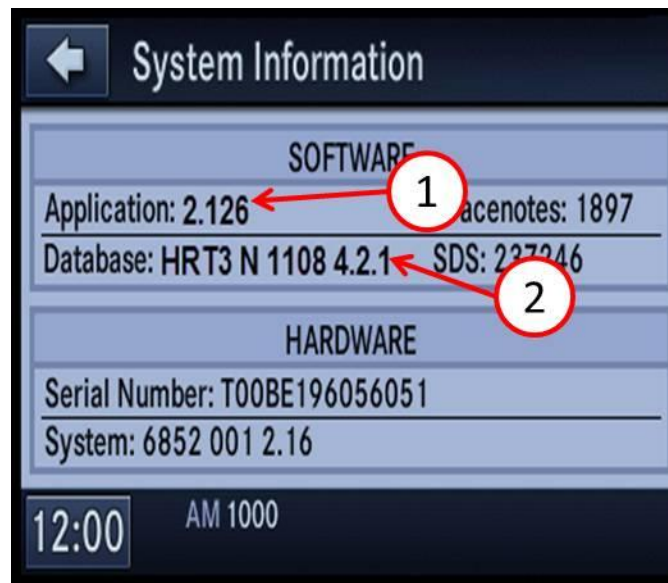
Fig. 4 Software Versions

1 - Application Version

2 - Database Software Version

6. Is the application software level at 2.126? (Fig. 4).
a. No >>> Perform service bulletin 08-053-12 first, before proceeding with this bulletin.
b. Yes >>> proceed to [Step #7](#).

-
7. Is the Database software level at 4.3.1 or higher? (Fig. 4).
- Yes >>> This service bulletin doesn't pertain, normal diagnostic should be performed.
 - No >>> Proceed to [Step #8](#).

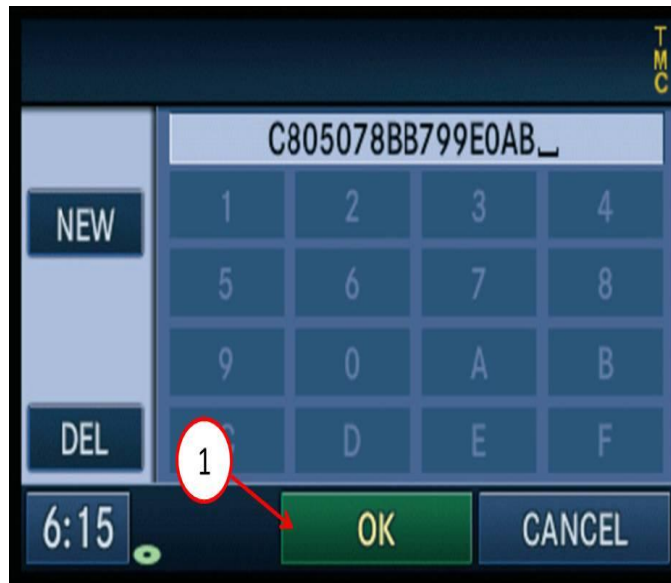
Fig. 8 Radio Face Plate

1 - Press OK

15. After successful entry of the activation key, the following screen will be displayed ([Fig. 8](#)).

- 16. Press "OK" and the update process will begin.
- 17. The following screen will be displayed (Fig. 9).

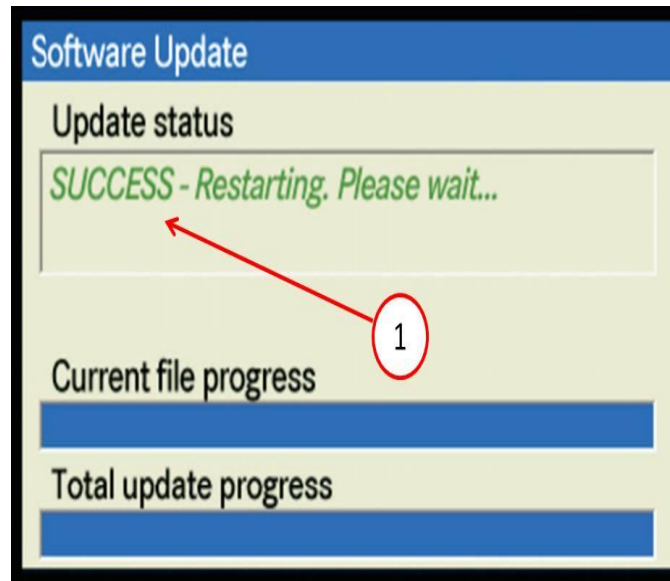
Fig. 11 Radio Face Plate

1 - Success

19. After successful update, the following screen will be displayed ([Fig. 11](#))
