Technical Service Bulletin

SUBJECT:			No: TSB-12-13-006
ECM REPROGRAMMING FOR ENGINE SYSTEM SERVICE REQUIRED ILLUMINATED – REVISED			DATE: November, 2012
			MODEL: See below
CIRCULATE TO:	<input type="checkbox"/> GENERAL MANAGER	<input type="checkbox"/> PARTS MANAGER	<input checked="" type="checkbox"/> TECHNICIAN
<input checked="" type="checkbox"/> SERVICE ADVISOR	<input checked="" type="checkbox"/> SERVICE MANAGER	<input checked="" type="checkbox"/> WARRANTY PROCESSOR	<input type="checkbox"/> SALES MANAGER

This bulletin supercedes TSB-11-13-007, issued June, 2011, to correct the subject, include Lancer Evolution SST, Lancer and Lancer Sportback Ralliart models, clarify instructions for performing mechanical checks and change Warranty Information. Changes are italicized and indicated by ◀.

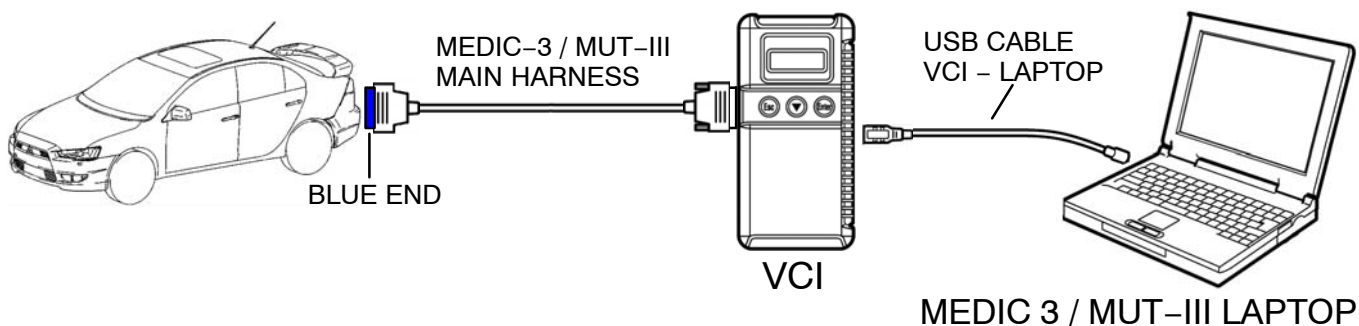
Connect the equipment as follows:

- Turn the laptop computer on. If you're running on battery power and the charge indicator in the lower right hand corner of the screen does not show a full charge, it is recommended that either the laptop battery be charged prior to beginning, or that reprogramming be completed with the A/C power adaptor connected to the laptop.
- Connect the USB cable to the VCI.
- When the laptop displays the MUT-III main screen, connect the USB cable to the laptop.
- Connect the MUT-III main harness with the blue DLC connection to the VCI.
- Connect the blue connector of the MUT-III main harness to the vehicle's data link connector.
- Turn the VCI power switch ON. Verify that the indicator lamp in the upper right corner of the screen is green.

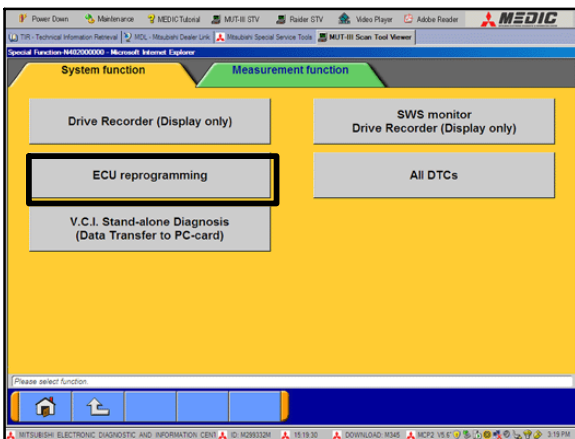
- b. If using MEDIC-III, from the main page, click the MUT-III STV icon at the top center of the screen.
 - c. Select "Special Function."

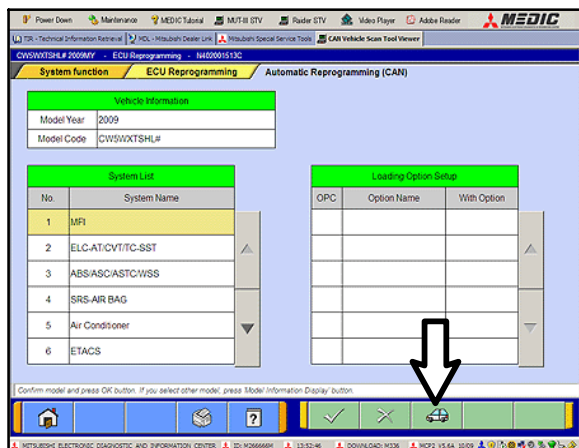
- e. Select "Automatic Reprogramming (CAN)."

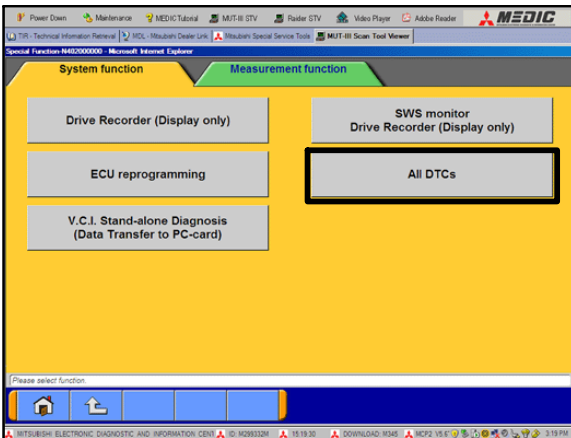
3. Using the MUT-III, check and erase ALL DTCs from all systems as follows.

a. Select “Special Function.”

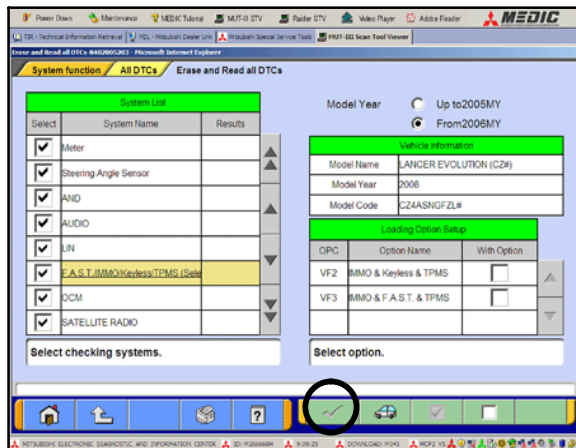
b. Select “All DTCS,” then select “ERASE AND READ ALL DTCS.”

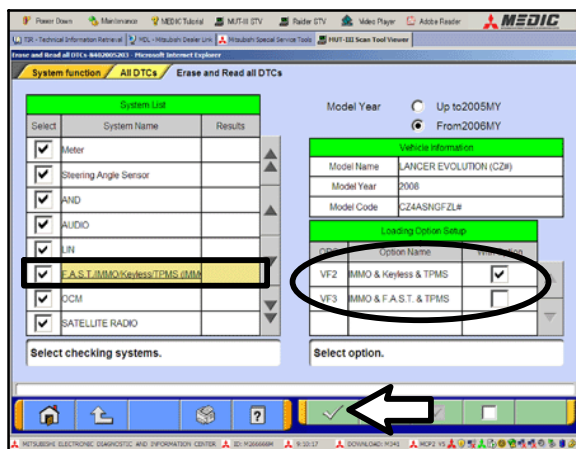
c. The list on the left side of the screen (System List) will have all selections checked. Do not change these selections. DTCs may be set if the vehicle is equipped with options that are unchecked.

NOTE: At this time, the check mark at the bottom of the page is not highlighted (inactive).

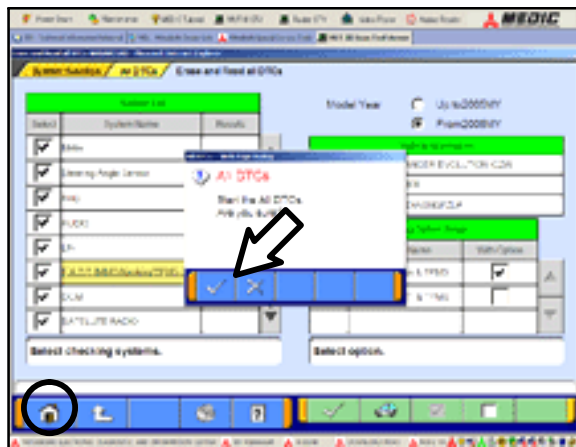
d. In the System List, scroll to and click FAST/IMMOB/KEYLESS/TPMS. In the Loading Option Setup list, check the correct OPC (VF#). This will activate the check mark at the bottom of the page.

- Vehicles with regular keyless entry (buttons on a multi-function key), select VF2.
 - Vehicles with F.A.S.T. key, select VF3.
- Click the check mark to continue.
