AT12-002b

November 14, 2012

2011 – 2012 M37/M56; SHIFT RESPONSIVENESS ISSUES

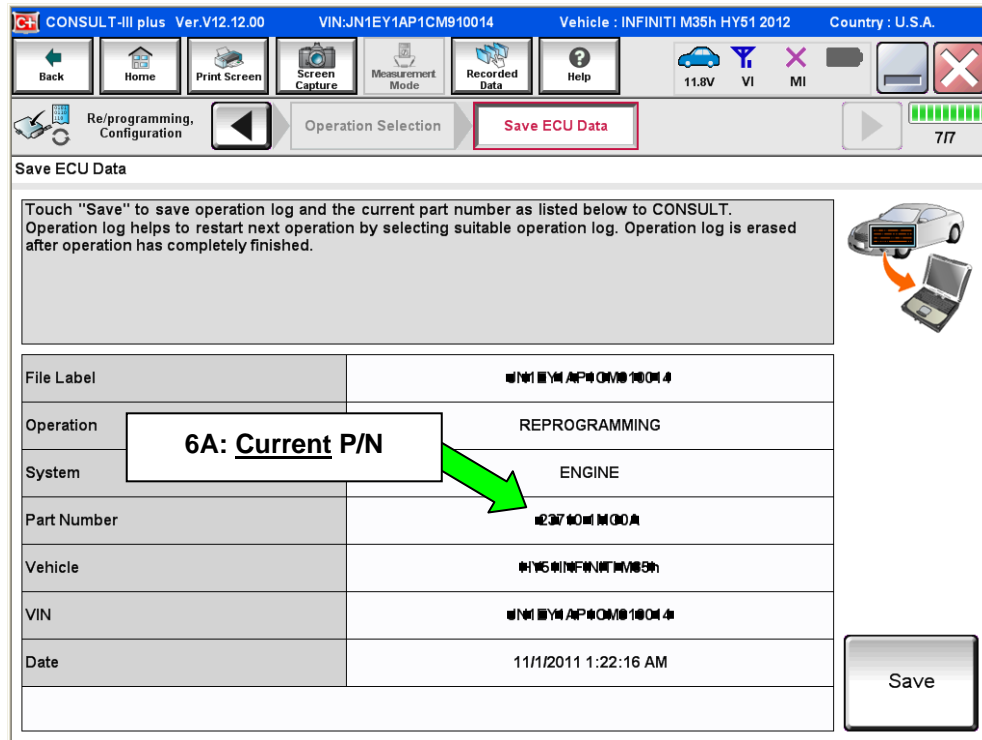
6. When you get to the screen shown in Figure 2, confirm this bulletin applies as follows:

A. Find the ECM or TCM **Part Number** and write it on the repair order.

NOTE: This is the current ECM or TCM Part Number (P/N).

5. Follow the on-screen instructions and navigate the C-III plus to the screen shown in Figure 2 on the next page.

B. Compare the P/N you wrote down to the numbers in the **Current ECM or TCM Part Number** column in **Table A** below.

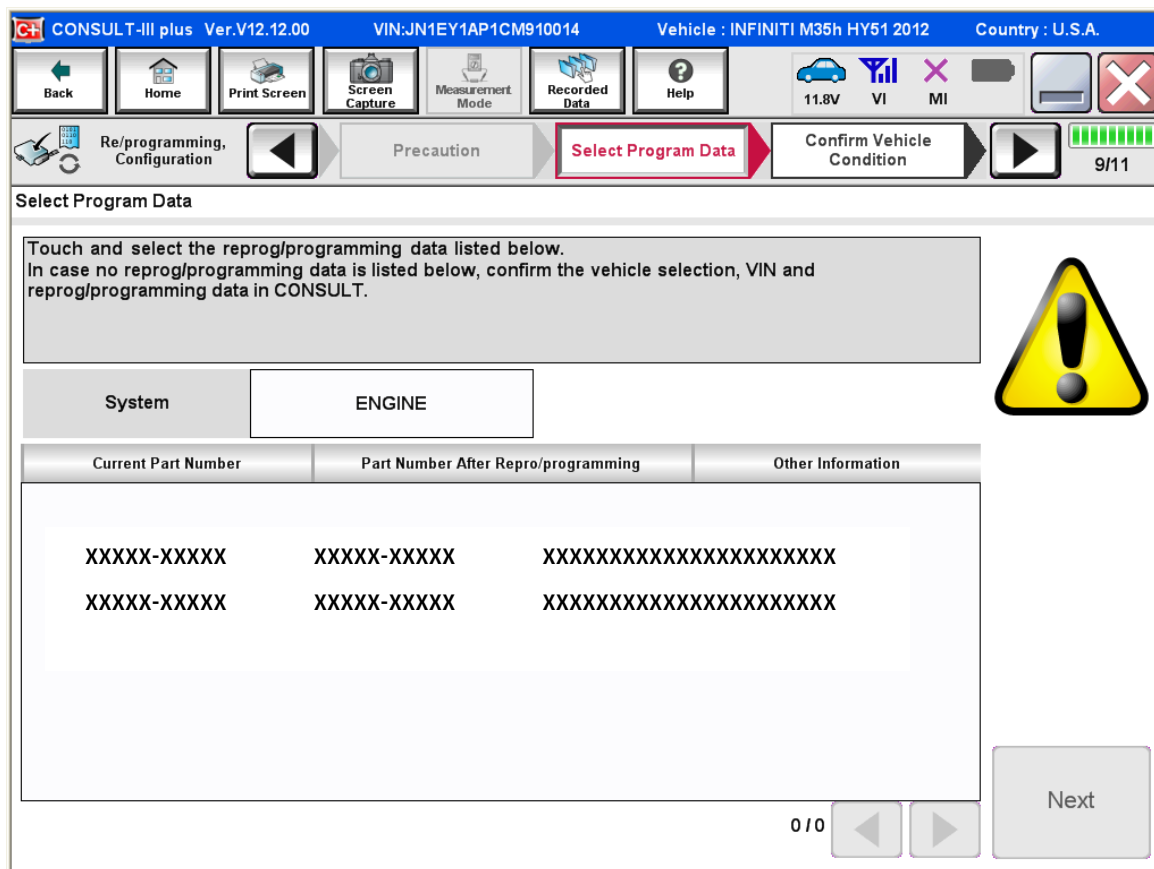
- In some cases, more than one new P/N for reprogramming is available.
 - In this case, the screen in Figure 3 displays.
 - Select and use the reprogramming option that **does not** have the message "Caution! Use ONLY with ITBXX-XXX".
- If you get this screen and it is **blank** (no reprogramming listed), it means there is no reprogramming available for this vehicle.

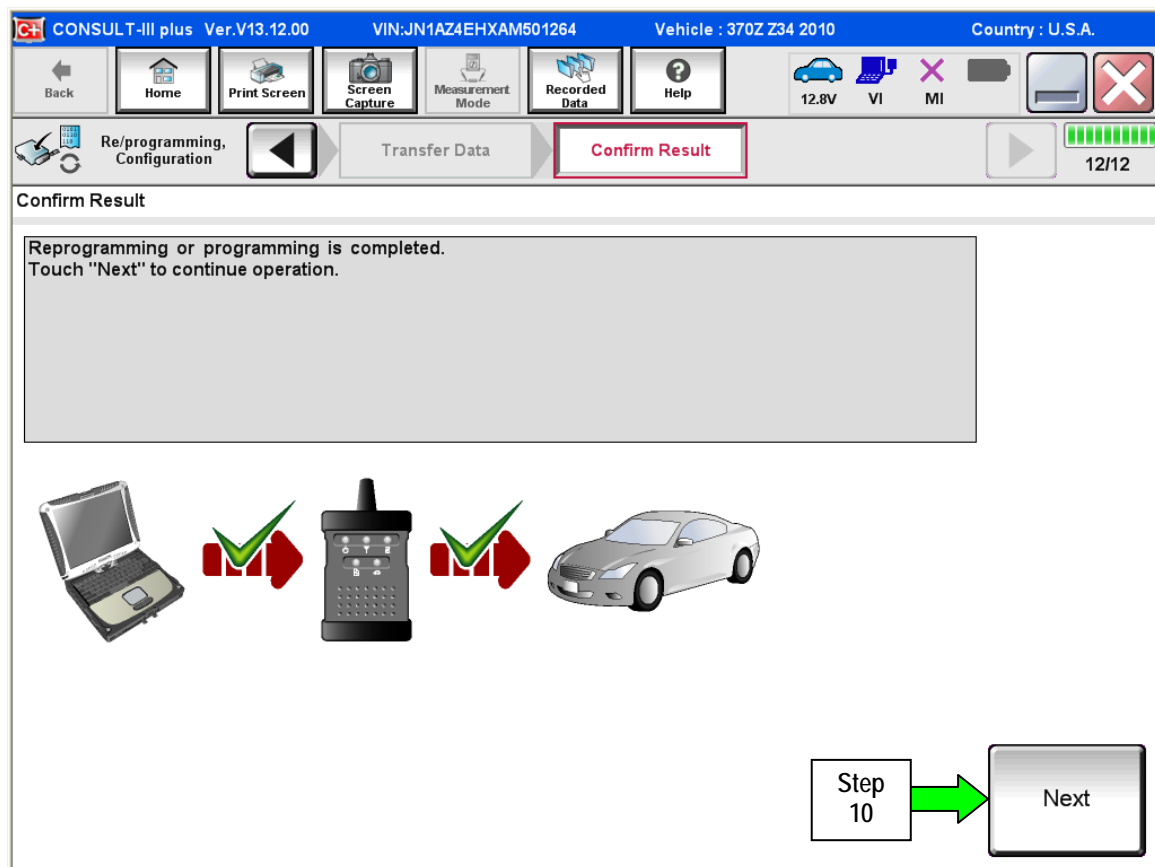
8. When the screen in Figure 4 displays, reprogramming is complete.

NOTE: If the screen in Figure 4 does not display (reprogramming does not complete), refer to the information on the next page.

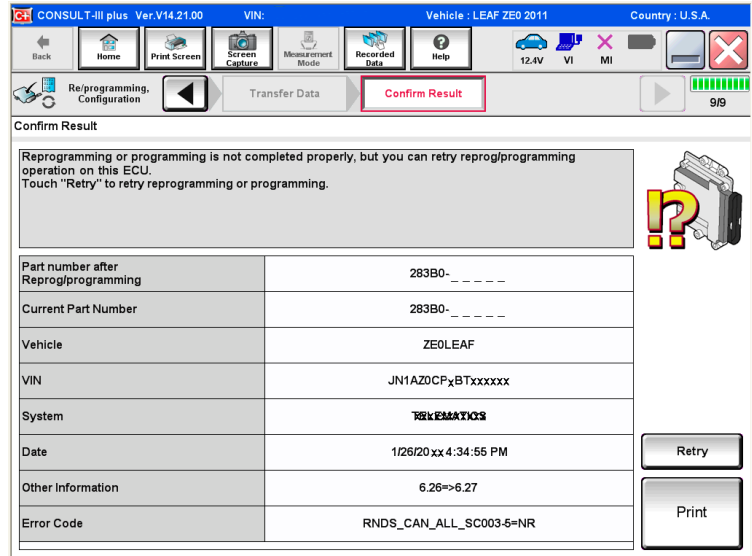
Figure 5

If reprogramming does not complete and the “!?” symbol displays as shown in Figure 5:

- Check battery voltage (12.0 – 15.5V).
- Ignition is ON, engine not running.
- External Bluetooth® devices are OFF.
- All electrical loads are OFF.
- **Select Retry and follow the on screen instructions.**

NOTE: Retry may not go through on first attempt and can be selected more than once.

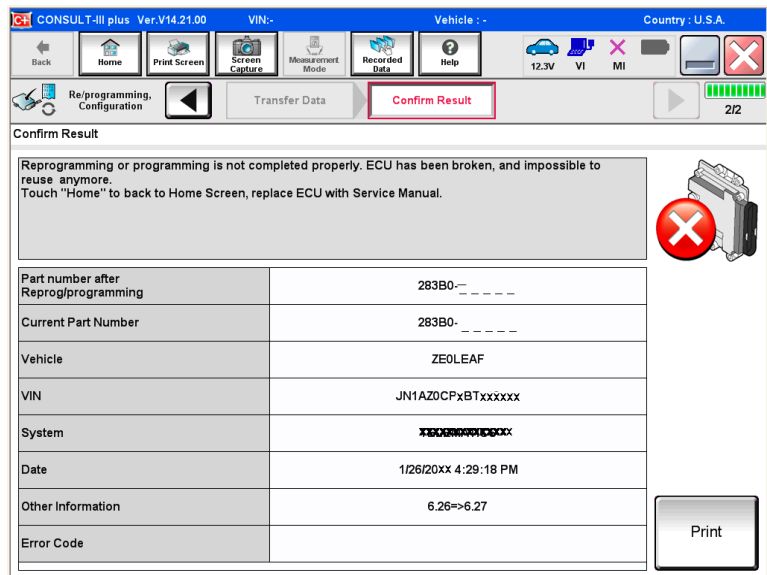
Figure 6

If reprogramming does not complete and the “X” symbol displays as shown in Figure 6:

- Do not disconnect the VI or shut down C-III plus if reprogramming does not complete.
- Check battery voltage (12.0 – 15.5V).
- CONSULT A/C adapter is plugged in.
- Ignition is ON, engine not running.
- Transmission in Park.
- All C-III plus / plus VI cables are securely connected.
- All C-III plus updates are installed.
- **Select Home, and then restart the reprogram procedure from the beginning.**

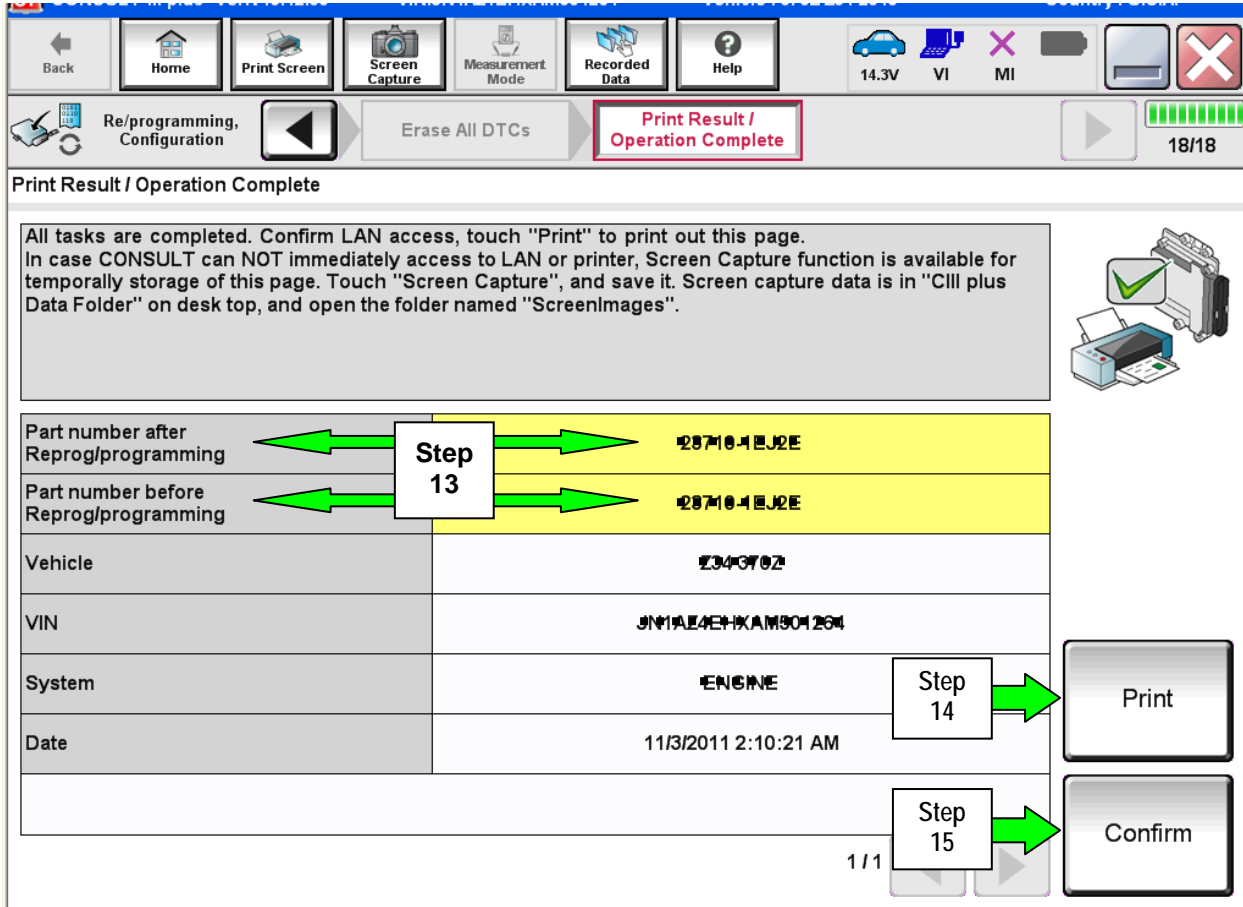
12. When the entire reprogramming process is complete, the screen in Figure 7 will display.
13. Verify the before and after part numbers are different.
14. Print a copy of this screen (Figure 7) and attach it to the repair order for warranty documentation.
15. Select **Confirm**.
