AT12-003d

## 2009 - 2012 G37; SHIFT RESPONSIVENESS ISSUES

**APPLIED VEHICLES:** 2009 – 2011 G37 Sedan and Coupe (V36/CV36)  
2009 – 2012 Convertible (HV36)

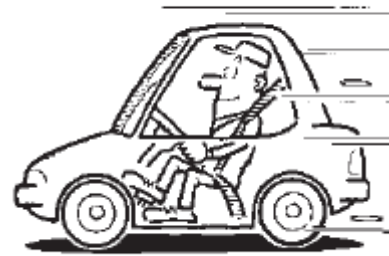
Figure A

- Take the vehicle for a 10 minute drive in order to meet the following Idle Air Volume Learn (IAVL) conditions:
  - Engine coolant temperature: 70 -100°C (158 -212°F)
  - Battery voltage: More than 12.9V (At idle)
  - Transmission: Warmed up

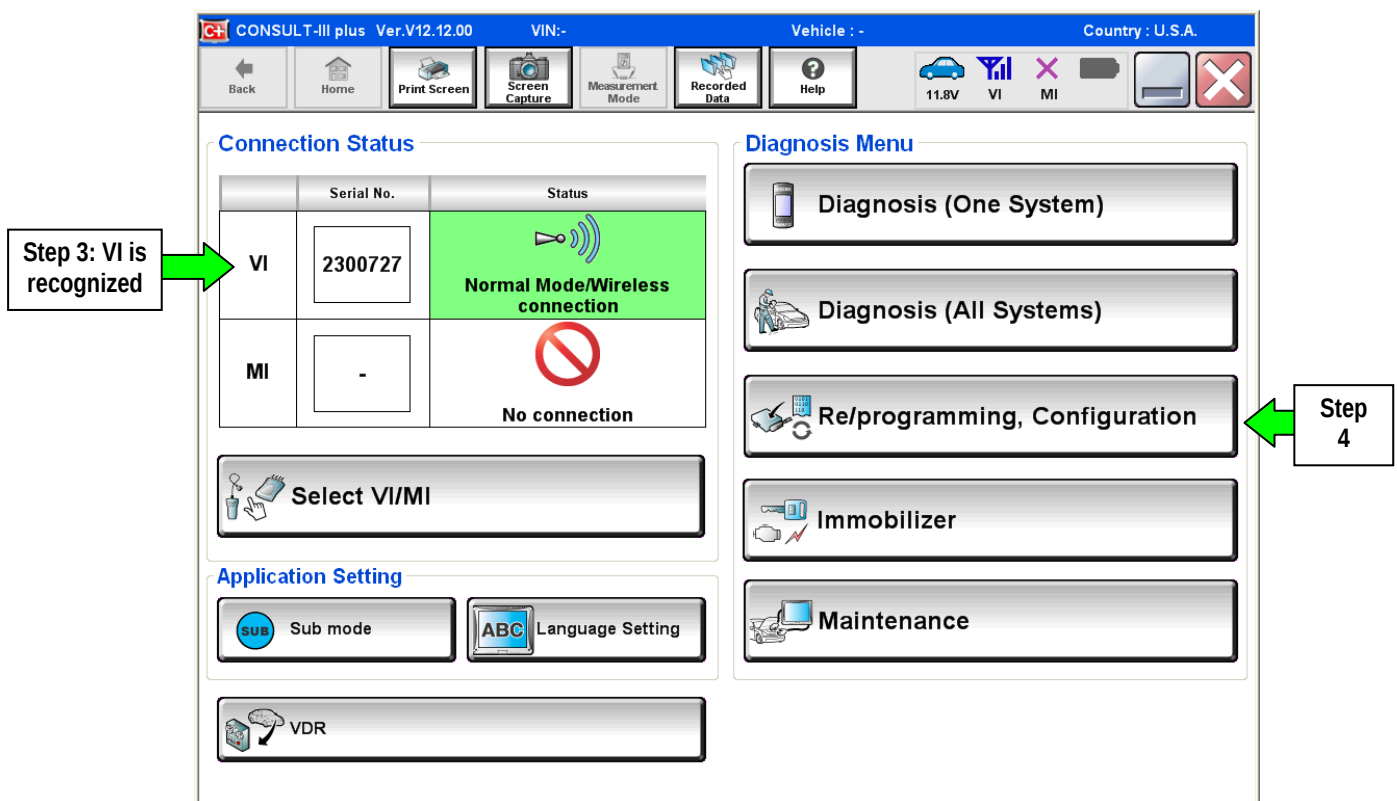
Figure 1

1. **Connect the CONSULT PC** to the vehicle to begin the reprogramming procedure.
2. Open ASIST on the CONSULT PC and start C-III plus.
3. Wait for the plus VI to be recognized / connected.
  - Serial number will display when the plus VI is recognized / connected.
4. Select **Re/programming, Configuration**.

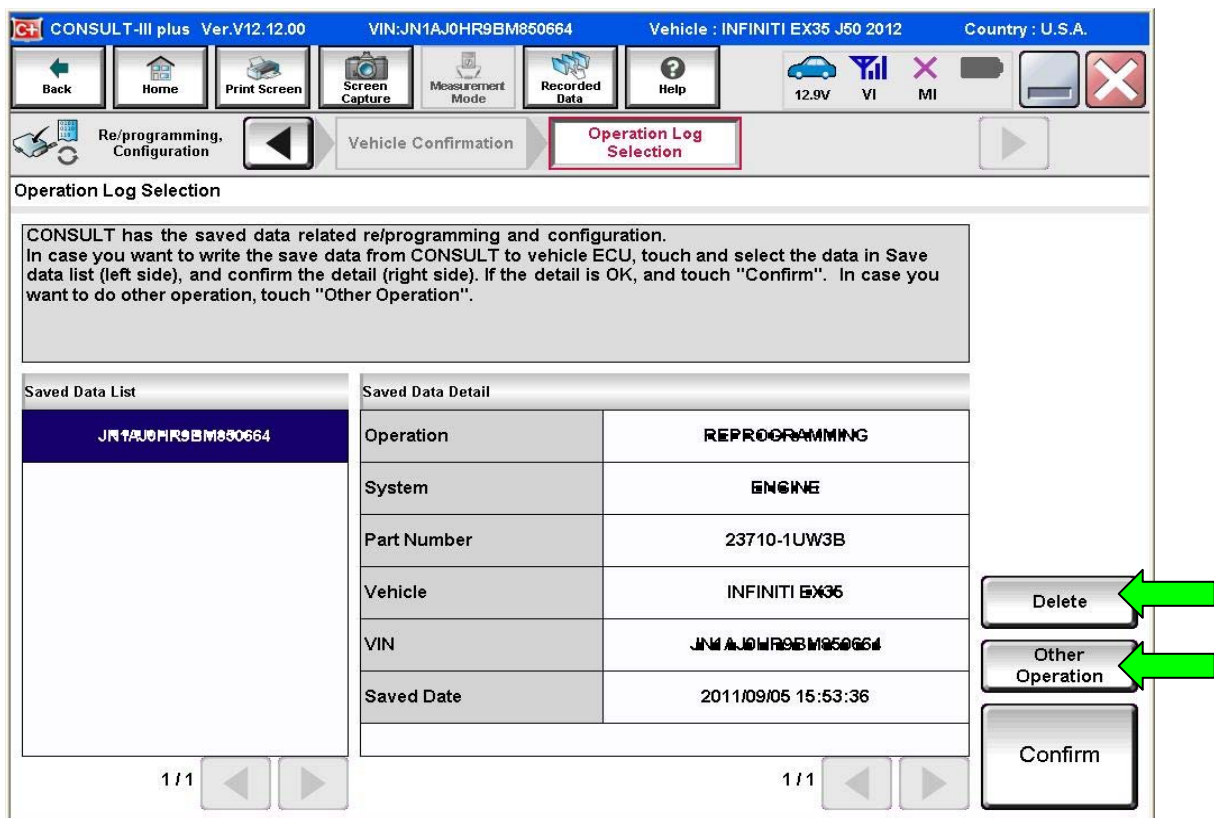
While navigating C-III plus, if the screen in Figure 1A displays, select **Delete** and then **Other Operation**.

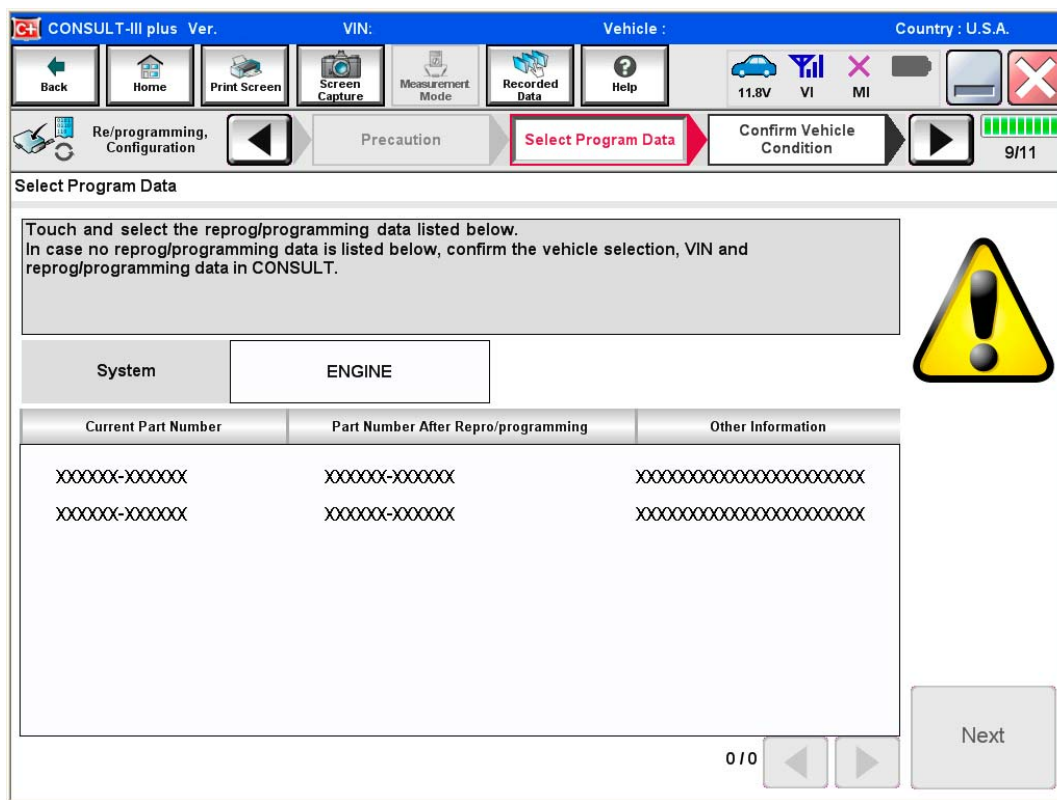
- In some cases, more than one new P/N for reprogramming is available.
  - In this case, the screen in Figure 3 displays.
  - Select and use the reprogramming option that **does not** have the message “Caution! Use ONLY with ITBXX-XXX”.
- If you get this screen and it is blank (no reprogramming listed), it means there is no reprogramming available for this vehicle.

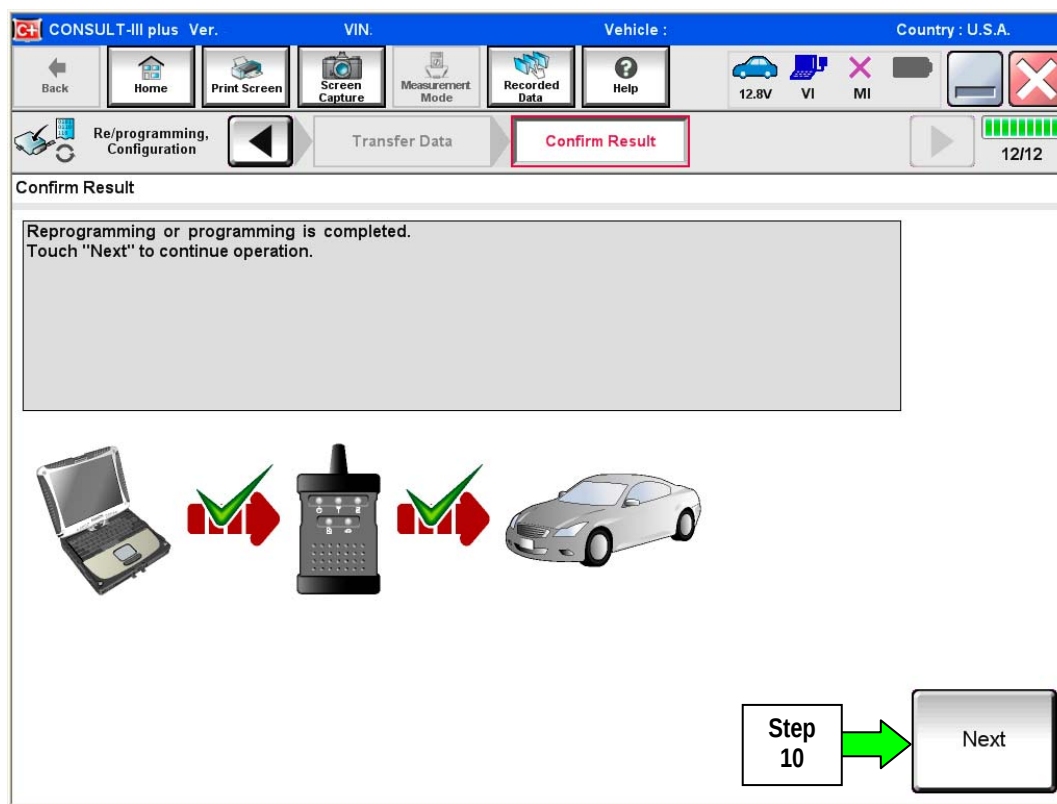
8. When the screen in Figure 4 displays, reprogramming is complete.

**NOTE:** If the screen in Figure 4 does not display (reprogramming does not complete), refer to the information on the next page.

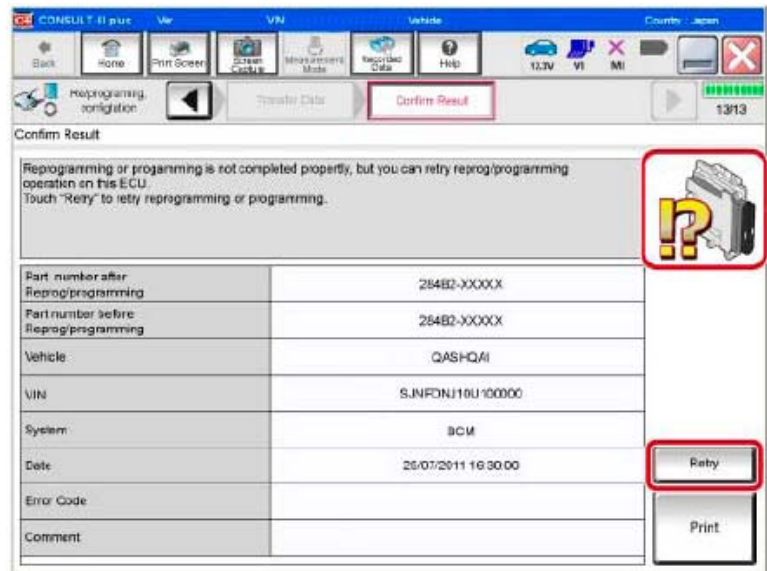
Figure 5

If reprogramming does not complete and the “!” icon displays as shown in Figure 5:

- Check battery voltage (12.0–15.5 V).
- Ignition is ON, engine OFF.
- External Bluetooth® devices are OFF.
- All electrical loads are OFF.
- **Select retry and follow the on screen instructions.**
- **“Retry” may not go through on first attempt and can be selected more than once.**

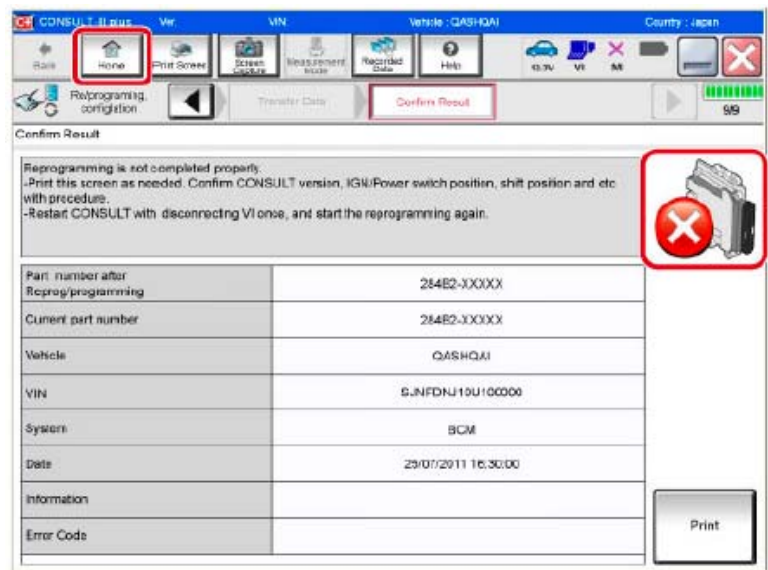
Figure 6

If reprogramming does not complete and the “X” icon displays as shown in Figure 6:

- Check battery voltage (12.0 – 15.5 V).
- CONSULT A/C adapter is plugged in.
- Ignition is ON, engine OFF.
- Transmission is in Park.
- All C-III plus / VI cables are securely connected.
- All C-III plus updates are installed.
- **Select Home, and restart the reprogram procedure from the beginning.**

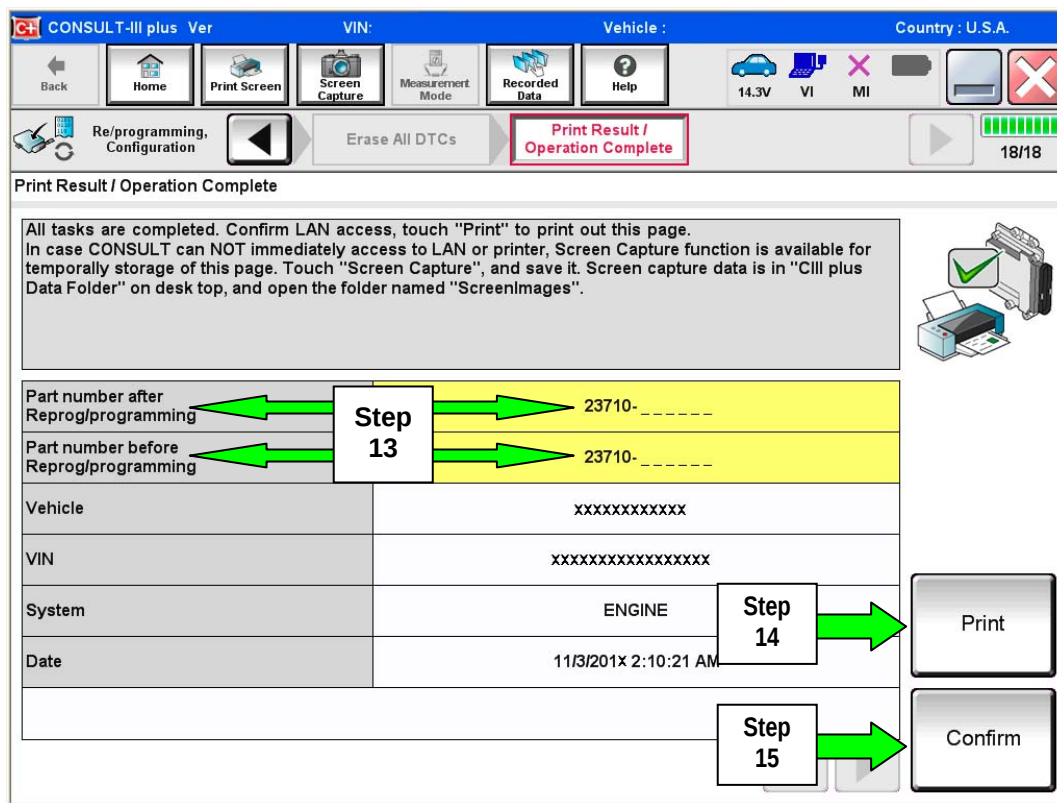
12. When the entire reprogramming process is complete, the screen in Figure 7 will display.
13. Verify the before and after part numbers are different.
14. Print a copy of this screen (Figure 7) and attach it to the repair order for warranty documentation.
15. Select **Confirm**.
