**Classification:**  
AT12-004b

**Reference:**  
ITB12-023b

## 2011 G25; SHIFT RESPONSIVENESS ISSUES

**APPLIED VEHICLE:** 2011 G25 (V36)  
**APPLIED ENGINE:** VQ25  
**APPLIED TRANSMISSION:** 7 speed

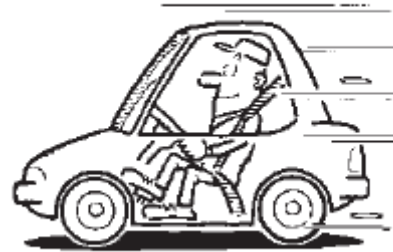
Figure A

- Most instructions for reprogramming with CONSULT-III plus (C-III plus) are displayed on the CONSULT PC screen.
- If you are not familiar with the reprogramming procedure, [click here](#). This will link you to the "CONSULT- III plus (C-III plus) ECM or TCM Reprogramming" general procedure.
- Take the vehicle for a 10 minute drive in order to meet the following Idle Air Volume Learn (IAVL) conditions:
  - Engine coolant temperature: 70 -100°C (158 -212°F)
  - Battery voltage: More than 12.9V (At idle)
  - Transmission: Warmed up

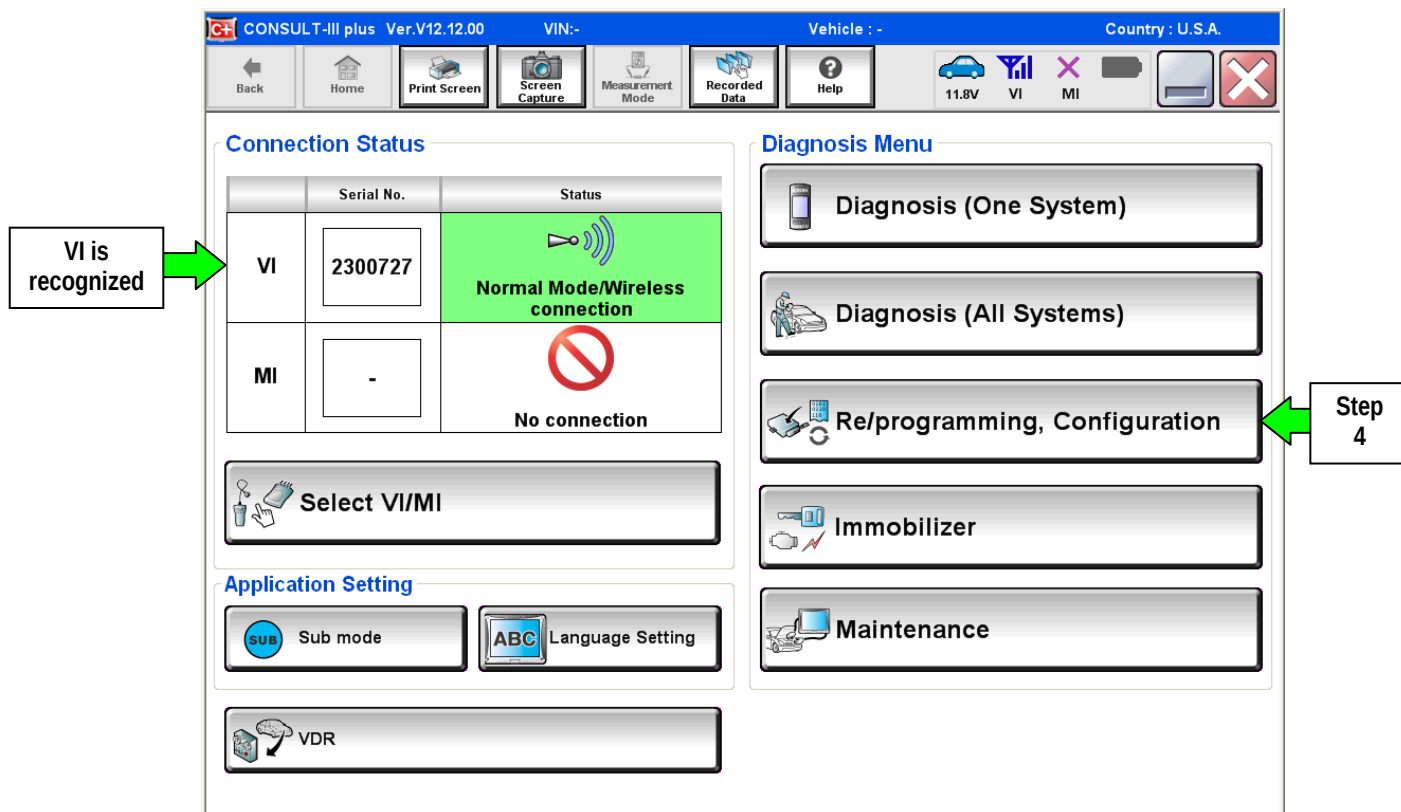
Figure 1

1. Connect the CONSULT PC to the vehicle to begin the reprogramming procedure.
2. Open ASIST on the CONSULT PC and start C-III plus.
3. Wait for the plus VI to be recognized / connected.
  - The serial number will display when the plus VI is recognized / connected.
4. Select **Re/programming, Configuration**.

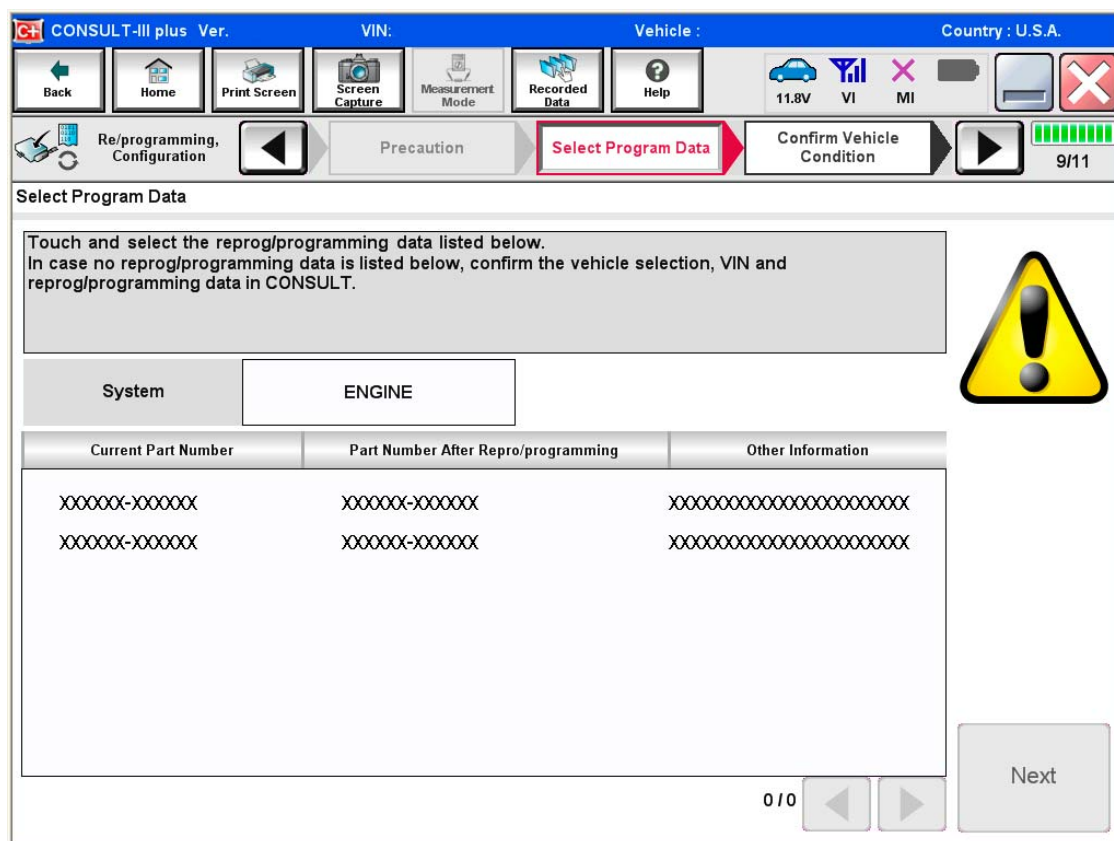
- In some cases, more than one new P/N for reprogramming is available.
  - In this case, the screen in Figure 3 displays.
  - Select and use the reprogramming option that **does not** have the message “Caution! Use ONLY with NTBXX-XXX”.
- If you get this screen and it is blank (no reprogramming listed), it means there is no reprogramming available for this vehicle. Close C-III plus and refer back to ASIST for further diagnosis.

7. Follow the on-screen instructions to navigate C-III plus to reprogram the TCM **first** (and then the ECM).
  - When programming the ECM the file number written down in step 13 will be displayed in Figure 3 under “**Other Information**”.
    - o Select the file number that was written down in step 13, and then follow the on-screen instructions.

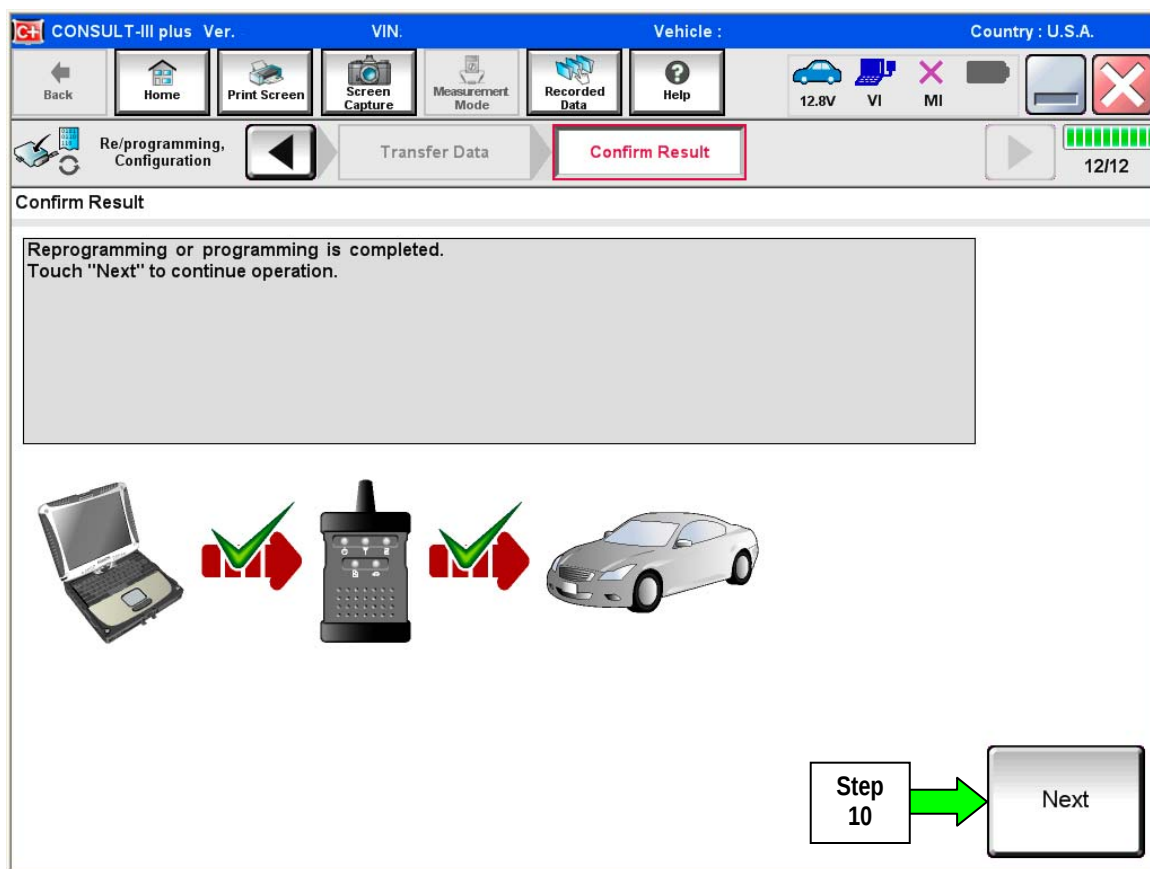
8. When the screen in Figure 4 displays, reprogramming is complete.

**NOTE:** If the screen in Figure 4 does not display (reprogramming does not complete), refer to the information on page 9.

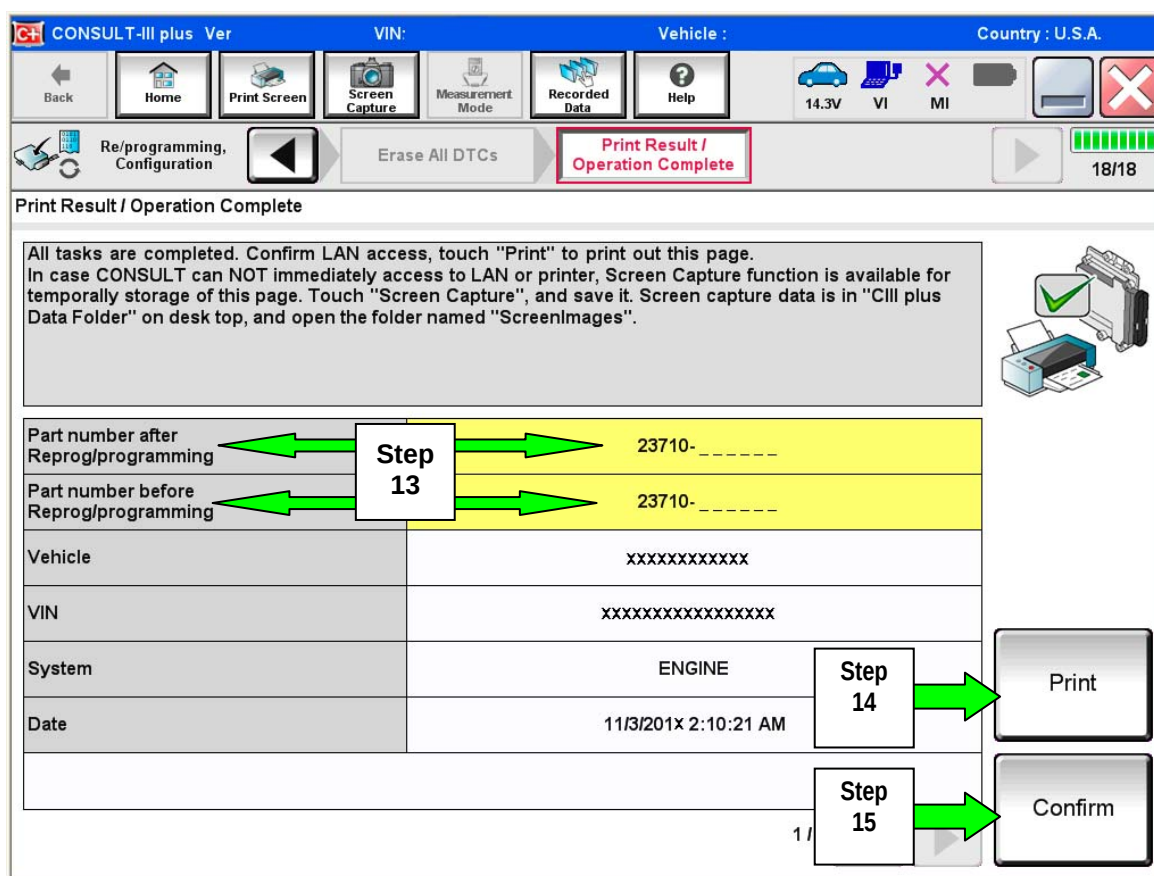
11. When the entire reprogramming process is complete (**TRANSMISSION** or **ENGINE**), the screen in Figure 5 will display.

12. Verify the before and after part numbers are different.

- When reprogramming the ECM (**after TCM reprogramming is complete**), verify the before and after part numbers and then skip to step 14.

13. After TCM reprogramming is complete:
  - a. Compare the **"Part number after Reprogramming"** to the numbers in Table B (bottom of page).
  - b. Choose the correct ECM file to use from Table B, and write it down.

➤ Figure 6 is shown as a reference only and will be displayed instead of the screen in Figure 3 during the ECM reprogramming procedure.
14. Print a copy of this screen (Figure 5) and attach it to the repair order for warranty documentation.
15. Select **Confirm**.

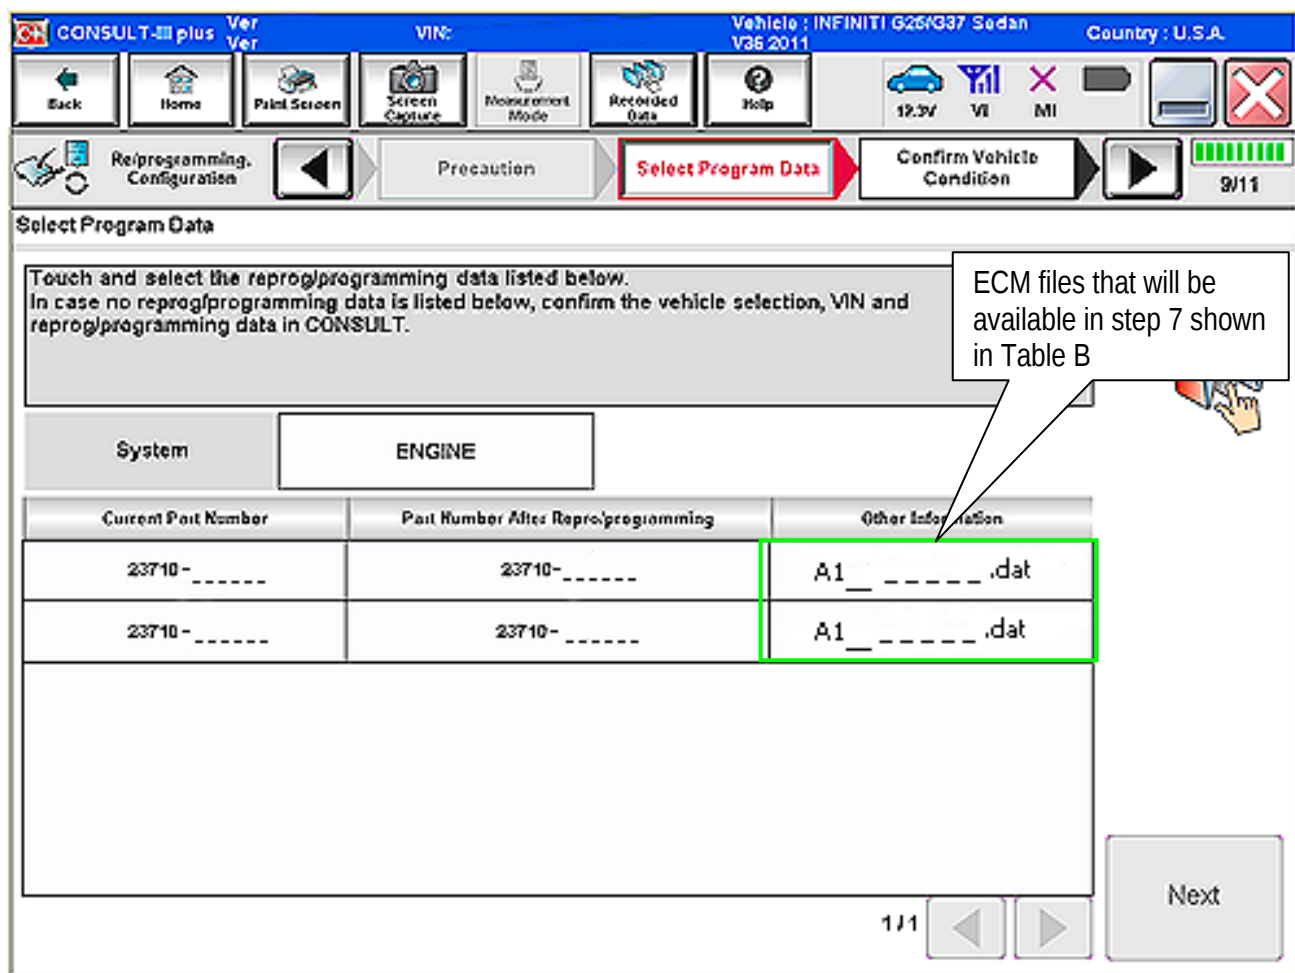
Figure 6

Choose correct ECM reprogram file from Table B

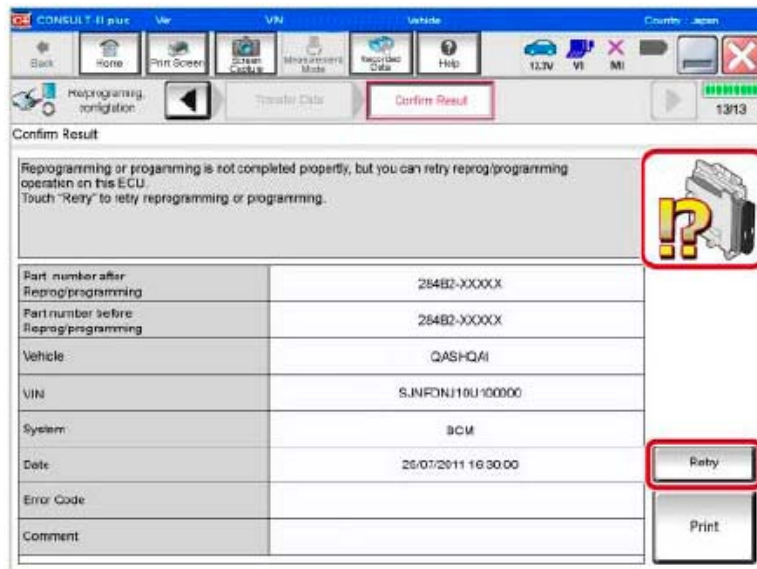
Figure 7

If reprogramming does not complete and the “!?” icon displays as shown in Figure 7:

- Check battery voltage (12.0–15.5 V).
- Ignition is ON, engine OFF.
- External Bluetooth® devices are OFF.
- All electrical loads are OFF.
- **Select retry and follow the on screen instructions.**
- “Retry” may not go through on first attempt and can be selected more than once.

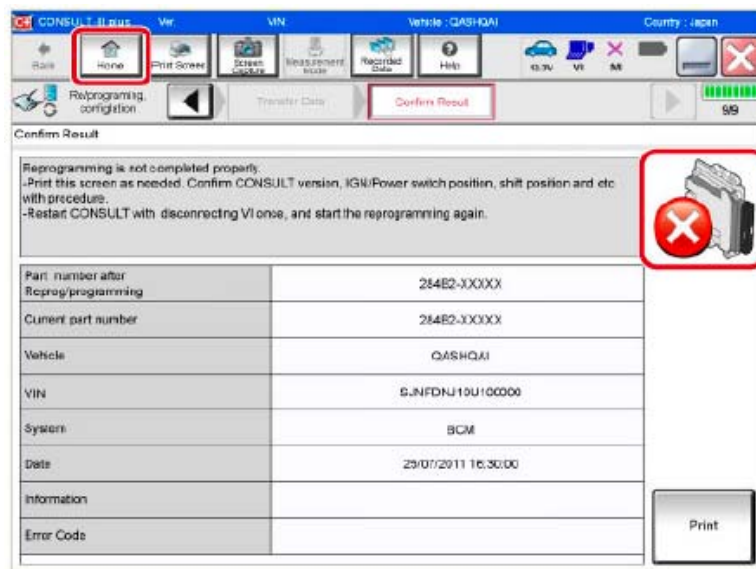
Figure 8

If reprogramming does not complete and the “X” icon displays as shown in Figure 8:

- Check battery voltage (12.0 – 15.5 V).
- CONSULT A/C adapter is plugged in.
- Ignition is ON, engine OFF.
- Transmission is in Park.
- All C-III plus / VI cables are securely connected.
- All C-III plus updates are installed.
- **Select Home, and restart the reprogram procedure from the beginning.**
