## EX AND FX; SHIFT RESPONSIVENESS ISSUES

**APPLIED VEHICLES:** 2011 EX35 (J50)

2009 - 2011 FX35 (S51)

**APPLIED ENGINE:** VQ37VHR

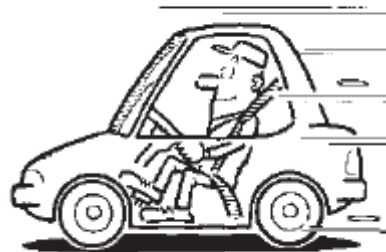
Figure A

- Take the vehicle for a 10 minute drive in order to meet the following Idle Air Volume Learn (IAVL) conditions:
  - Engine coolant temperature: 70 -100°C (158 -212°F)
  - Battery voltage: More than 12.9V (At idle)
  - Transmission: Warmed up

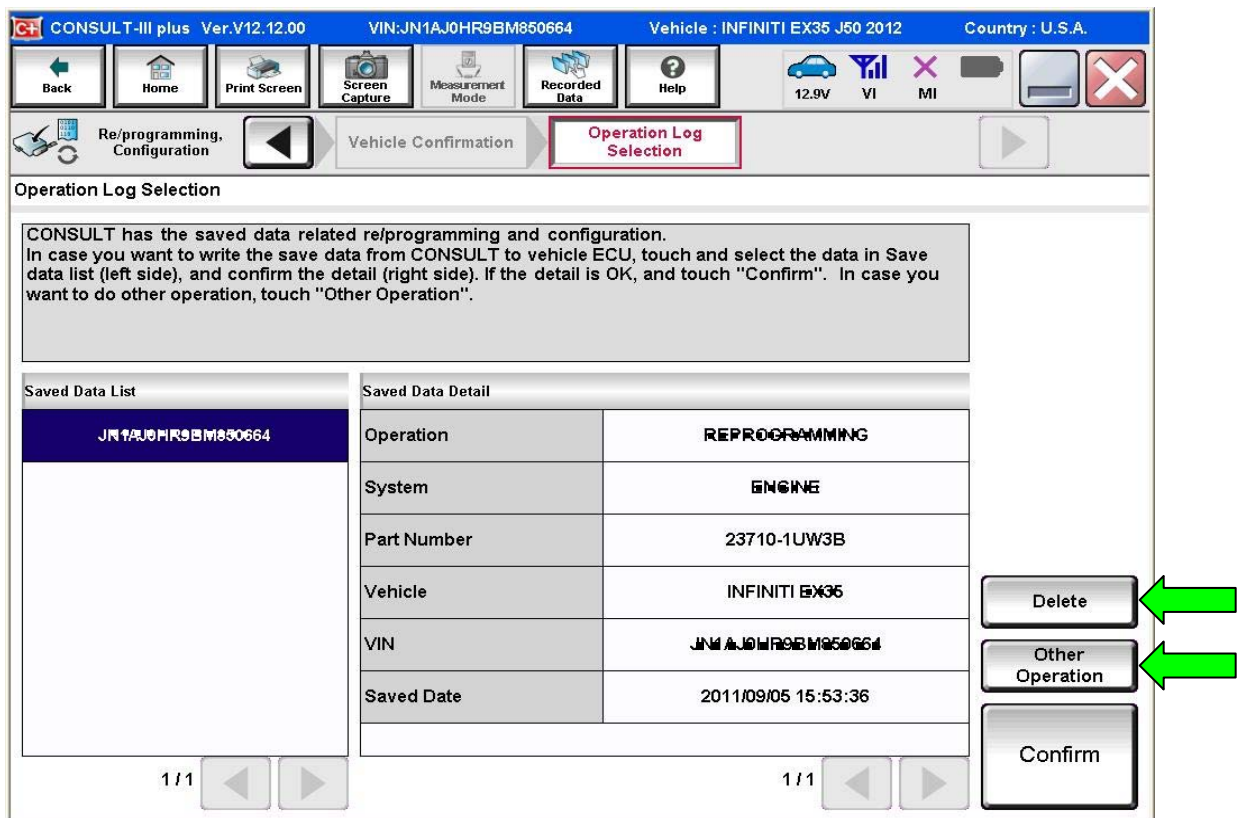
Figure 1A

During the initial "Reprogramming Confirmation" set-up, if you get the screen shown in Figure 1A:

1. Select **Delete**, then
2. Select **Other Operation**, then
3. Continue with the reprogramming procedure.

**NOTE:** If reprogramming does not complete, this screen can display for reprogramming recovery.  
Do not select **Delete** if this screen displays during reprogram recovery.

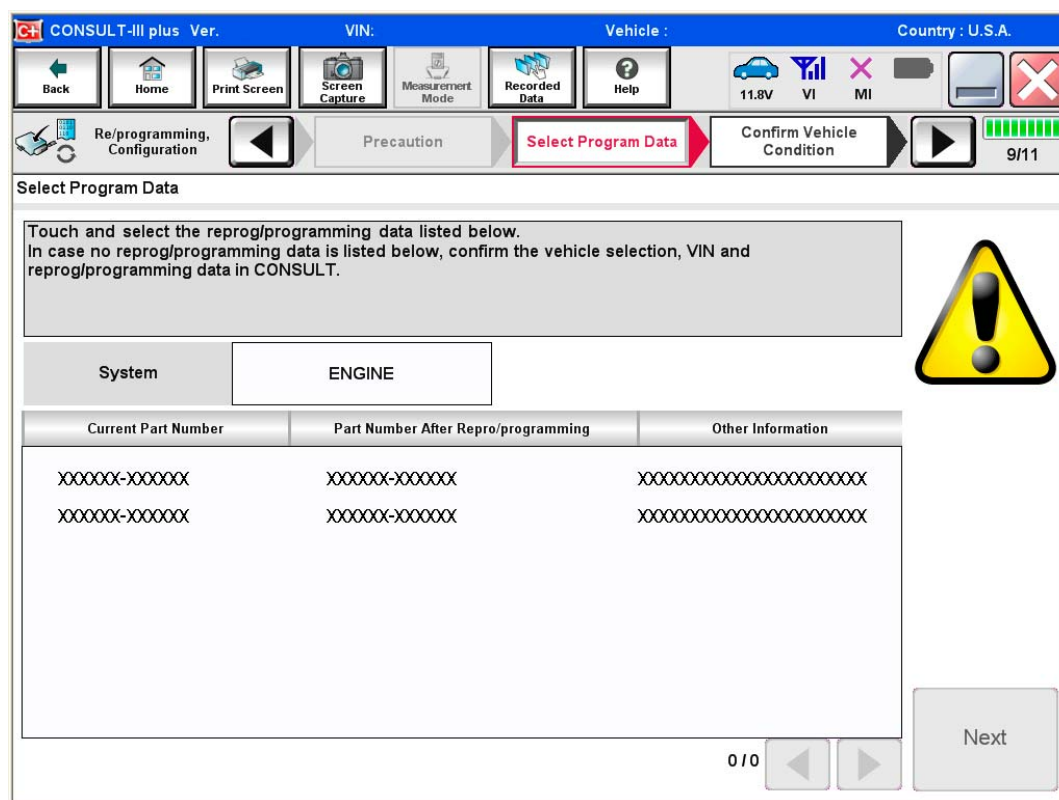
- In some cases, more than one new P/N for reprogramming is available.
  - In this case, the screen in Figure 3 displays.
  - Select and use the reprogramming option that **does not** have the message “Caution! Use ONLY with ITBXX-XXX”.
- If you get this screen and it is blank (no reprogramming listed), it means there is no reprogramming available for this vehicle.

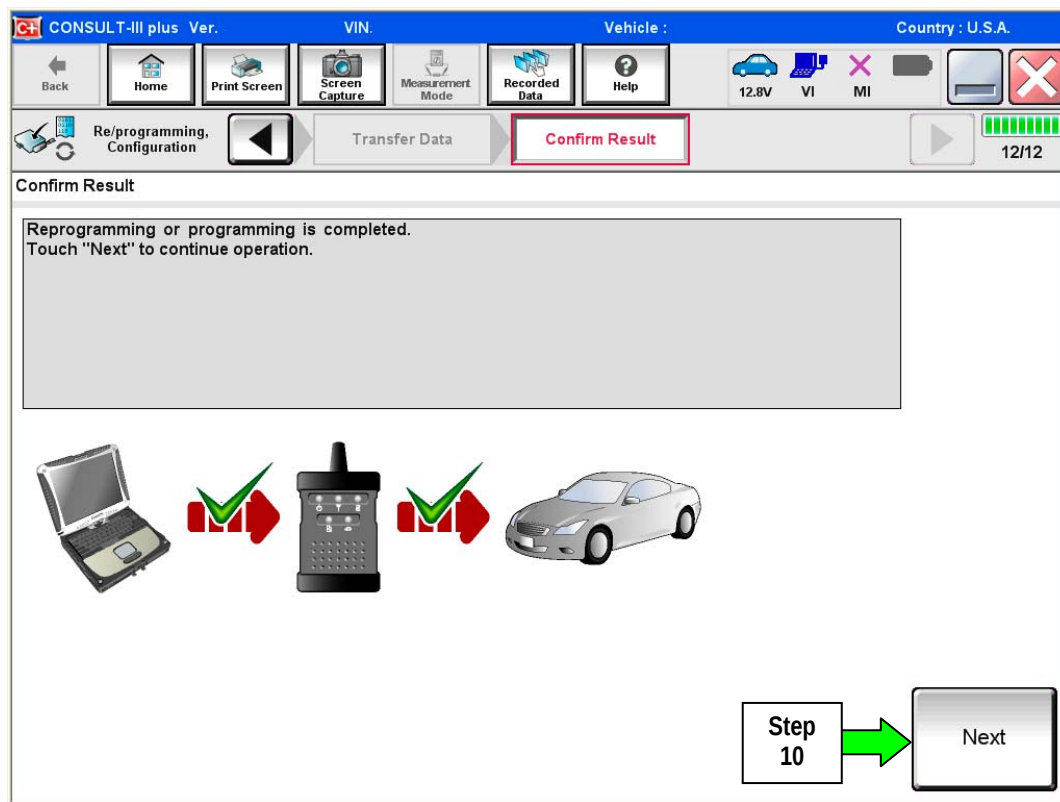
8. When the screen in Figure 4 displays, reprogramming is complete.

**NOTE:** If the screen in Figure 4 does not display (reprogramming does not complete), refer to the information on the next page.

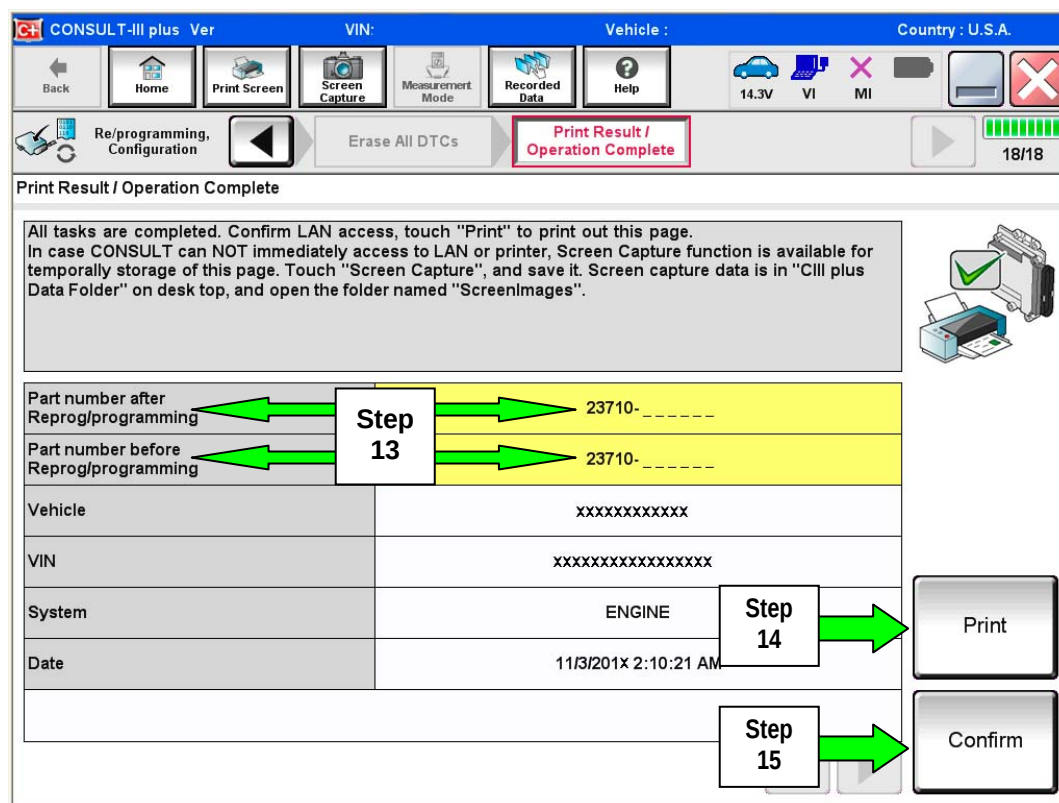
12. When the entire reprogramming process is complete, the screen in Figure 7 will display.
13. Verify the before and after part numbers are different.
14. Print a copy of this screen (Figure 7) and attach it to the repair order for warranty documentation.
15. Select **Confirm**.
