SERVICE CAMPAIGN BULLETIN

NTB12-100a

VOLUNTARY SERVICE CAMPAIGN 2009 – 2011 VERSA SPEEDOMETER AND ODOMETER REPROGRAMMING

APPLIED VEHICLES: 2009 – 2011 Versa (C11)

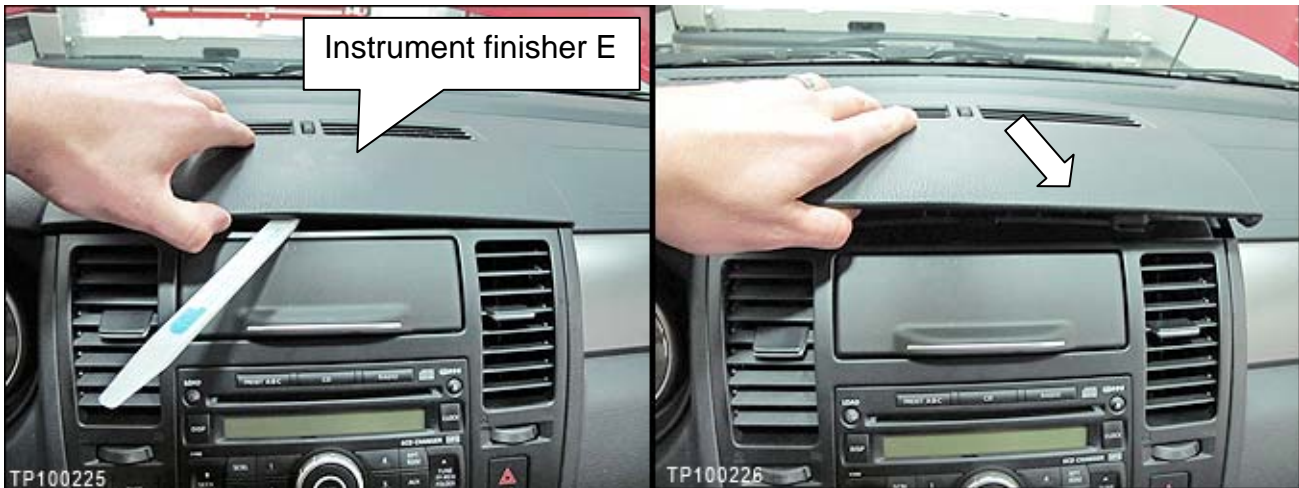
Figure 1

1. Adjust and lock the steering column to the Full Down position.
2. Remove instrument finisher E as follows (see Figure 1).
 - a. Use a plastic trim tool to raise the front edge.
 - b. Grasp and pull rearward (toward you) to unsnap and remove.

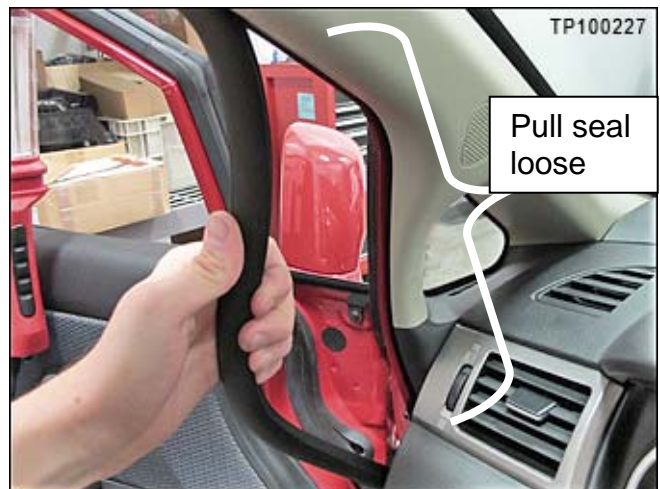
Figure 2

3. Pull the driver's door seal loose in the area shown in Figure 2.

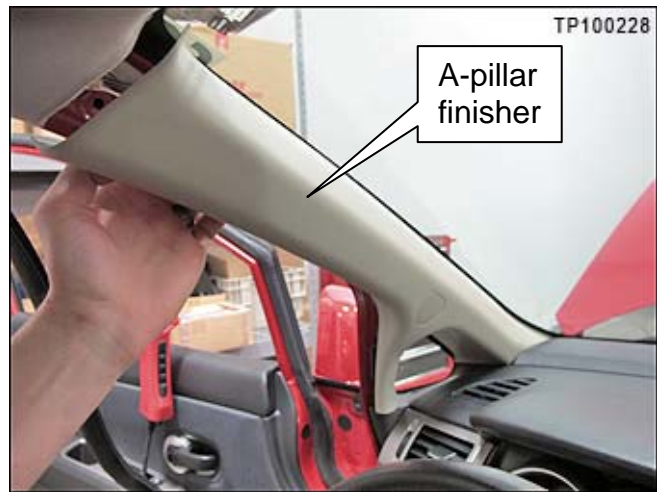
Figure 3

4. Snap loose and remove the A-pillar finisher.
 - Use a plastic trim tool as needed.

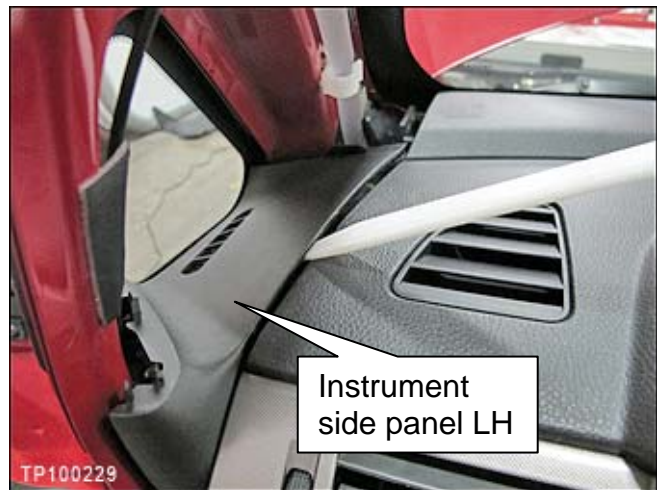
Figure 4

5. Snap loose and remove the instrument side panel LH.
 - Use a plastic trim tool as needed.

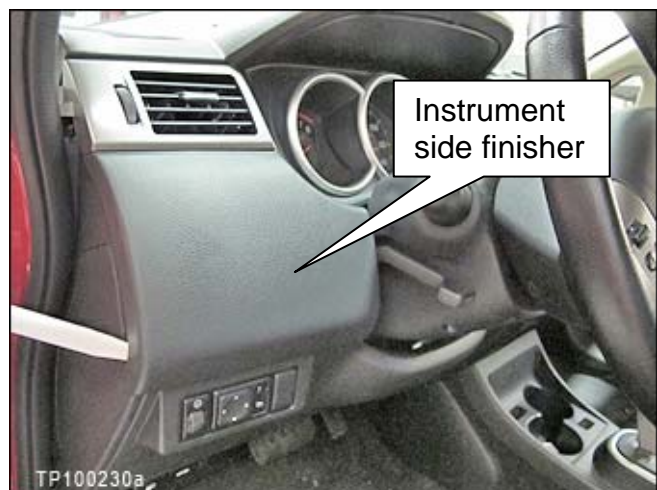
Figure 5

6. Snap loose and remove the instrument side finisher.
 - Use a plastic trim tool as needed.

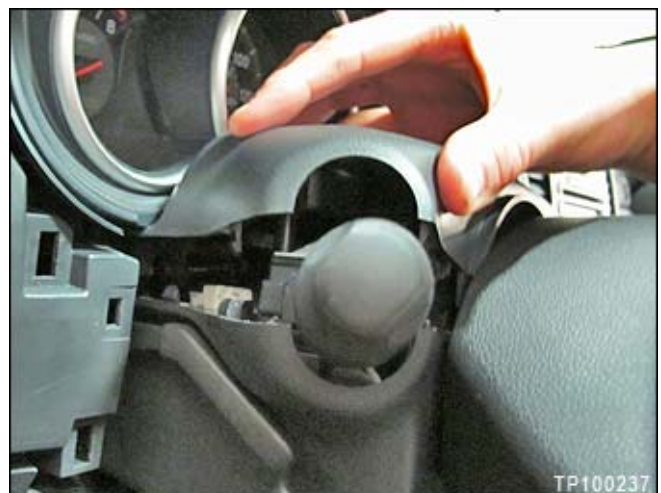
Figure 10

- b. Snap loose and remove the steering column upper cover.

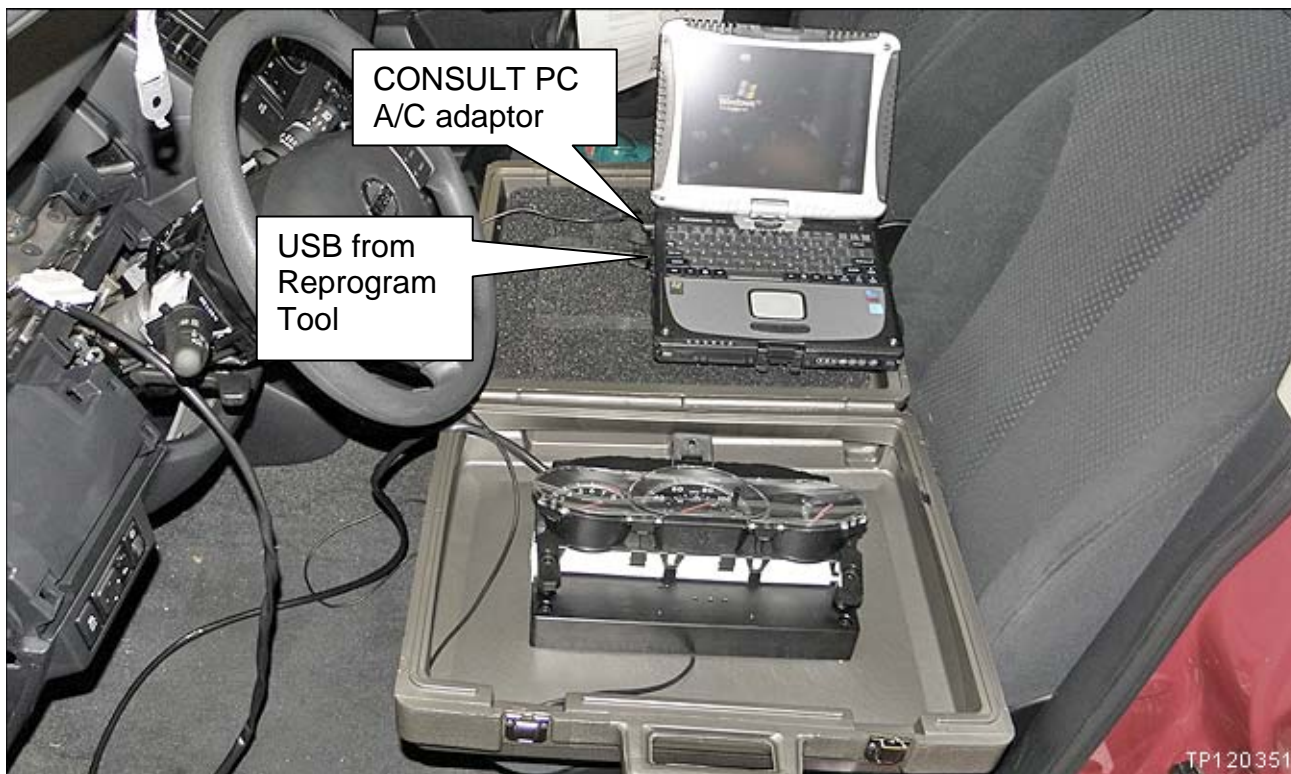
Figure 19

2. Connect the USB cable from the Reprogramming Tool to the CONSULT PC (see Figure 19).
3. Connect the AC Adapter to the CONSULT PC (see Figure 19).

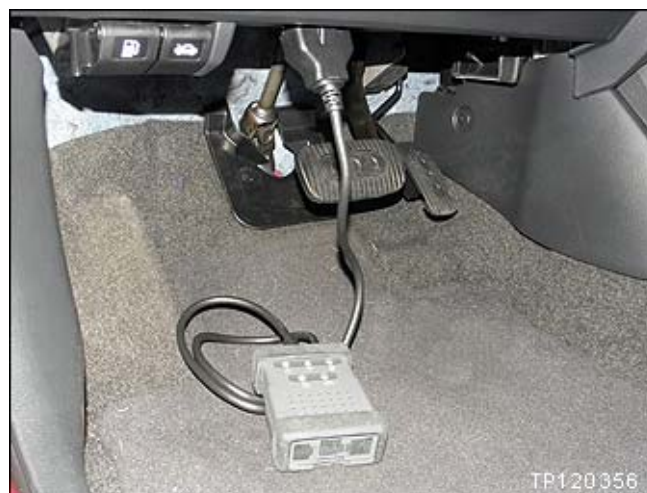
Figure 20

4. Connect the C-III plus VI to the vehicle.

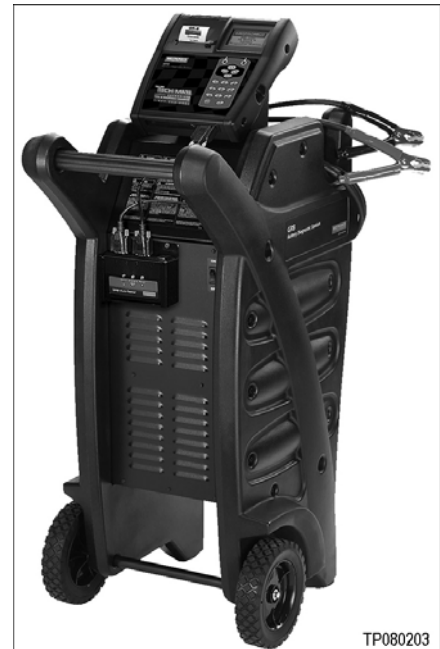
Figure 21

5. Connect a battery charger to the vehicle battery set to a 20 amp charge rate.
 - The GR-8 (Battery and Electrical Diagnostic Station) set to “Power Supply” mode is recommended.
