EL11-009a

## 2011 - 2013 M; BATTERY LOW VOLTAGE / NO START

**APPLIED VEHICLES:** 2011 - 2013 M37and M56 (Y51)

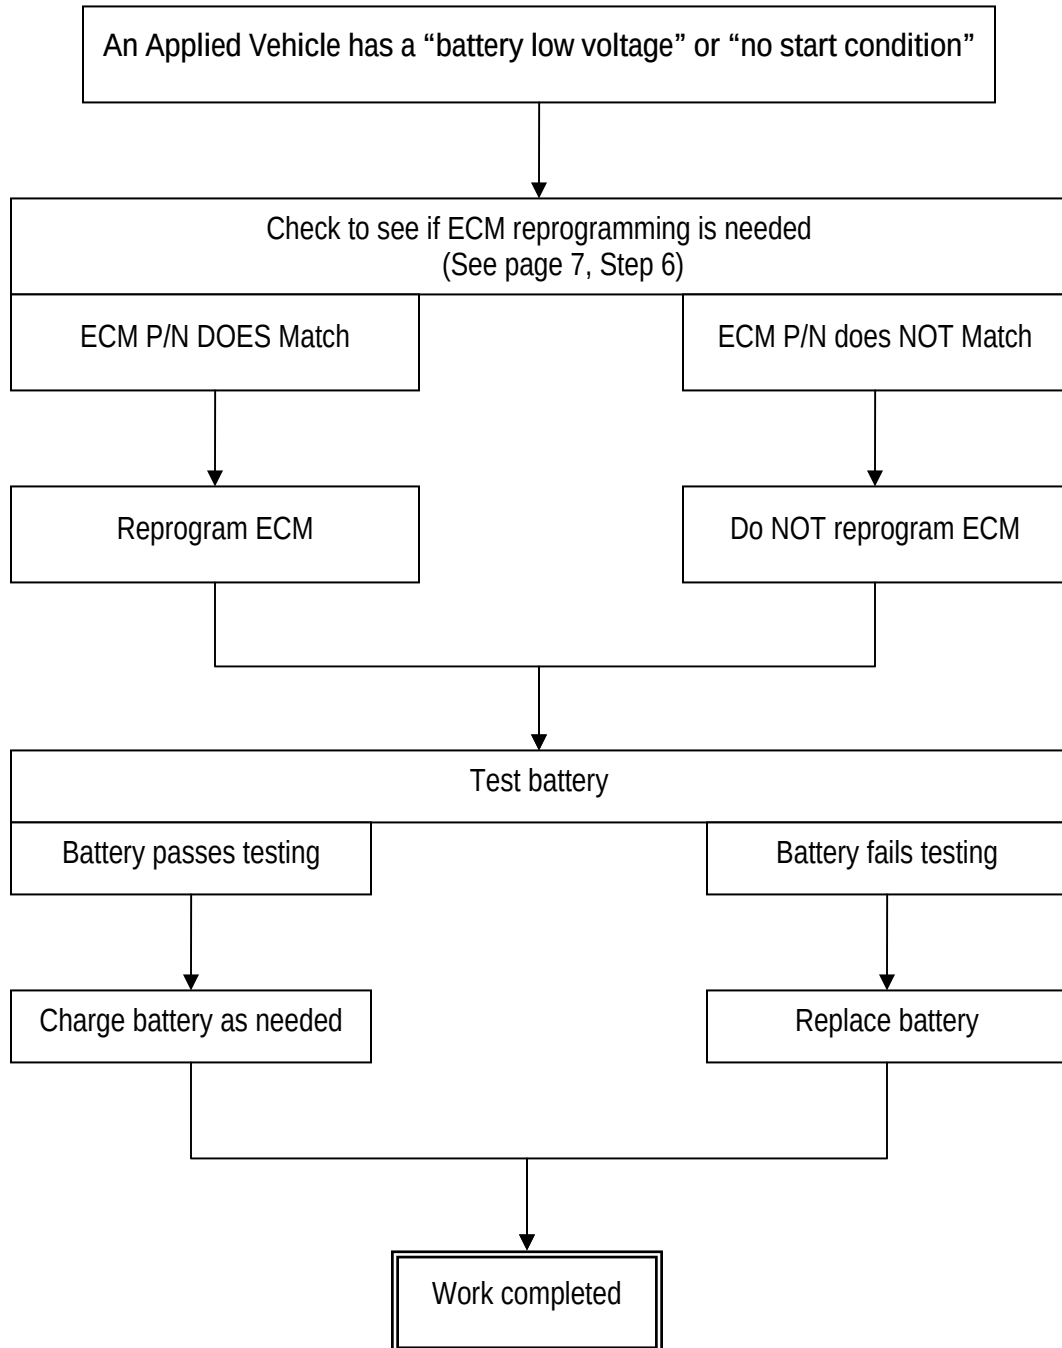
## Repair Overview

1. Confirm this bulletin applies (see the Repair Overview flowchart on page 3).
2. If this bulletin applies, use the Repair Overview flowchart on page 3 to determine which repair procedures to apply to your vehicle.

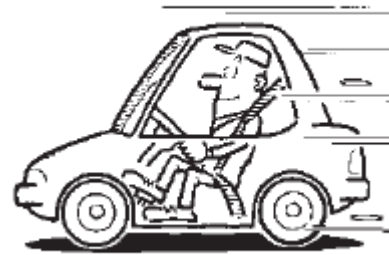
Figure A

- Take the vehicle for a 10 minute drive in order to meet the following Idle Air Volume Learn (IAVL) conditions:
  - Engine coolant temperature: 70 - 100°C (158 - 212°F)
  - Battery voltage: More than 12.9V (At idle)
  - Transmission: Warmed up

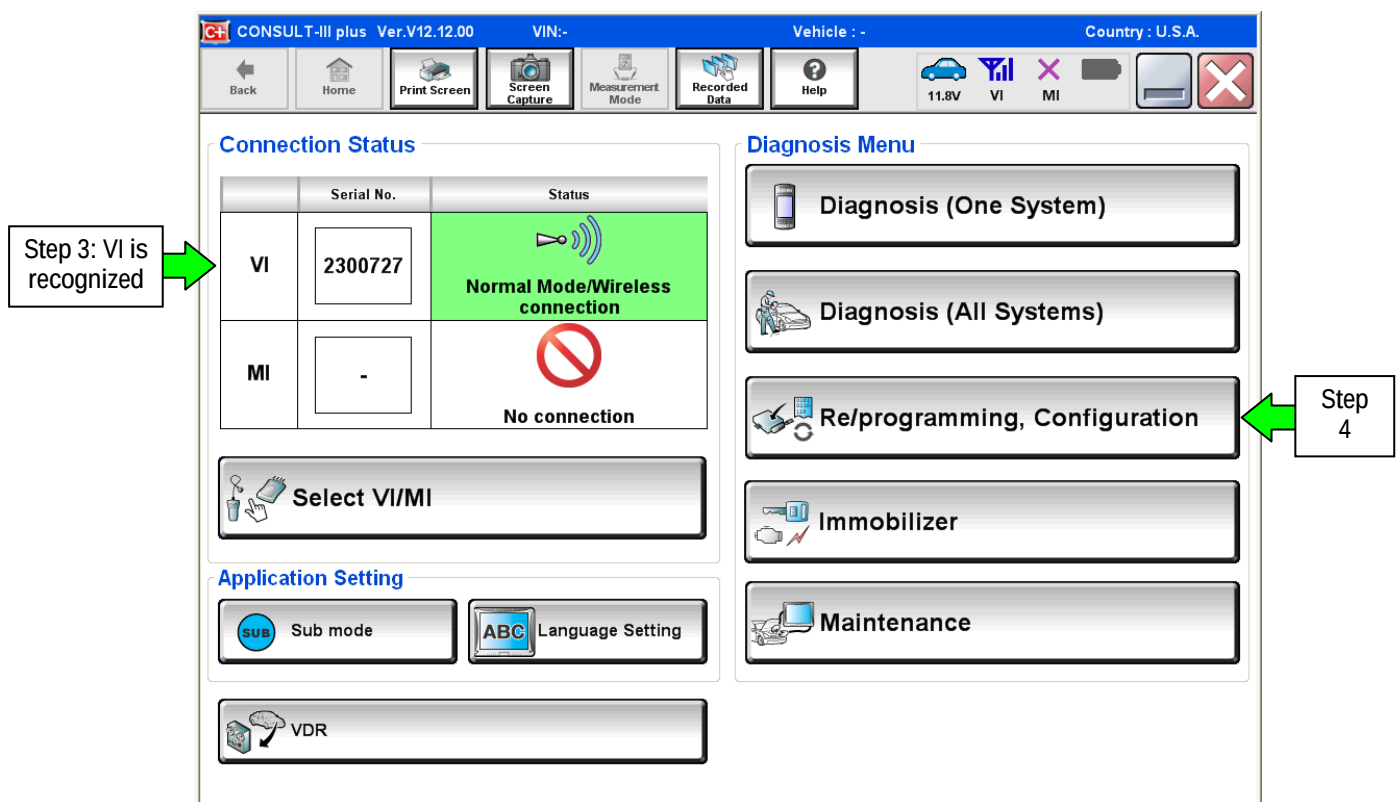
Figure 1

1. Connect the CONSULT PC to the vehicle to begin the reprogramming procedure.
2. Open ASIST on the CONSULT PC and start C-III plus.
3. Wait for the plus VI to be recognized / connected.
  - The serial number will display when the plus VI is recognized / connected.
4. Select Re/programming, Configuration.

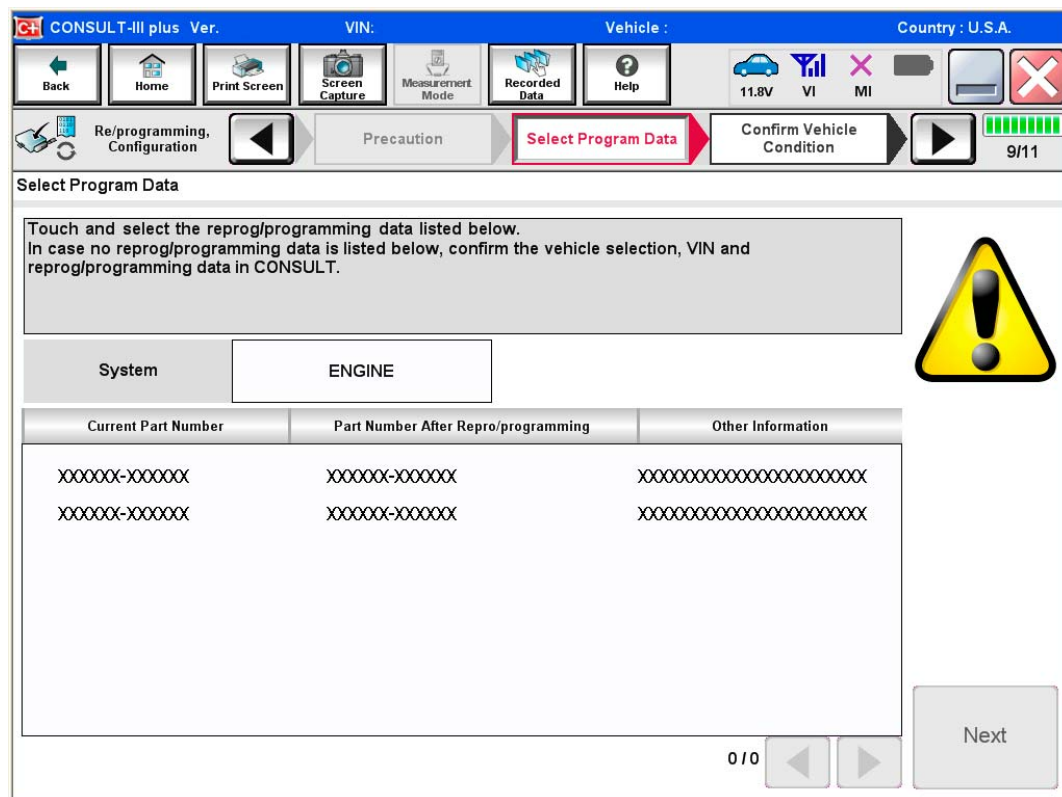
- In some cases, more than one new P/N for reprogramming is available.
  - In this case, the screen in Figure 3 displays.
  - Select and use the reprogramming option that does not have the message “Caution! Use ONLY with ITBXX-XXX”.
- If you get this screen and it is blank (no reprogramming listed), it means there is no reprogramming available for this vehicle.

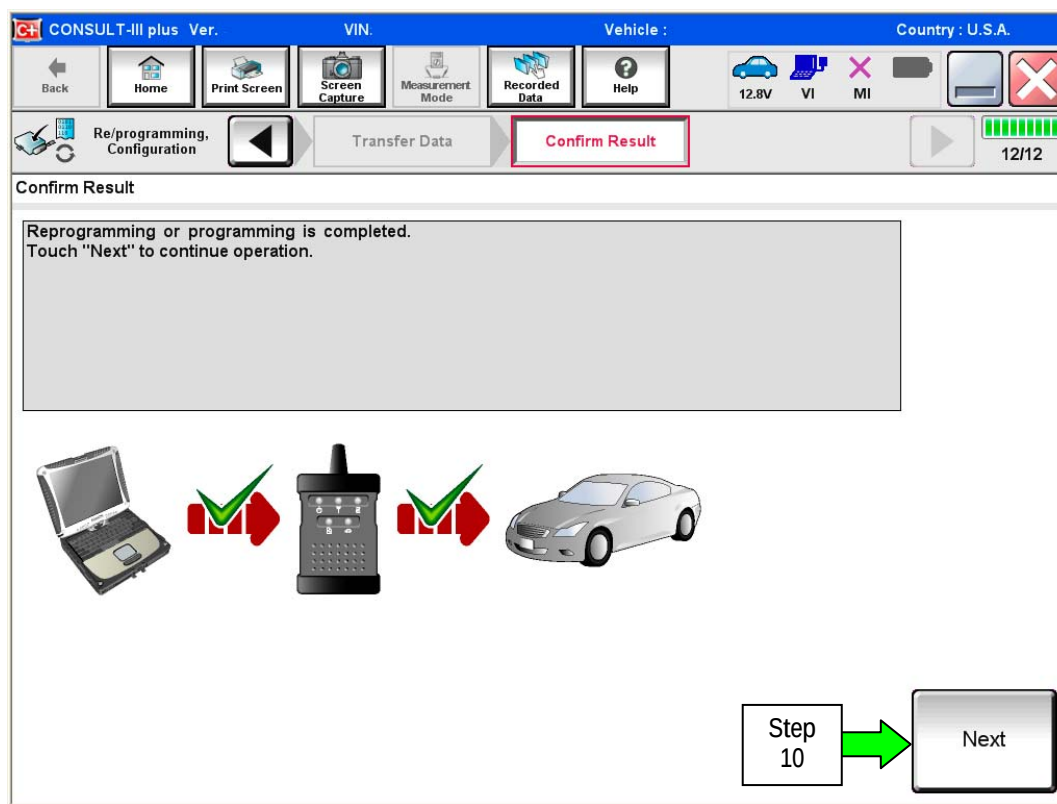
8. When the screen in Figure 4 displays, reprogramming is complete.

NOTE: If the screen in Figure 4 does not display (reprogramming does not complete), refer to the information on the next page.

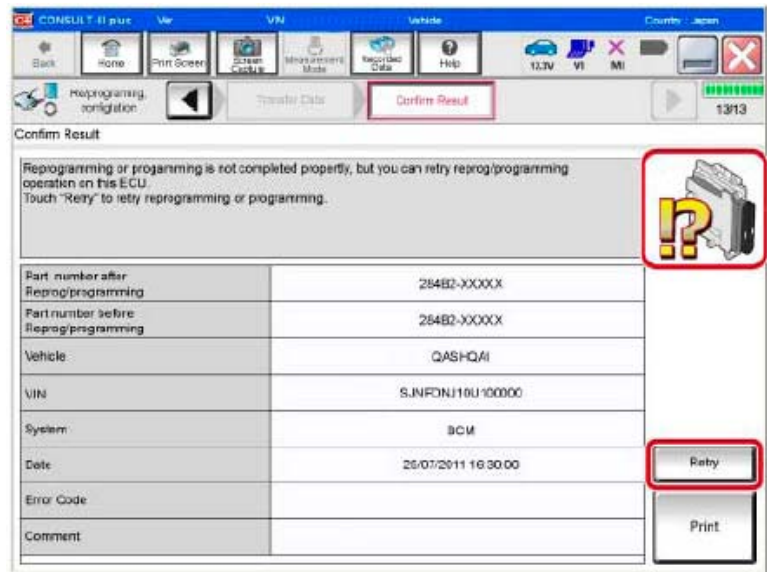
Figure 5

If reprogramming does not complete and the “!?” icon displays as shown in Figure 5:

- Check battery voltage (12.0–15.5 V).
- Ignition is ON, engine OFF.
- External Bluetooth® devices are OFF.
- All electrical loads are OFF.
- Select retry and follow the on screen instructions.
- “Retry” may not go through on first attempt and can be selected more than once.

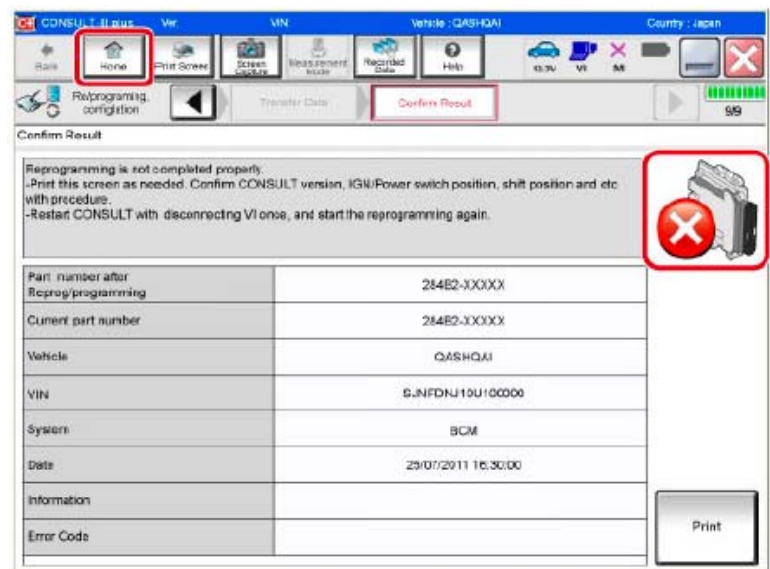
Figure 6

If reprogramming does not complete and the “X” icon displays as shown in Figure 6:

- Check battery voltage (12.0 – 15.5 V).
- CONSULT A/C adapter is plugged in.
- Ignition is ON, engine OFF.
- Transmission is in Park.
- All C-III plus / VI cables are securely connected.
- All C-III plus updates are installed.
- Select Home, and restart the reprogram procedure from the beginning.

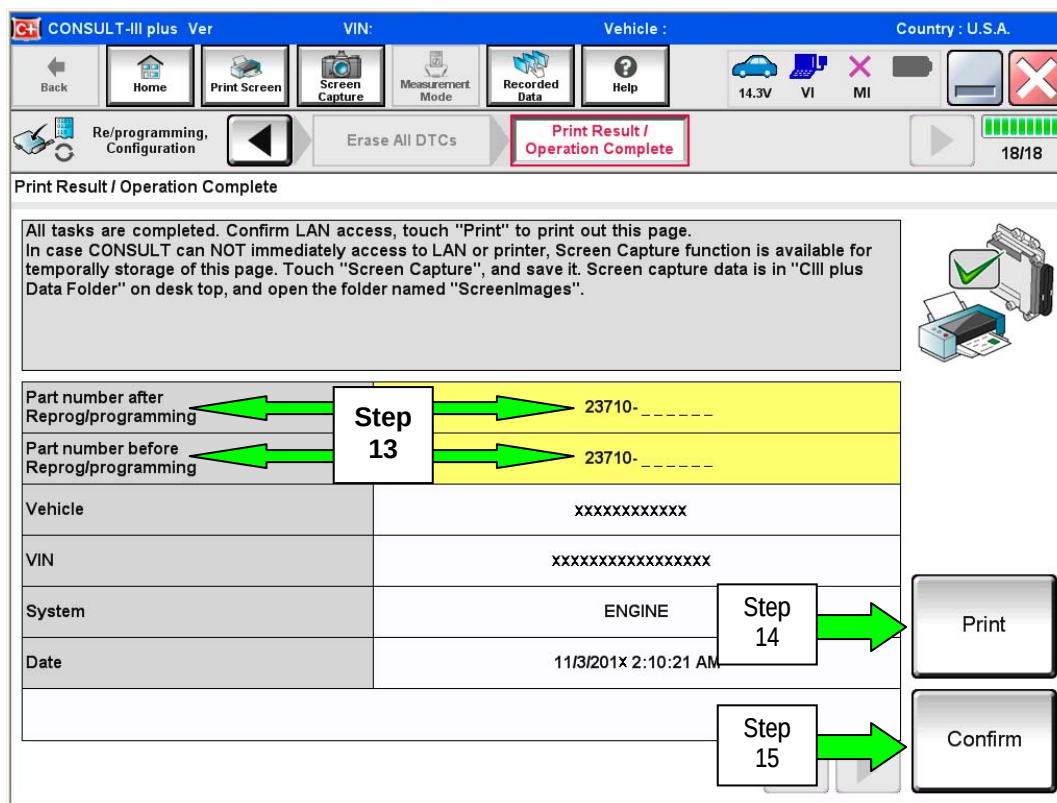
12. When the entire reprogramming process is complete, the screen in Figure 7 will display.
13. Verify the before and after part numbers are different.
14. Print a copy of this screen (Figure 7) and attach it to the repair order for warranty documentation.
15. Select Confirm.
