Technical Service Bulletin

SUBJECT:			No: TSB-12-13-002
ECM REPROGRAMMING FOR DTC P0016 or P0017: CRANKSHAFT/CAMSHAFT POSITION			DATE: February, 2012
			MODEL: See below
CIRCULATE TO:	<input type="checkbox"/> GENERAL MANAGER	<input type="checkbox"/> PARTS MANAGER	<input checked="" type="checkbox"/> TECHNICIAN
<input checked="" type="checkbox"/> SERVICE ADVISOR	<input checked="" type="checkbox"/> SERVICE MANAGER	<input checked="" type="checkbox"/> WARRANTY PROCESSOR	<input type="checkbox"/> SALES MANAGER

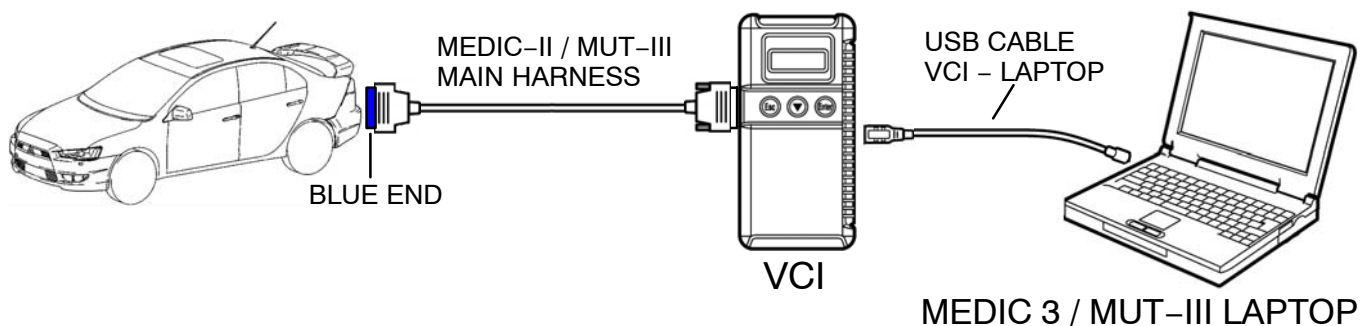
Connect the equipment as follows:

- Turn the laptop computer on. If you're running on battery power and the charge indicator in the lower right hand corner of the screen does not show a full charge, it is recommended that either the laptop battery be charged prior to beginning, or that reprogramming be completed with the A/C power adaptor connected to the laptop.
- Connect the USB cable to the VCI.
- When the laptop displays the MUT-III main screen, connect the USB cable to the laptop.
- Connect the MUT-III main harness with the blue DLC connection to the VCI.
- Connect the blue connector of the MUT-III main harness to the vehicle's data link connector.
- Turn the VCI power switch ON. Verify that the indicator lamp in the upper right corner of the screen is green.

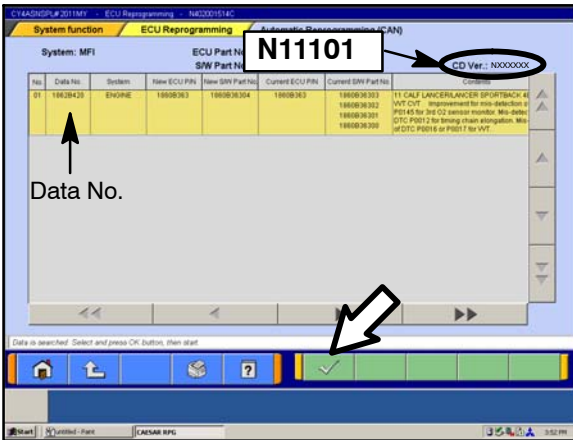
- l. The Automatic Reprogramming(CAN) database screen will display.

Confirm the database number at the top right of the table is **N11101** or higher.

If more than one row is displayed in the table, refer to the ECM Reprogramming Chart beginning on page 2 to select the proper Data No. for this procedure and select the appropriate row.

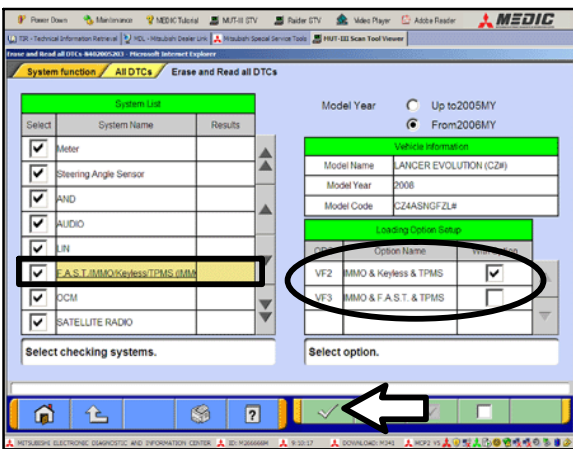
- e. In the left column, scroll to and click FAST/IMMOB/KEYLESS/TPMS. In the right column, check the correct option code (VF#) from the Loading Options Setup list. This will activate the check mark at the bottom of the page.

- Vehicles with regular keyless entry (buttons on a multi-function key), select VF2.
- Vehicles with F.A.S.T. key, select VF3.
