Technical Service Bulletin

SUBJECT: ECM REPROGRAMMING FOR DTC P0016 or P0017: CRANKSHAFT/CAMSHAFT POSITION			No: TSB-11-13-008
			DATE: June, 2011
			MODEL: 2010-11 Lancer Evolution
CIRCULATE TO:	<input type="checkbox"/> GENERAL MANAGER	<input type="checkbox"/> PARTS MANAGER	<input checked="" type="checkbox"/> TECHNICIAN
<input checked="" type="checkbox"/> SERVICE ADVISOR	<input checked="" type="checkbox"/> SERVICE MANAGER	<input checked="" type="checkbox"/> WARRANTY PROCESSOR	<input type="checkbox"/> SALES MANAGER

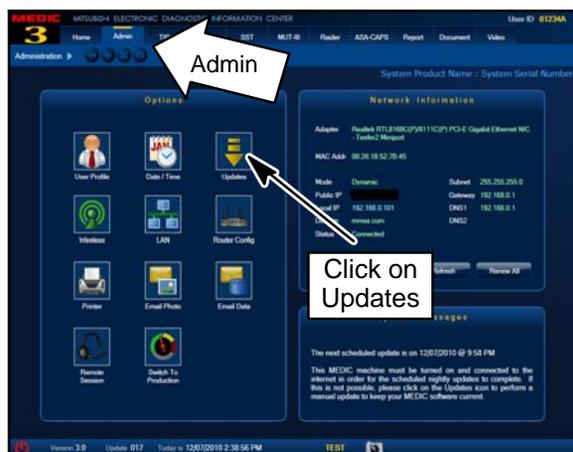
3. Select the MEDIC 3 Admin tab and click on “Updates.”

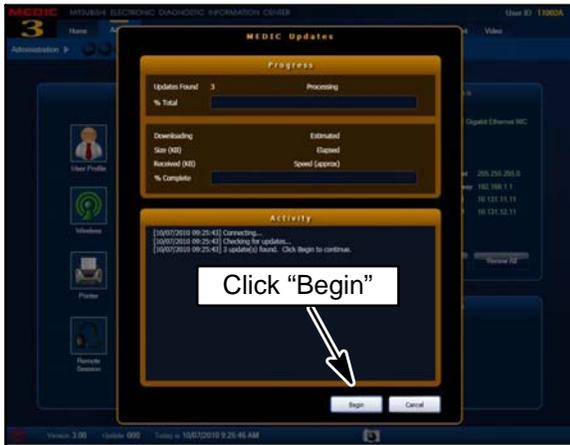
4. If the Medic Update screen advises updates are available, click the “Begin” button. After the updates are complete, **GO TO THE REPROGRAMMING PROCEDURE ON PAGE 4.**

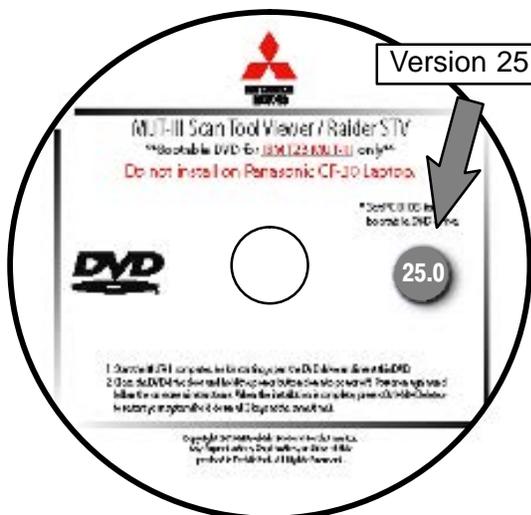
- a. From the MUT-III Main Page, confirm your MUT-III version is Ver 25.0.
- (1) If version 25.0 is displayed on your MUT-III, continue to the Reprogramming Procedure on page 4.

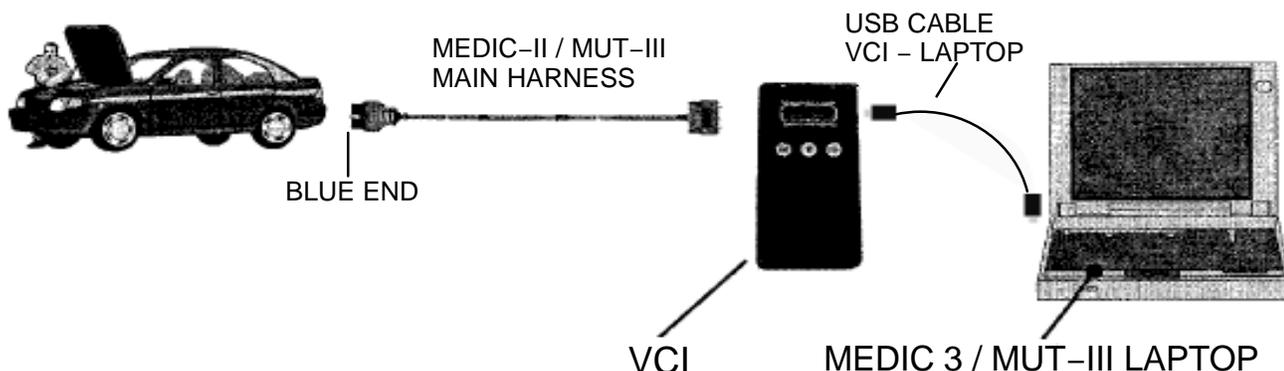
- Turn the laptop computer on. If you're running on battery power and the charge indicator in the lower right hand corner of the screen does not show a full charge, it is recommended that either the laptop battery be charged prior to beginning, or that reprogramming be completed with the A/C power adaptor connected to the laptop.
- Connect the USB cable to the VCI.
- When the laptop displays the MUT-III main screen, connect the USB cable to the laptop.
- Connect the MUT-III main harness with the blue DLC connection to the VCI.
- Connect the blue connector of the MUT-III main harness to the vehicle's data link connector.
- Turn the VCI power switch ON. Verify that the indicator lamp in the upper right corner of the screen is green.

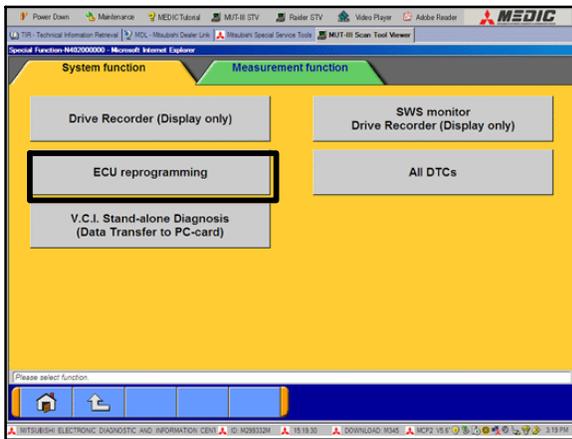
- d. Select “ECU reprogramming.”

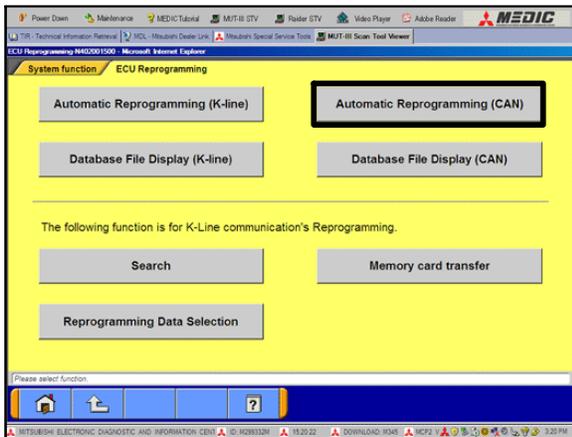
- e. Select “Automatic Reprogramming (CAN).”

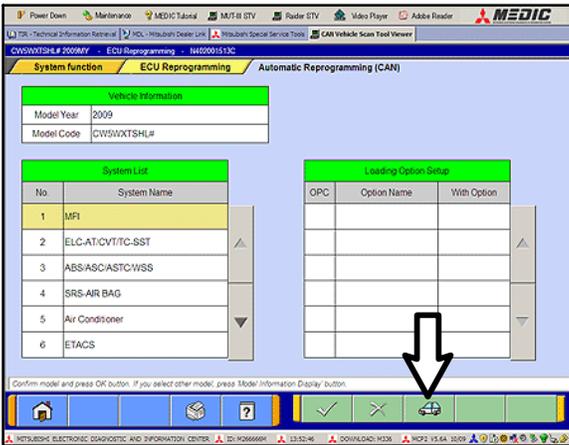
f. Click on the car icon at the bottom of the page.

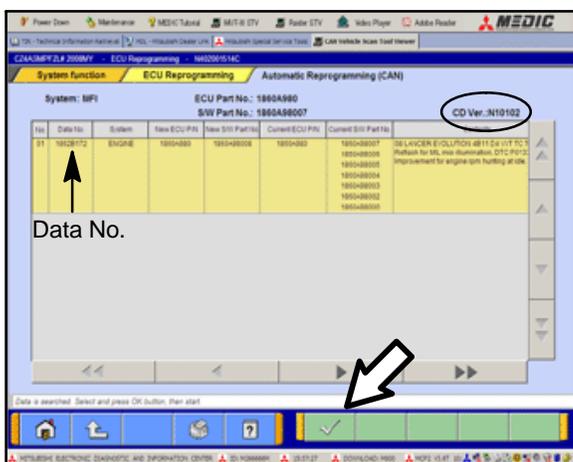
m. A message will ask you to “Check reprogramming data.”

n. Click on the check mark to begin reprogramming.

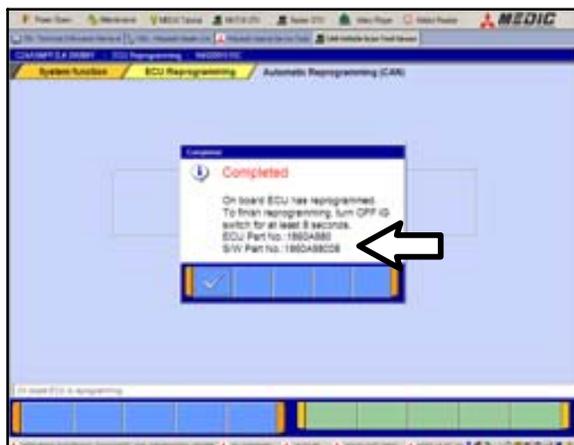
- o. This message will display when ECM reprogramming is successfully completed. Confirm the “New S/W P/N” displayed matches the table at the beginning of this TSB.
 - p. You will be prompted to turn the ignition switch to the OFF position, wait at least 8 seconds, then turn it back on.
 - q. Click the check mark and you will be returned to the “ECU Reprogramming” page.
2. Click the Home icon at the lower left corner of the page to return to the MUT-III main page.

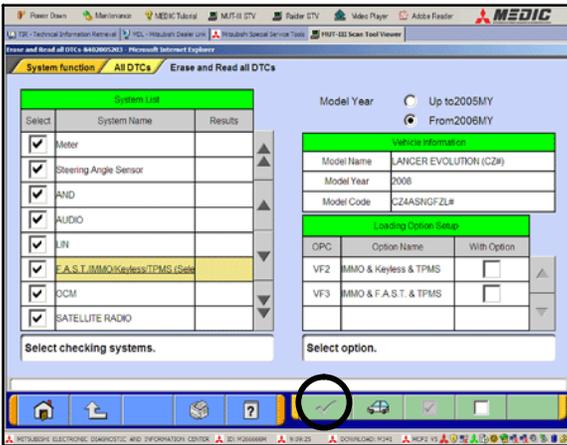
c. The list on the left side of the screen will have all selections checked. Do not change these selections. DTCs may be set if the vehicle is equipped with options that are unchecked.

NOTE: At this time, the check mark at the bottom of the page is not highlighted (inactive).

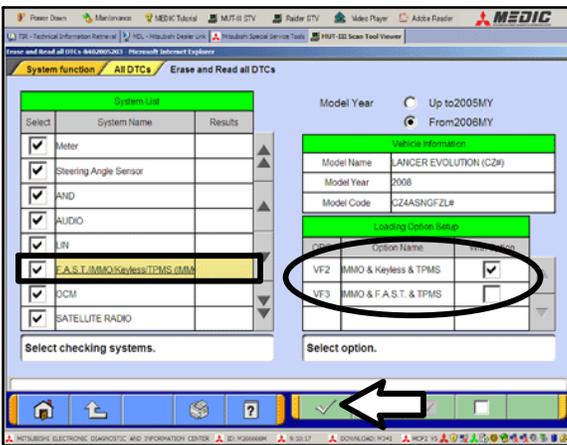
d. In the left column, scroll to and click FAST/IMMOB/KEYLESS. In the right column, check the correct option code (VF#) from the Loading Options Setup list. This will activate the check mark at the bottom of the page.

- Vehicles with regular keyless entry (buttons on a multi-function key), select VF2.
 - Vehicles with F.A.S.T. key, select VF3.
- Click the check mark to continue.

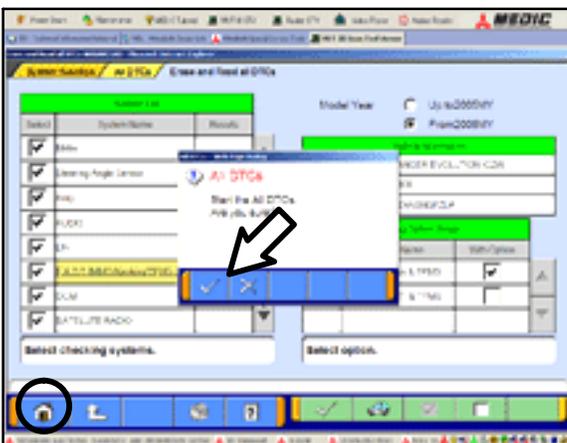
4. A window will pop up asking you to confirm DTC erasing. Click the check mark for DTC erasing and reading to begin.
