WB43 - Replacing Transfer Case (Workshop Campaign)

Vehicle Type: **Cayenne S (92A)**

Concerns: **Transfer case**

Replacing transfer gear

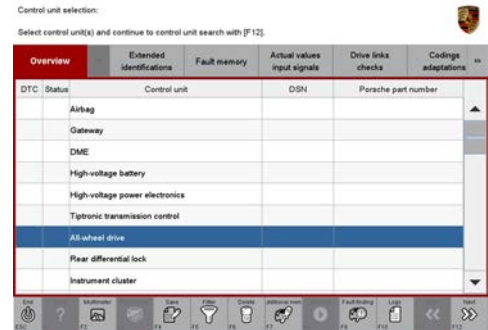
Control unit selection - All-wheel

- 1 Select the ⇒ **'All-wheel'** control unit in the control unit selection screen (⇒ **'Overview'** menu) and press **[>>]** to confirm your selection ⇒ *Control unit selection - All-wheel.*

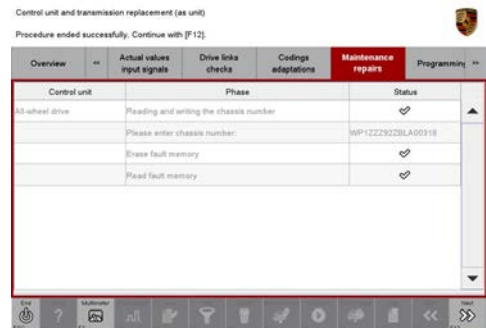
Procedure ended successfully

- 8 The message **“Procedure ended successfully”** appears ⇒ *Procedure ended successfully*.

Once coding is completed successfully, press **[>>]** to continue.

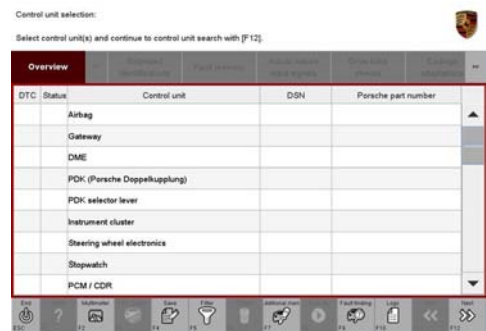
Control unit selection

- 9 Select the ⇒ **'Overview'** menu and press **[<<]** to return to the control unit selection screen ⇒ *Control unit selection*.

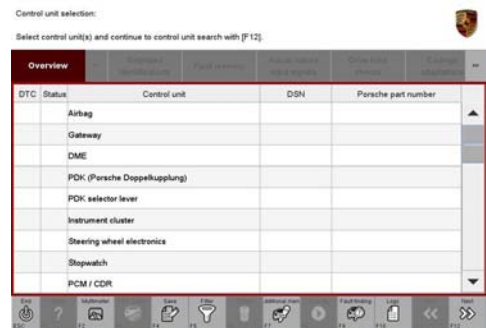
Control unit selection

- 5 Once you have erased the fault memories, select the ⇒ ‘**Overview**’ menu and press **<<** to return to the control unit selection screen ⇒ *Control unit selection*.
