WB43 - Replacing Transfer Case (Workshop Campaign)

Vehicle Type: **Cayenne Turbo (92A)**

Model Year: **2011**

Concerns: **Transfer case**

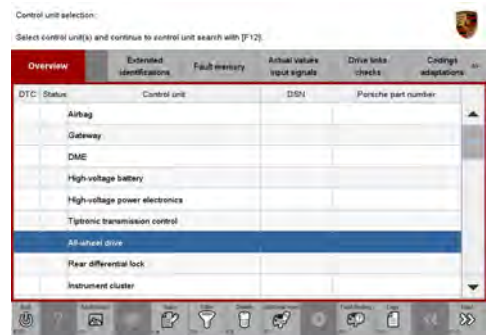
Control unit selection - All-wheel

- 1 Select the ⇒ **'All-wheel'** control unit in the control unit selection screen (⇒ **'Overview'** menu) and press **[>>]** to confirm your selection ⇒ *Control unit selection - All-wheel.*

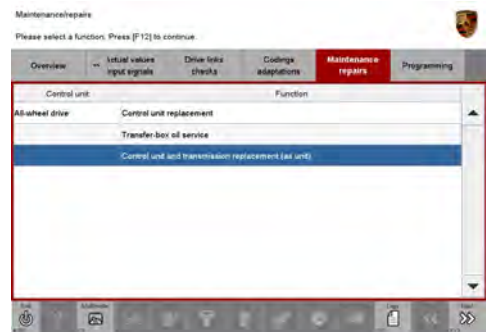
All-wheel control unit - Maintenance/repairs

- 4 Select the ⇒ **'Maintenance/repairs'** menu.
- 5 Select the function ⇒ **'Control unit and transmission replacement (together)'** in the ⇒ **'Maintenance/repairs'** menu and confirm your selection by pressing **[>>]** (⇒ *All-wheel control unit - Maintenance/repairs.*)

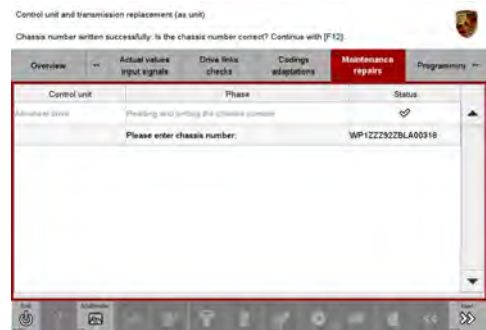
Checking chassis number

- 6 Start **reading and writing the chassis number** by pressing the **[>>]** button.
- 7 The message 'Chassis number written successfully' appears. **Check the chassis number** and correct it if necessary ⇒ *Checking chassis number.*

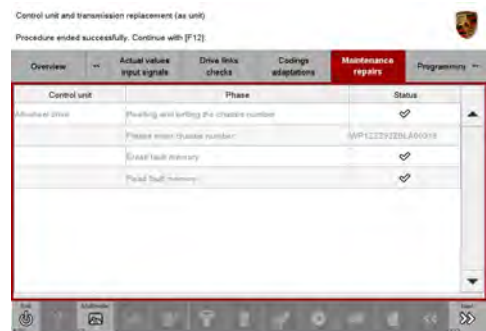
Procedure ended successfully

- 8 The message **“Procedure ended successfully”** appears ⇒ *Procedure ended successfully*.

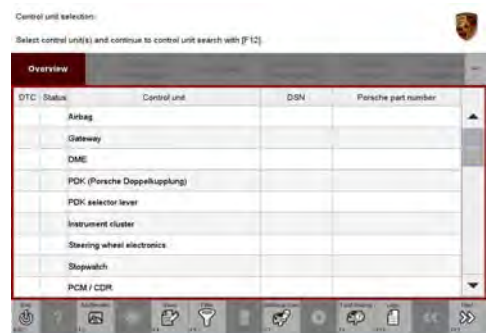
Control unit selection

- 9 Select the ⇒ **'Overview'** menu and press **<<** to return to the control unit selection screen ⇒ *Control unit selection*.

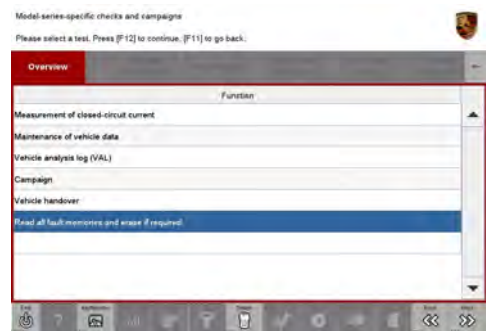
Erasing fault memories

- 1 In the control unit selection screen, press **F7** to call up the Additional menu.
2 Select the function “Read all fault memories and erase if required” and press **>>** to confirm ⇒ *Erasing fault memories*.

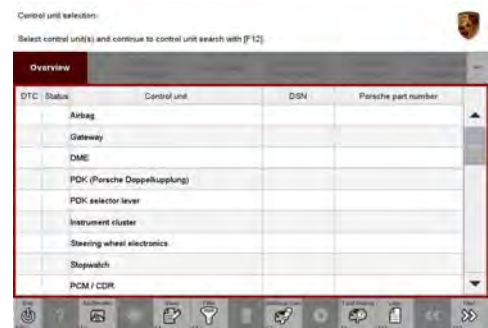
Control unit selection

- 5 Once you have erased the fault memories, select the ⇒ **'Overview'** menu and press **[<<]** to return to the control unit selection screen ⇒ *Control unit selection*.
