VOLKSWAGEN DEALERSHIP COMMUNICATION

Subject: Emissions Service Action 24V3 (Was UPDATE 24V3)

2011 MY Volkswagen Routan – PCM Programming

Emissions Service Action 24V3 (Was UPDATE 24V3) PCM Programming

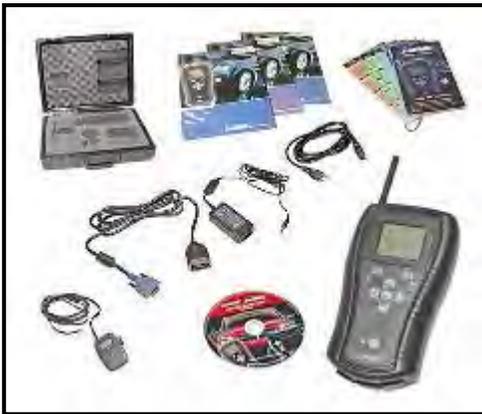
← Star Mobile Diagnostic Tool

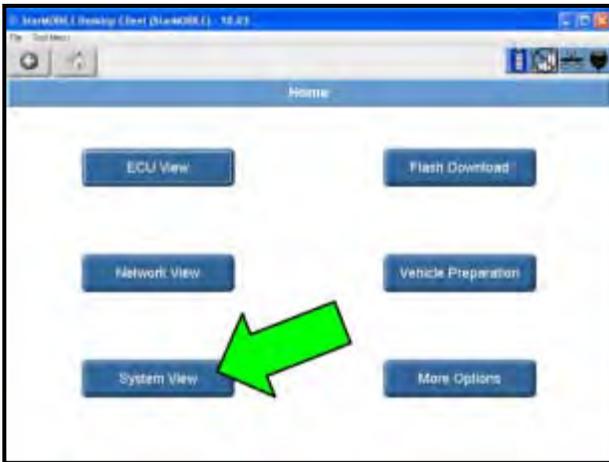
- Connect the StarMobile diagnostic device to the vehicle
- ← With the StarMobile diagnostic application, Select “System View” <arrow>

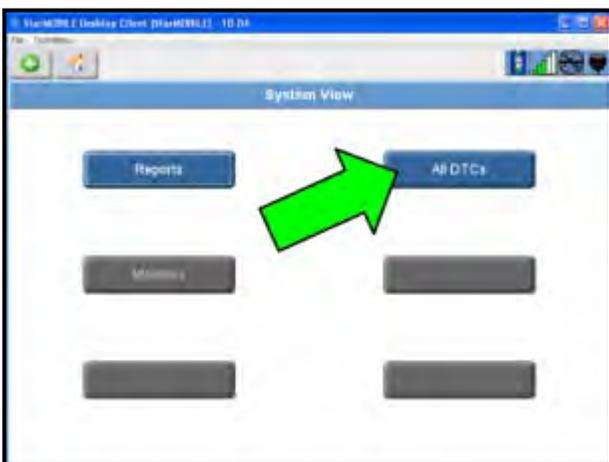
- ← Select “All DTCs” <arrow>

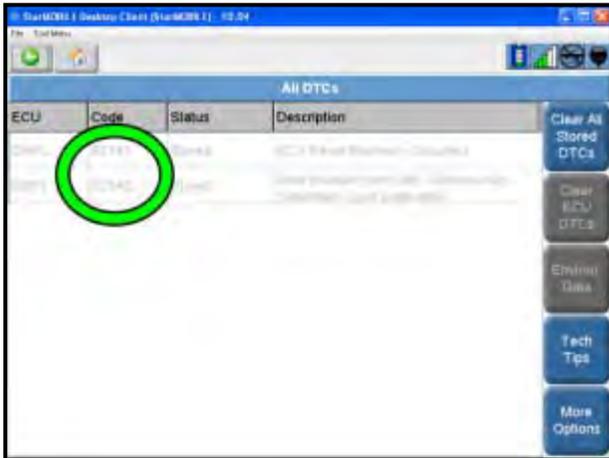
⇐ Check and record DTCs <circle>

- P0032 – O2 Sensor 1/1 Heater Circuit High
- P0038 – O2 Sensor 1/2 Heater Circuit High
- P0052 – O2 Sensor 2/1 Heater Circuit High
- P0058 – O2 Sensor 2/2 Heater Circuit High

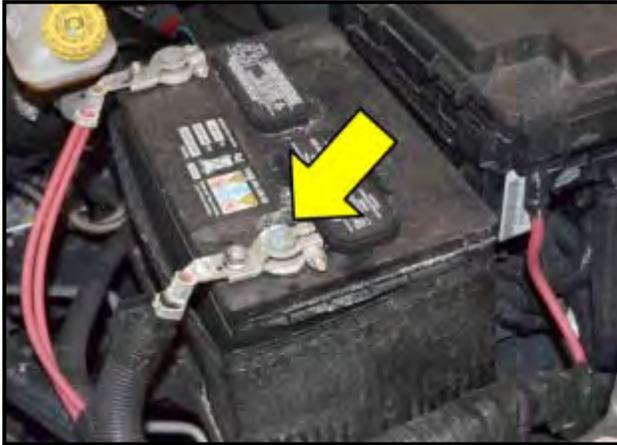
⇐ Disconnect the negative battery cable <arrow> and isolate from the battery negative post

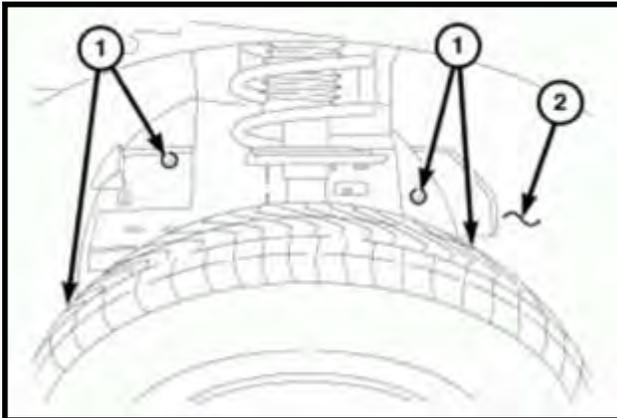
- Raise and suitably support the vehicle
- ⇐ Remove the push pin retainers <1> securing the liner <2> to the body

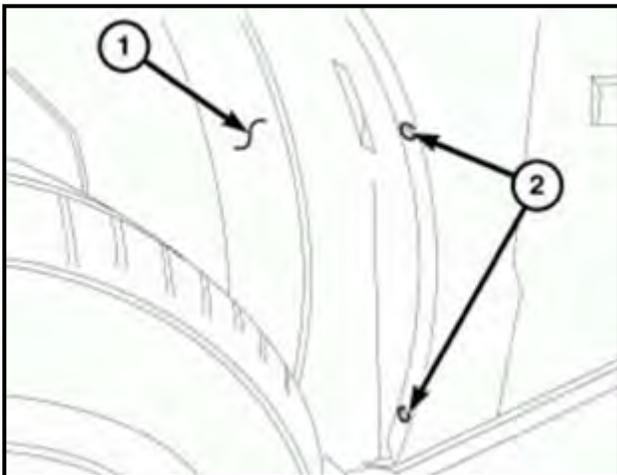
- ⇐ Remove the screws <2> securing the liner <1> to the fender
- ⇐ Remove the wheelhouse liner <1> from the vehicle

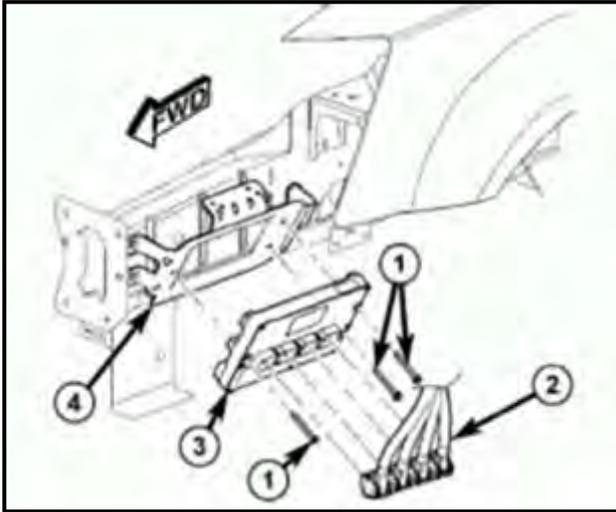
- ⇐ Disconnect the wiring harness electrical connectors <2> from the Powertrain Control Module (PCM) <3>
- ⇐ Remove the PCM bolts <1> and PCM <3> from the bracket <4>

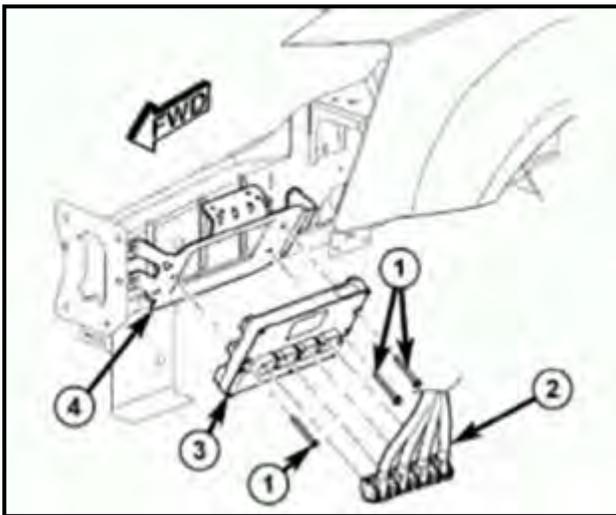
- ⇐ Install the new PCM <3> part number **7B0 906 032 EX RMN**
- ⇐ Reinstall bolts <1> to the bracket <4> and torque bolts to 4.5Nm
- ⇐ Reconnect the electrical connectors <2> to the PCM <3>

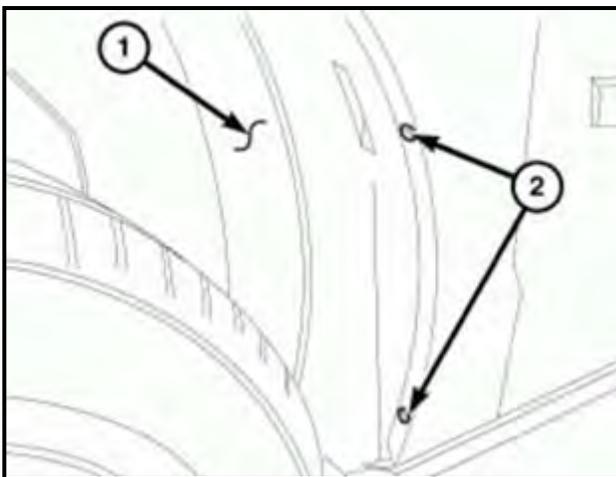
- ⇐ Place the wheelhouse liner <1> into position on the vehicle
- ⇐ Install the screws <2> securing the wheelhouse liner <1> to the fender

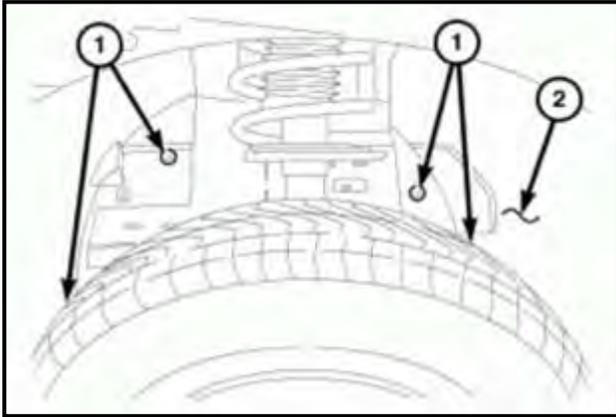
⇐ Reinstall the push pin retainers <1> securing the liner <2> to the body

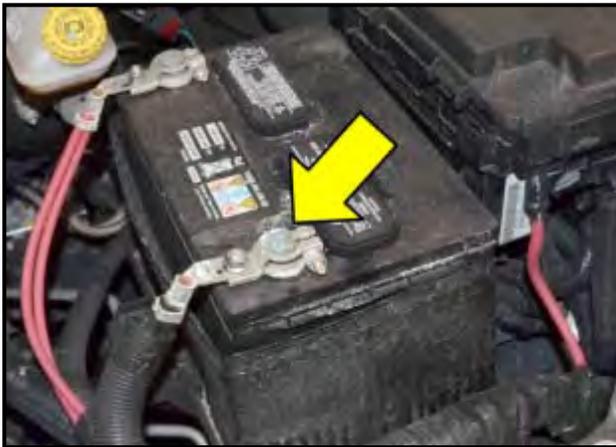
⇐ Reconnect the negative battery cable <arrow> and torque to 5Nm

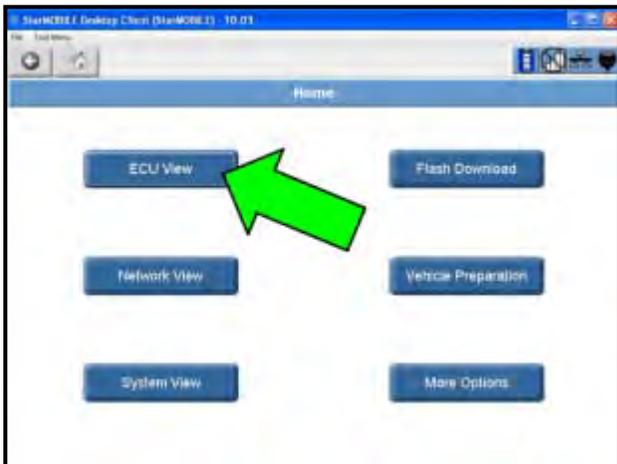
⇐ From the tool's Home screen, Select "ECU View" <arrow>

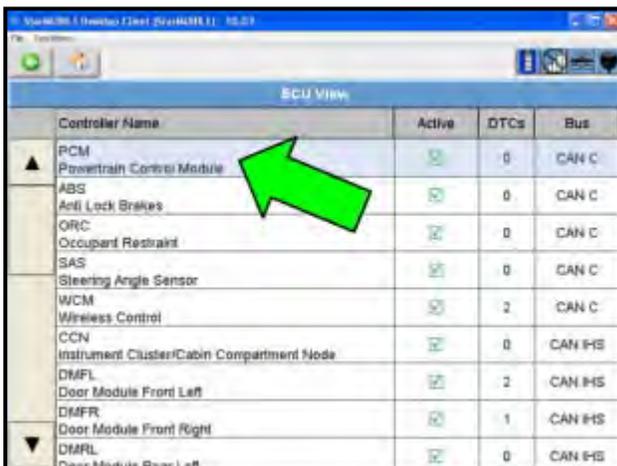
⇐ Select "PCM" <arrow>

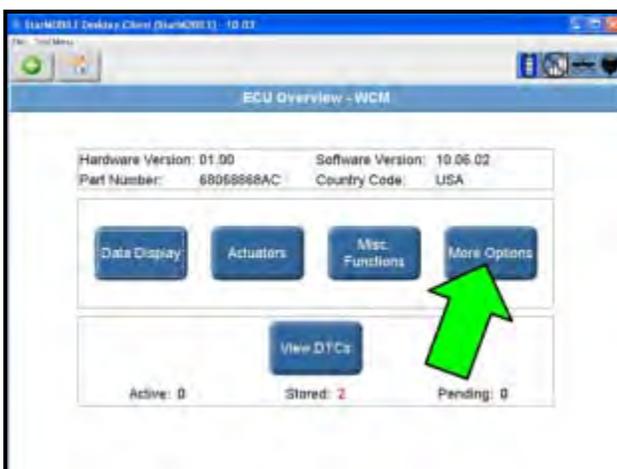
⇐ Select "More Options"

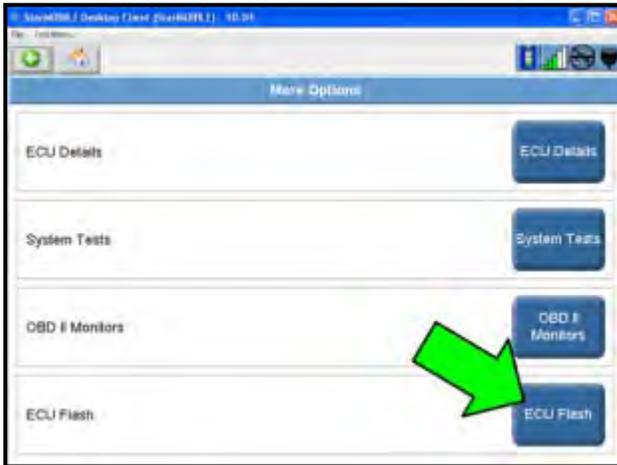
⇐ Select “ECU Flash” <arrow>

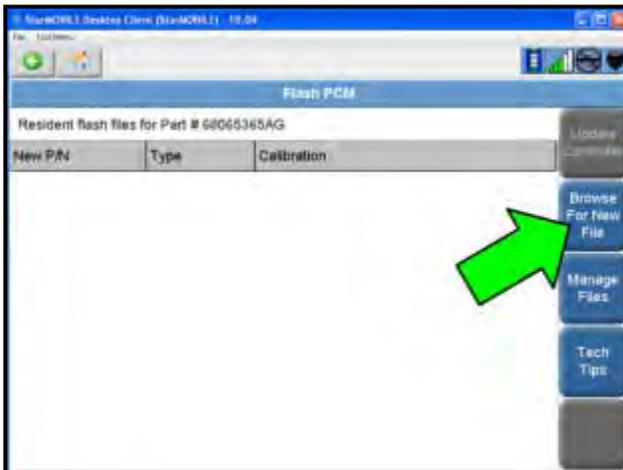
⇐ Select “Browse for New File” <arrow>

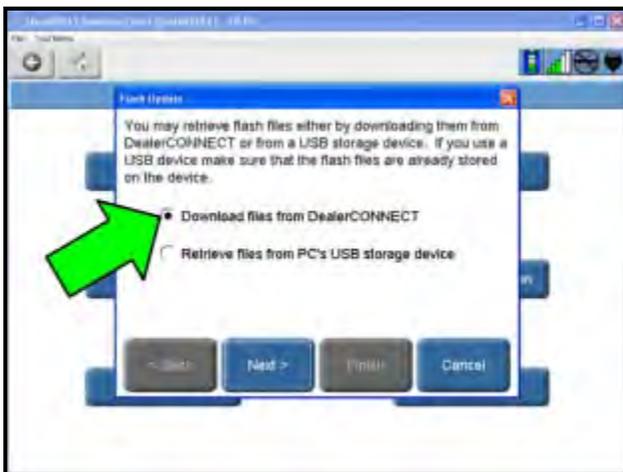
⇐ If files are not stored locally, select the appropriate radio button <arrow> to “Download files from DealerCONNECT”, then login when prompted

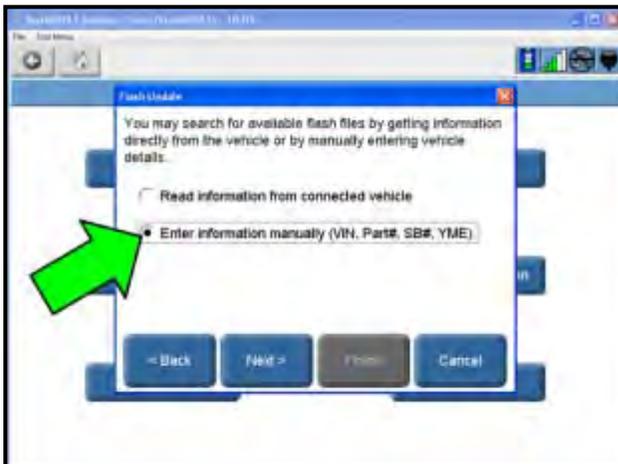
⇐ If PCM was replaced, select the appropriate radio button <arrow> to "Enter information manually..."

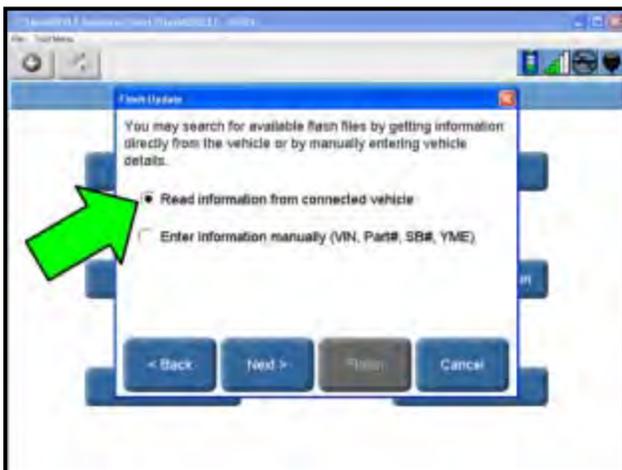
⇐ If PCM was not replaced, select the appropriate radio button <arrow> to "Read information from connected vehicle"

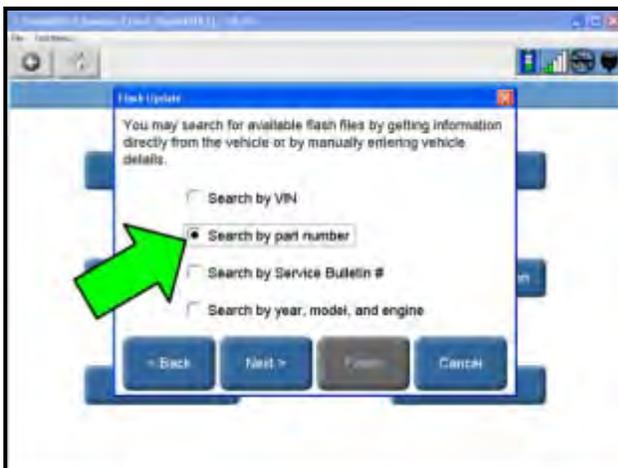
⇐ Select the appropriate radio button <arrow> to "Search by part number"

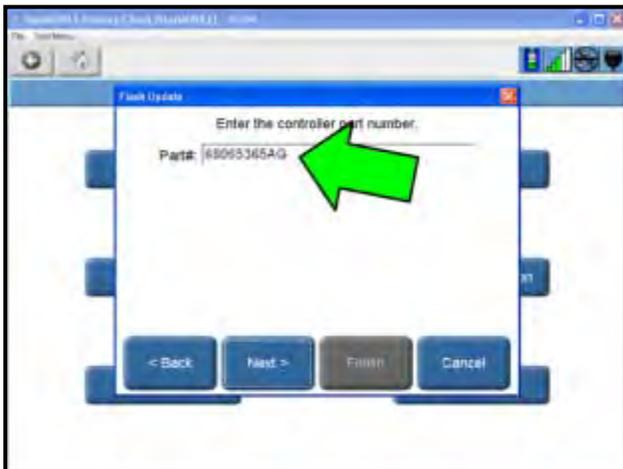
⇐ Enter part number “**68065365AG**” <arrow>, then select “Next>”

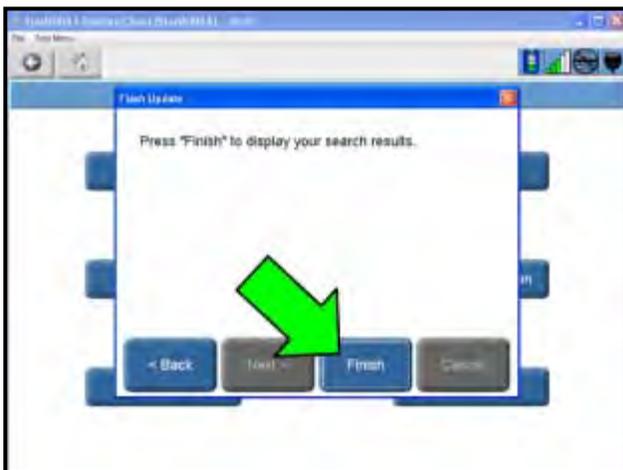
⇐ Press “Finish” <arrow>

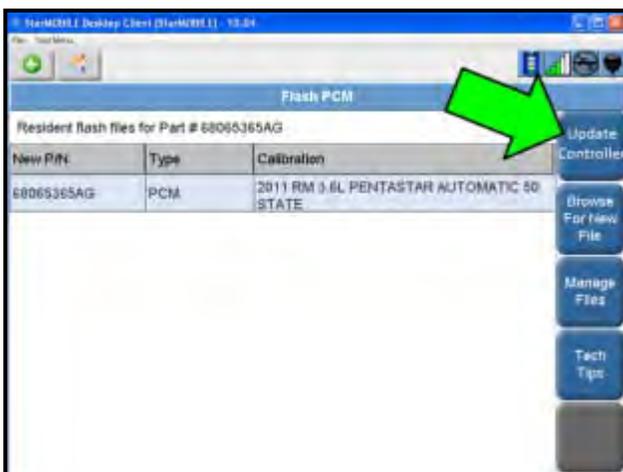
⇐ Highlight the software, then select “Update Controller” <arrow> and follow on-screen instructions

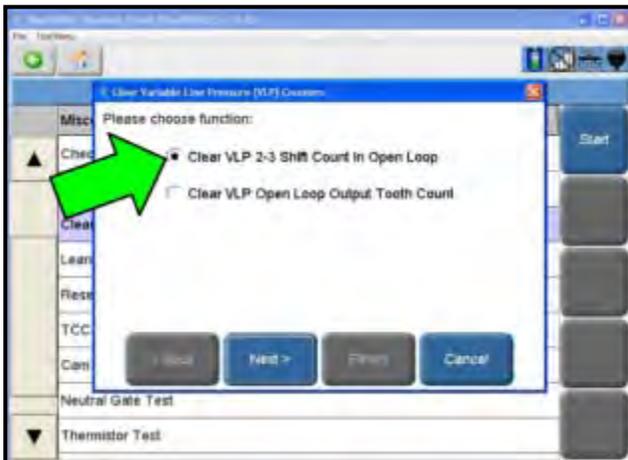
⇐ Make the selection <arrow> to “Clear the VLP 2-3 Shift Count in Open Loop”, then select “Next>”

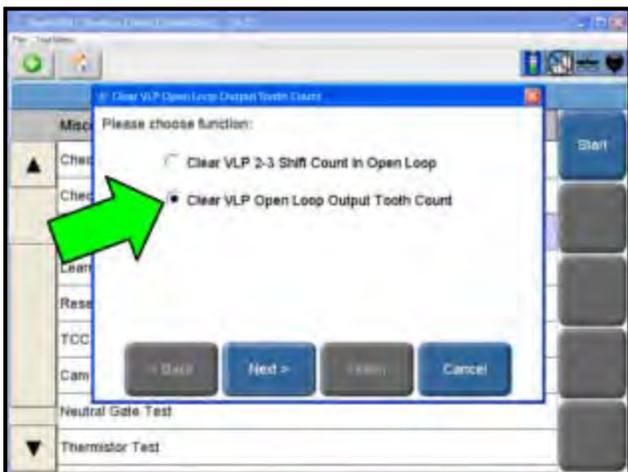
⇐ Make the selection <arrow> to “Clear VLP Open Loop Output Tooth Count”, then select “Next>”

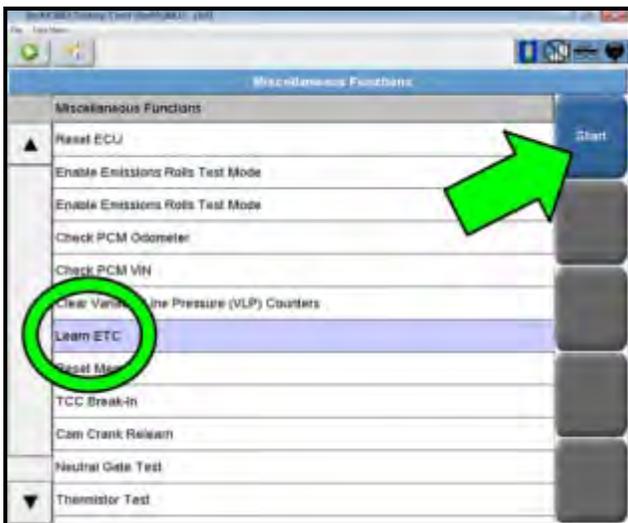
⇐ From the Miscellaneous Function screen, Highlight “Learn ETC” <circle>, then select “Start” <arrow> and follow on-screen instructions

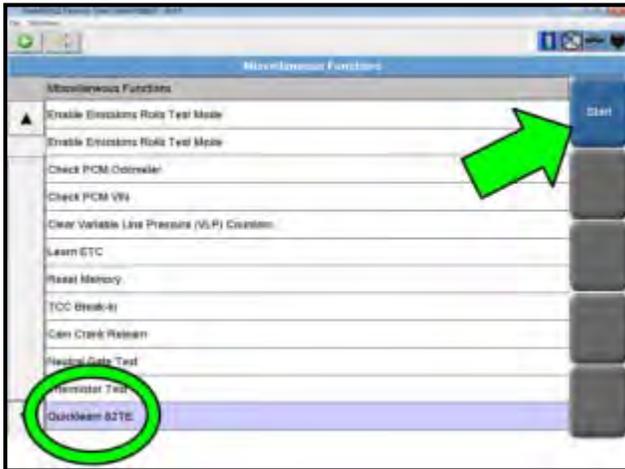
← From the Miscellaneous Functions screen, Highlight “Quicklearn 62TE” <circle>, then select “Start” <arrow> and follow on-screen instructions
