Technical Service Bulletin

01 A8 4.2 FSI, engine warning light on, DTC P010600 induction manifold pressure

24 12 11 2028445/1 January 25, 2012.

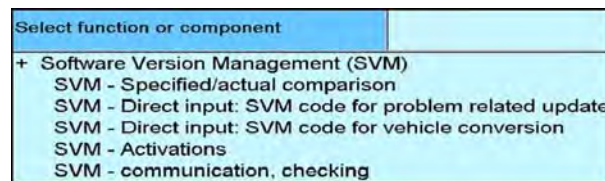
SVM is a function within GFF with the options illustrated in Figure 1 and explained below.

Figure 1. SVM options.
