Technical Service Bulletin

37 Gearbox warning light on, Fault P060B00 stored in TCM

37 12 35 2028405/1 January 26, 2012.

Model(s)	Year	VIN Range	Vehicle-Specific Equipment
Audi Q5	2010 – 2011	All	All with OBK Transmission
A4			
A4 Avant			
A5			
A5 Cabriolet

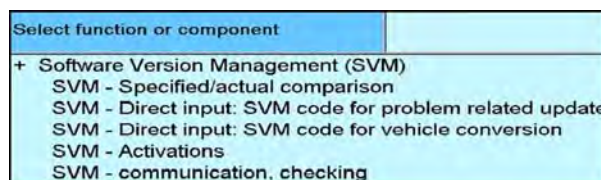
SVM is a function within GFF with the options illustrated in Figure 1 and explained below.

Figure 1. SVM options.
