**NUMBER: 290120011.01****MODEL: Karma****DATE: February 7, 2012****MODEL YEAR: 2012****TITLE: Baseline 614 Release Overview****PRIORITY:**

Flash reprogramming allows the ECU software to be updated without replacing the ECU. Flash calibration updates for specific vehicle models/ECUs are released as field-fix procedures described in individual service bulletins.

# SERVICE BULLETIN

FISKER AUTOMOTIVE, INC.

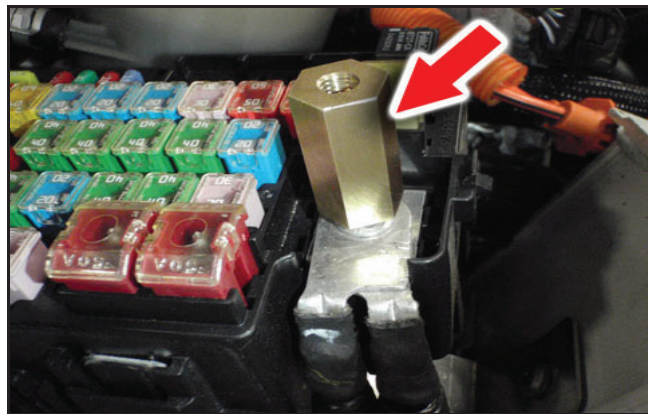
– For checking voltage, connect the positive lead of the Midtronics MDX series tester (or equivalent) to the B+ positive post at the Power Distribution Center (PDC) with Fisker Special Tool **FST9001 – Battery Charging Terminal Adaptor** (to be used for all electrical system testing and charging). Connect the – Negative lead to the Accessory Power Module (APM) ground terminal.

*FST9001 - Battery Charging Terminal Adaptor (red arrow) installed on the B+ post in the PDC.*

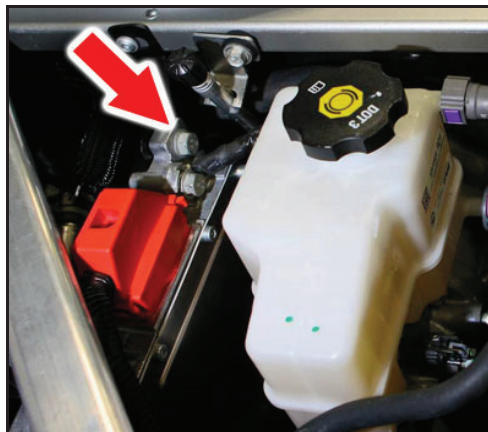
*Negative chassis ground (red arrow) location on Accessory Power Module (APM).*

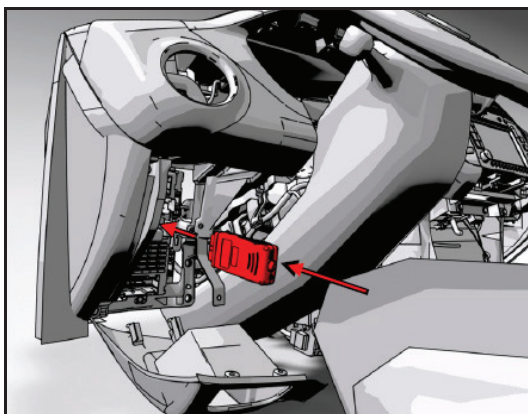
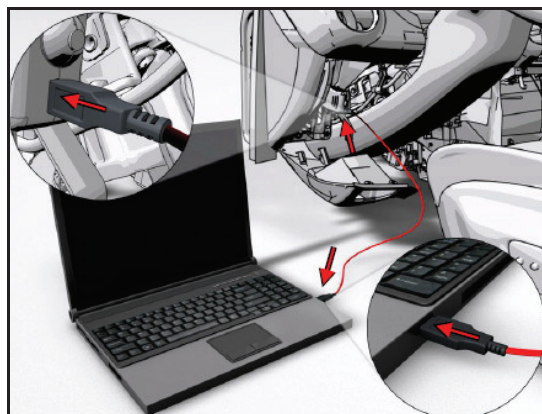
4a. Connect the WDI to the DLC – Data Link Connector located underneath the driver's side dash. Then connect the WDI to the Fisker laptop with the provided USB cable.

**NOTE:** The USB cable must be used when flashing and ECU.

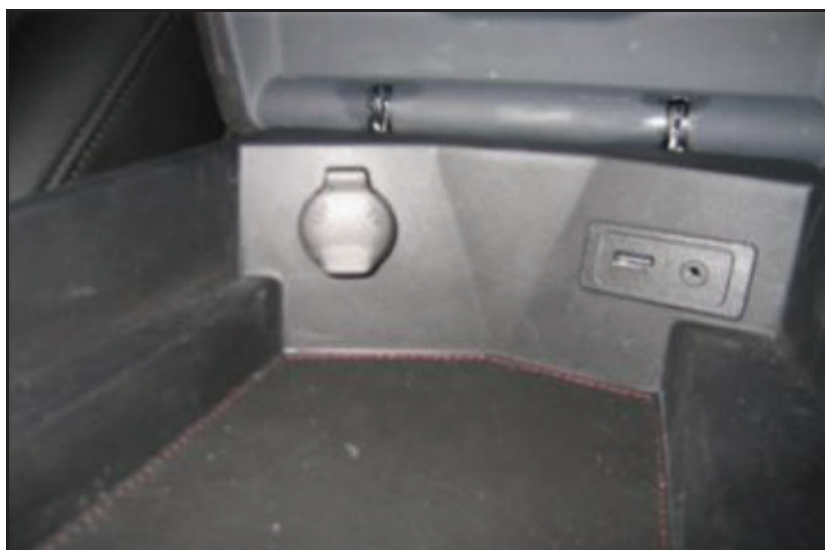
11a. Insert the USB flash drive into the center console USB port.

– If equipped with an LED, it should blink for a short period of time.

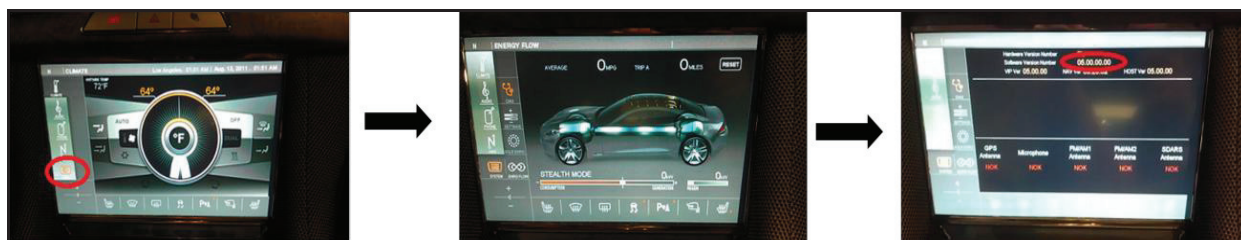
12c. Verify the CIU software version by pressing and holding the "System" button for 8 seconds.

- During the 8 second duration, the TPI will switch to the System Menu. Continue to hold the "System" button for the 8 second duration. When released, the TPI will display the diagnostic screen.

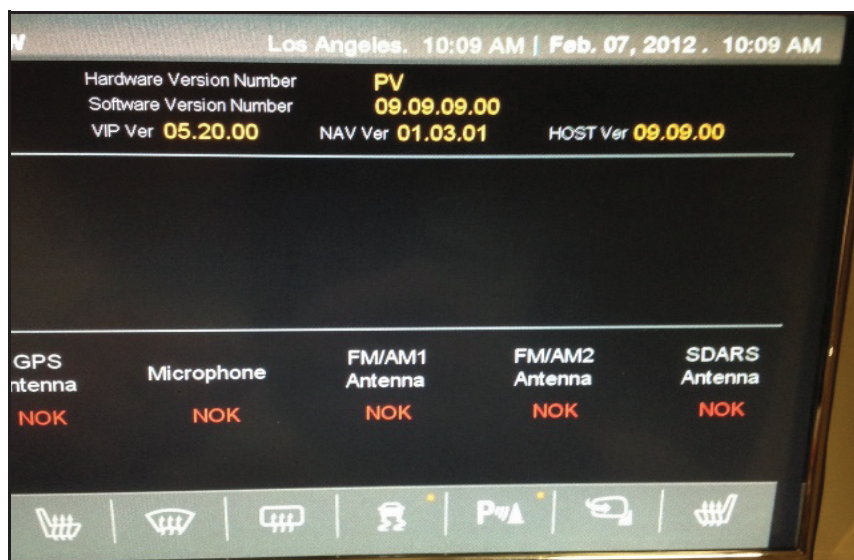
12d. Verify the CIU software number is in accordance with the latest release for BL614.

- Software Version Number: 09.09.09.00
- VIP Version 05.20.00
- NAV Version 01.03.01
- HOST Version: 09.09.00

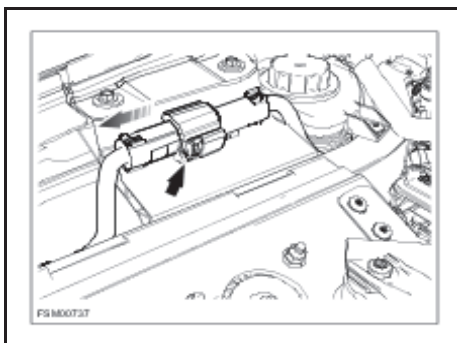
13b. Power down the vehicle. Open the hood and disconnect the 12 Volt battery via connector C104.

*12 Volt Battery Negative Connector C104*

13d. Reconnect the 12 Volt battery via connector C104 and install Fuse 27 (25 amps).
