Applies To: **2011–12 MDX with Navigation** – Check the iN VIN status for eligibility
2011–12 TSX with Navigation – Check the iN VIN status for eligibility
2012 ZDX with Navigation – Check the iN VIN status for eligibility

Product Update: CD or DVD (RES) Restarts When the Ignition Switch Is Turned OFF and ON

(Supersedes 11-032, dated December 15, 2011, to revise the information marked by the black bars)

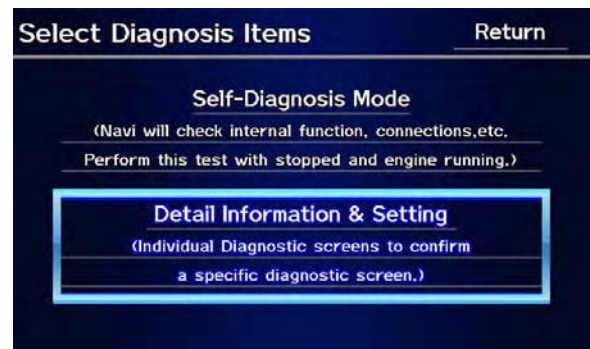
1. Start the engine.
2. Insert the update disc in the CD (upper) slot.
3. Enter the Diagnosis Mode by pressing and holding the **MENU**, **MAP/GUIDE**, and **CANCEL** buttons for about 5 seconds.
4. Select **Detail Information & Setting**.

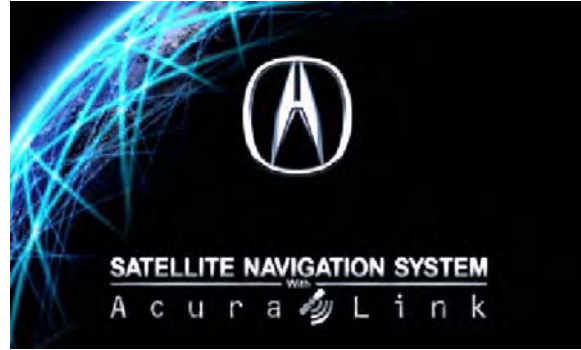
- Select **Download**. The system reboots and the update begins. It should take about 5 minutes.

- When the update is complete, the system reboots again. Wait for the system to completely reboot, then eject the update disc.

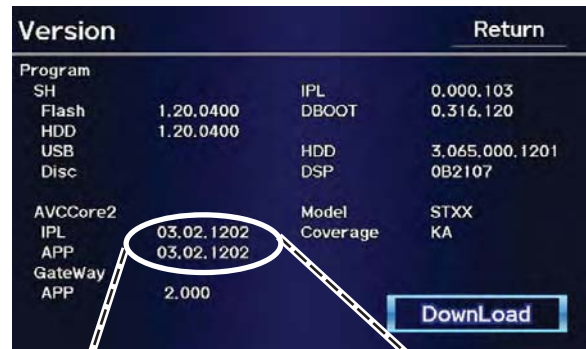
- Turn the ignition switch to LOCK (0) for 10 seconds.
- Start the engine.
- Enter the Diagnosis Mode. Select **Detail Information & Setting**, then select **Version**.
- Under AVCCore2, check the fourth digit of the IPL and the APP version numbers.
 - If it is still 1, turn the ignition switch to LOCK (0), then go to step 1, and repeat the update.
 - If it is now 2, turn the ignition switch to LOCK (0), then go to **CD Drive Update**.

XX.02.XXXX
XX.02.XXXX

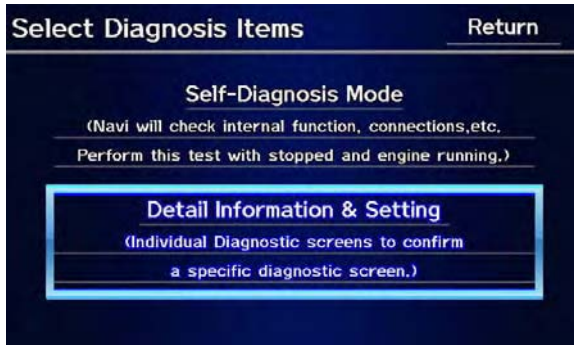
1. Start the engine.
2. Insert the update disc in the CD (upper) slot.
3. Enter the Diagnosis Mode by pressing and holding the **MENU**, **MAP/GUIDE**, and **CANCEL** buttons for about 5 seconds.
4. Select **Detail Information & Setting**.

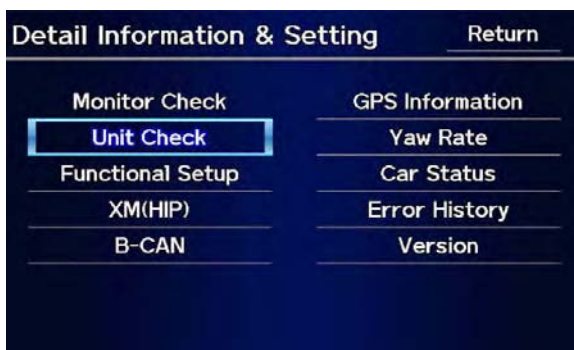
5. Select **Unit Check**.

NOTE: On some vehicles, you will have to go to screen 2 to select Unit Check.

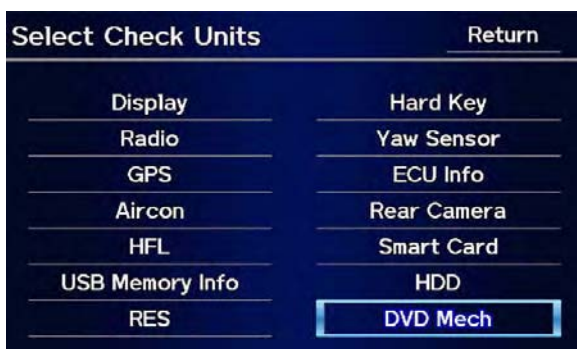
6. Select **DVD Mech**.

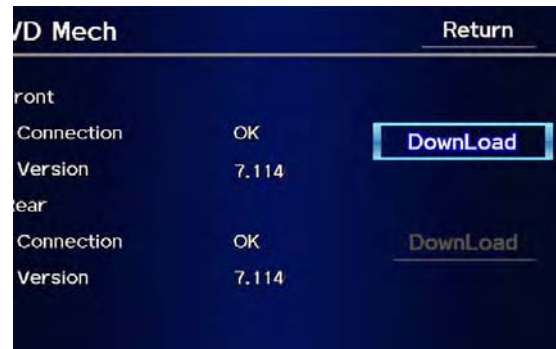
7. Select **Download** for the front mech.

NOTE: If the Download button is grayed out, select **Return**, then eject the disc. Stay on the Select Check Units Screen, then reinsert the update disc. Wait at least 20 seconds before selecting **DVD Mech**.

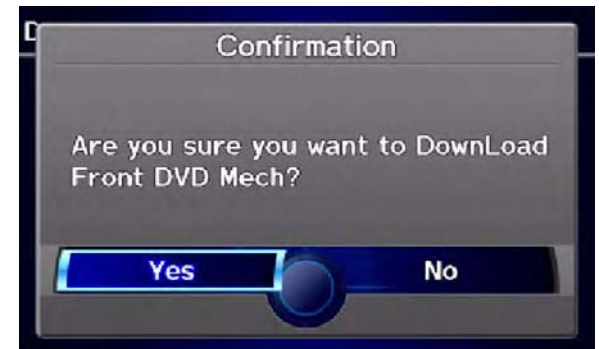
8. When the confirmation screen appears, select **Yes**, and the loading screen appears. The update takes about 5 minutes.

When the update is done, the system reboots.

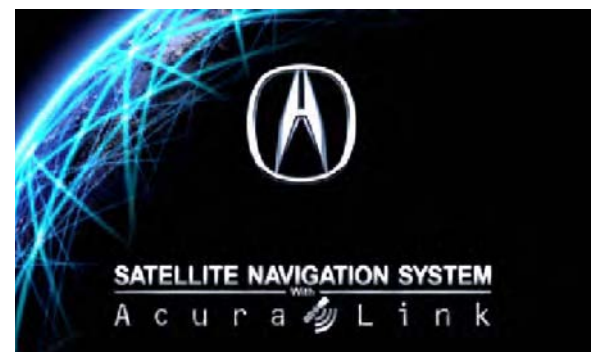
9. After the system reboots, eject the update disc.

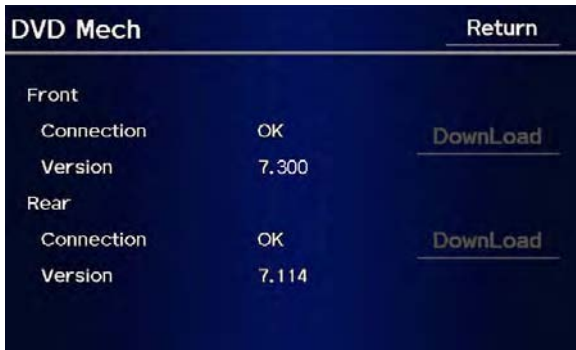
12. Enter the Diagnosis Mode. Select **Detail Information & Setting**, **Unit Check**, then select **DVD Mech**.

- Confirm that the front mech software version is **7.300**.

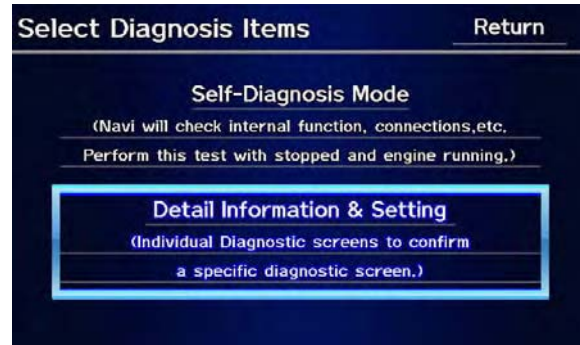
- Start the engine.
- Insert the update disc in the RES (lower) slot.
- Enter the Diagnosis Mode by pressing and holding the **MENU**, **MAP/GUIDE**, and **CANCEL** buttons for about 5 seconds.
- Select **Detail Information & Setting**

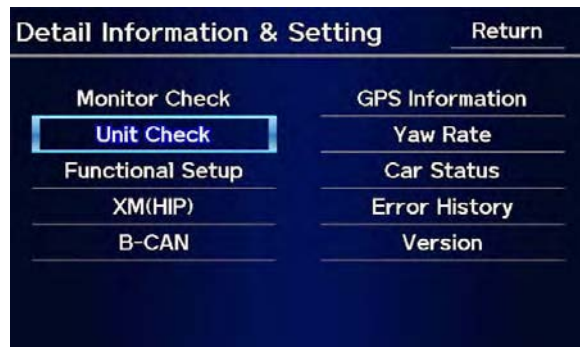
- Select **Unit Check**.

NOTE: On some vehicles, you will have to go to screen 2 to select Unit Check.

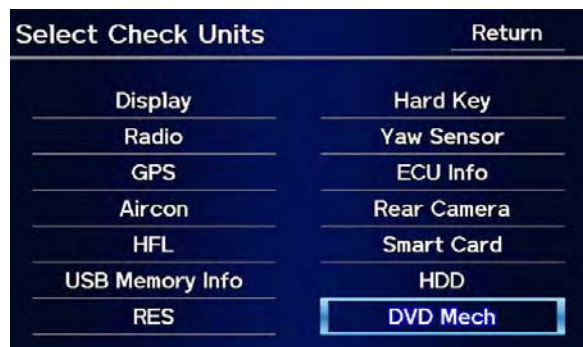
- Select **DVD Mech**.

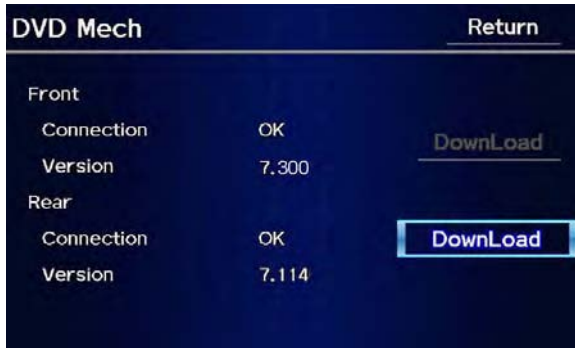
- Select **Download** for the rear mech.
NOTE: If the Download button is grayed out, select **Return**, then eject the disc. Stay on the Select Check Units Screen, then reinsert the update disc. Wait at least 20 seconds before selecting **DVD Mech**.

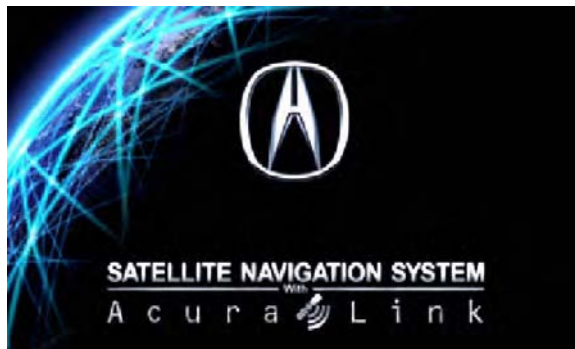
- After the system reboots, eject the update disc.

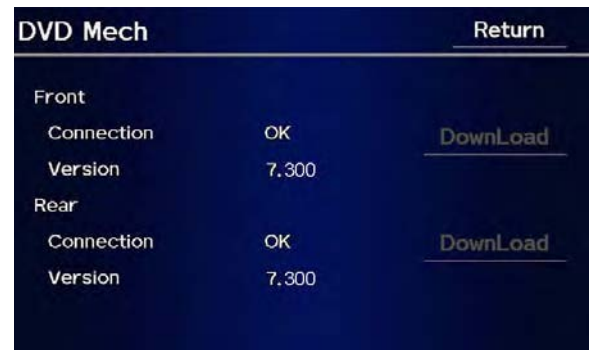
- Turn the ignition switch to LOCK (0) for 10 seconds.
- Start the engine.
- Enter the Diagnosis Mode. Select **Detail Information & Setting, Unit Check**, then select **DVD Mech**.

- Confirm that the rear mech software version is **7.300**.
