SB-10044130-2564

MODEL
2010/11MY Forte (TD)

TECHNICAL SERVICE BULLETIN

(EPS) ELECTRIC POWER STEERING ECM UPGRADE - DTC C1290

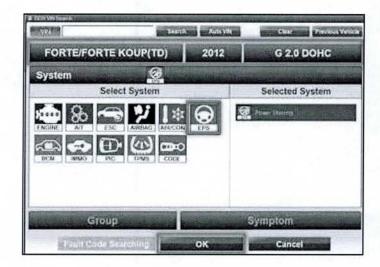
With the ignition key ON, turn ON the VCI and GDS tool. Access the GDS vehicle identification number (VIN) screen and configure the vehicle using the VIN Auto Detect function.

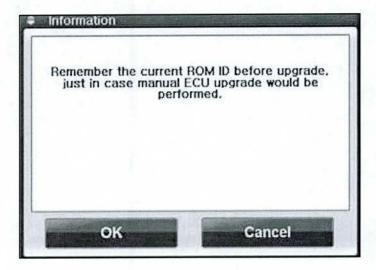
Once back at the GDS Main Screen, select ECU Upgrade from the bottom right-hand corner. Next select Auto Mode, and then EPS as the system. Perform the ECM upgrade in accordance with normal GDS tool ECM upgrade procedures.

Be sure to <u>record the ROM ID before</u> <u>performing EPS upgrade</u>, just in case manual ECM upgrade needs to be performed later on.

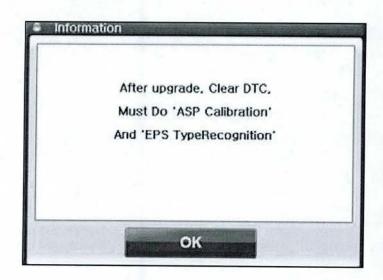
- When the GDS tool reports that the ECM upgrade has been successfully completed, click OK, turn OFF the ignition key, and wait at least 10 seconds before attempting to start the engine.
- After upgrade, clear any DTCs that are present, and then perform "ASP Calibration & EPS Type Recognition."

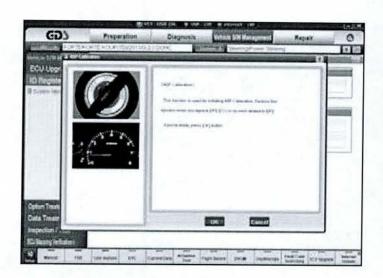
Select "Vehicle S/W Management" and then "ASP Calibration," then click OK.

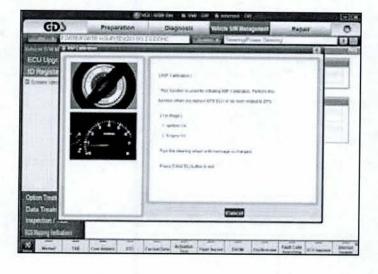
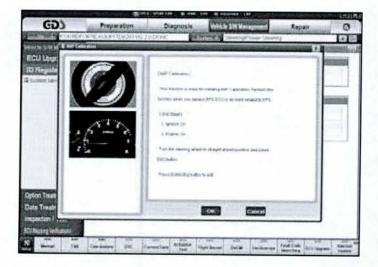
When the message box appears (text below), turn the steering wheel until message is changed.

Turn steering wheel until message is changed. Press [CANCEL] button to exit.

Turn the steering wheel to straight ahead position, and then click OK.

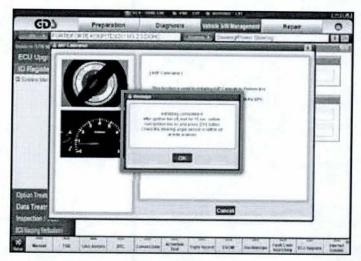
When the calibration is completed, "initializing completion" message will be displayed on the screen.

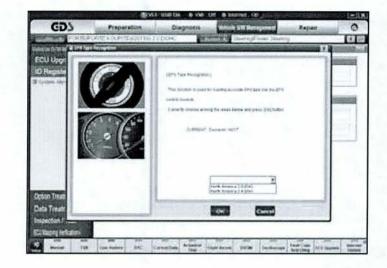
Select "Vehicle S/W Management," and then "EPS Type Recognition."

Confirm vehicle type, and then click OK.

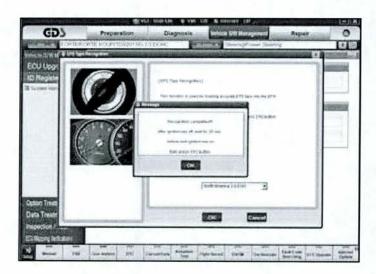
When the EPS Type Recognition is completed, a message box will be displayed, and then click OK.
