HYUNDAI NEW THINKING. NEW POSSIBILITIES. Technical Service Bulletin	GROUP FUEL SYSTEM	MODEL ACCENT (RB)
	DATE MARCH 2012	NUMBER 12-FL-002
SUBJECT ECM UPDATE – MIL ON DTC P0128/P0191/P061B/P2188

This bulletin provides information related to the ECM software update of some 1.6L vehicles that may experience any of the following DTC:

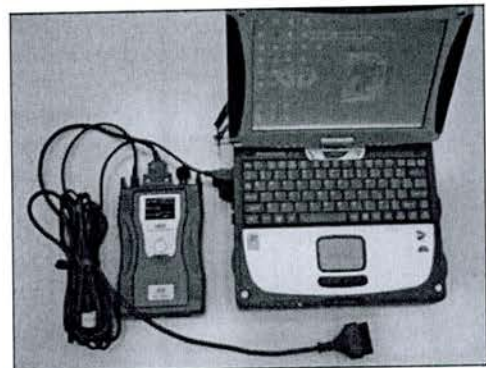
- Connect the USB cable between the GDS and the VCI.
- Connect the 16-pin DLC connector from the VCI into the DLC located under the driver's side dash.
