AT12-003b

## 2009 - 2012 G37; SHIFT RESPONSIVENESS ISSUES

**APPLIED VEHICLES:** 2009 – 2011 G37 Sedan and Coupe (V36/CV36)  
 2009 – 2012 Convertible (HV36)  
**APPLIED ENGINE:** VQ37VHR  
**APPLIED TRANSMISSION:** 7 speed

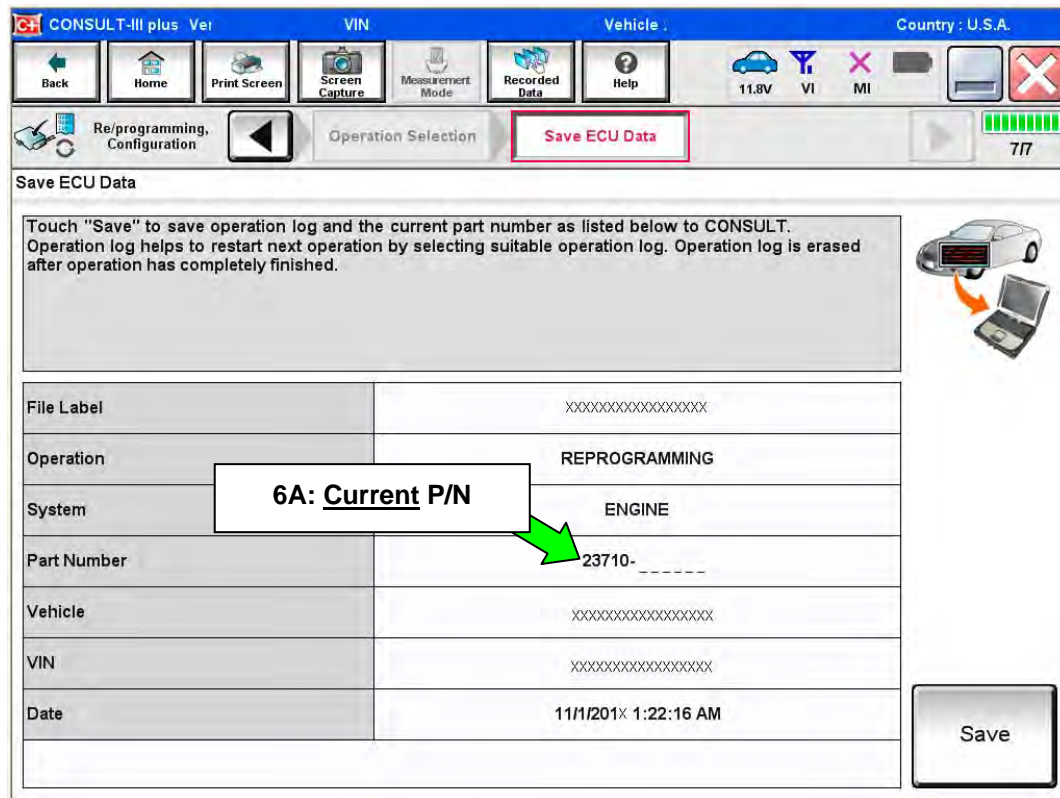
6. When you get to the screen shown in Figure 2, confirm this bulletin applies as follows:
  - A. Find the ECM or TCM **Part Number** and write it on the repair order.

**NOTE:** This is the current ECM or TCM Part Number (P/N).

Re/programming, Configuration Operation Selection **Save ECU Data** 7/7

Touch "Save" to save operation log and the current part number as listed below to CONSULT. Operation log helps to restart next operation by selecting suitable operation log. Operation log is erased after operation has completely finished.

File Label	XXXXXXXXXXXXXXXXXX
Operation	REPROGRAMMING
System	ENGINE
Part Number	23710- _____
Vehicle	XXXXXXXXXXXXXXXXXX
VIN	XXXXXXXXXXXXXXXXXX
Date	11/1/201X 1:22:16 AM

5. Follow the on-screen instructions and navigate the C-III plus to the screen shown in Figure 2 on the next page.

- B. Compare the P/N you wrote down to the numbers in the **Current ECM Part Number** column in **Table A** on page 5 and 6, and **TCM Part Number** column in **Table B** on page 7.
  - If there is a match, this bulletin applies. Continue with the reprogramming procedure.
  - If there is not a match, reprogramming does not apply. Make sure to check both ECM and TCM for a match.

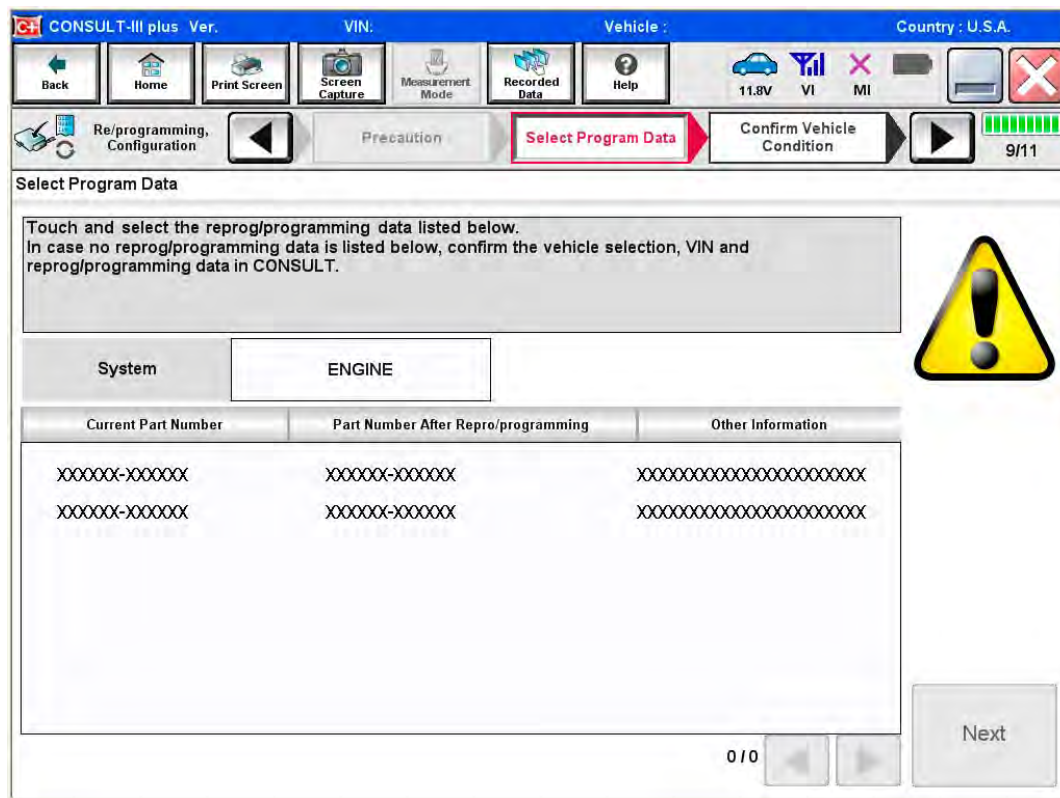
- In some cases, more than one new P/N for reprogramming is available.
  - In this case, the screen in Figure 3 displays.
  - Select and use the reprogramming option that **does not** have the message "Caution! Use ONLY with ITBXX-XXX".
- If you get this screen and it is **blank** (no reprogramming listed), it means there is no reprogramming available for this vehicle.

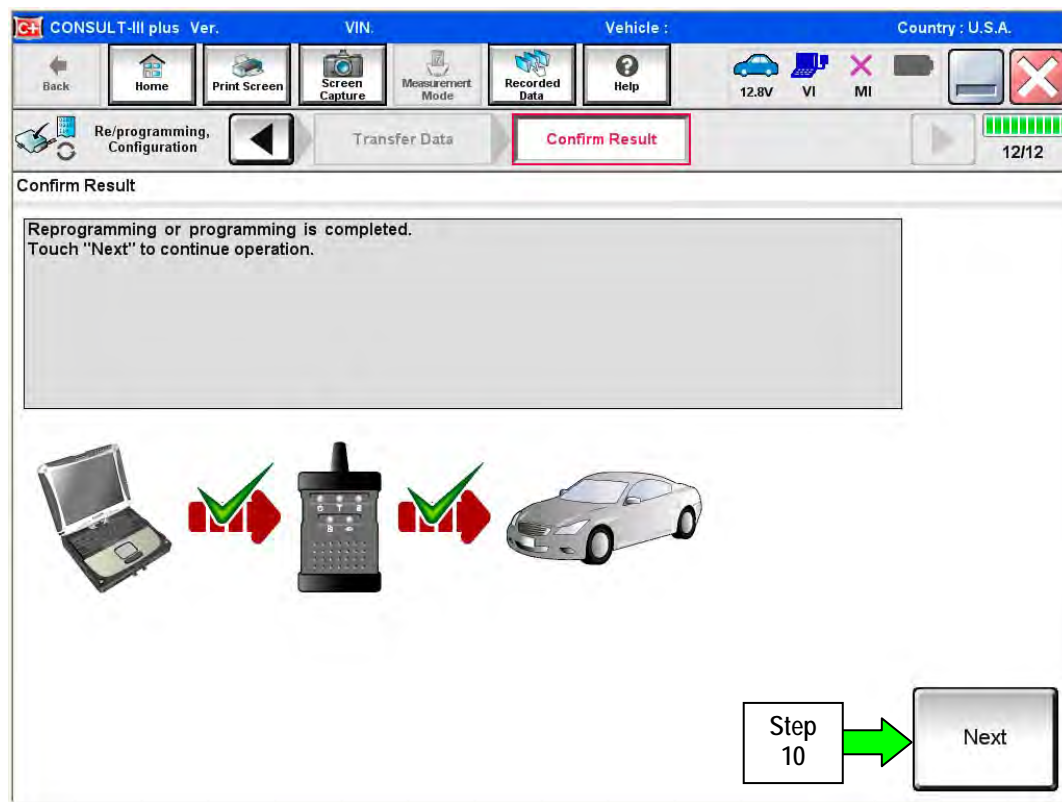
8. When the screen in Figure 4 displays, reprogramming is complete.

**NOTE:** If the screen in Figure 4 does not display (reprogramming does not complete), refer to the information on the next page.

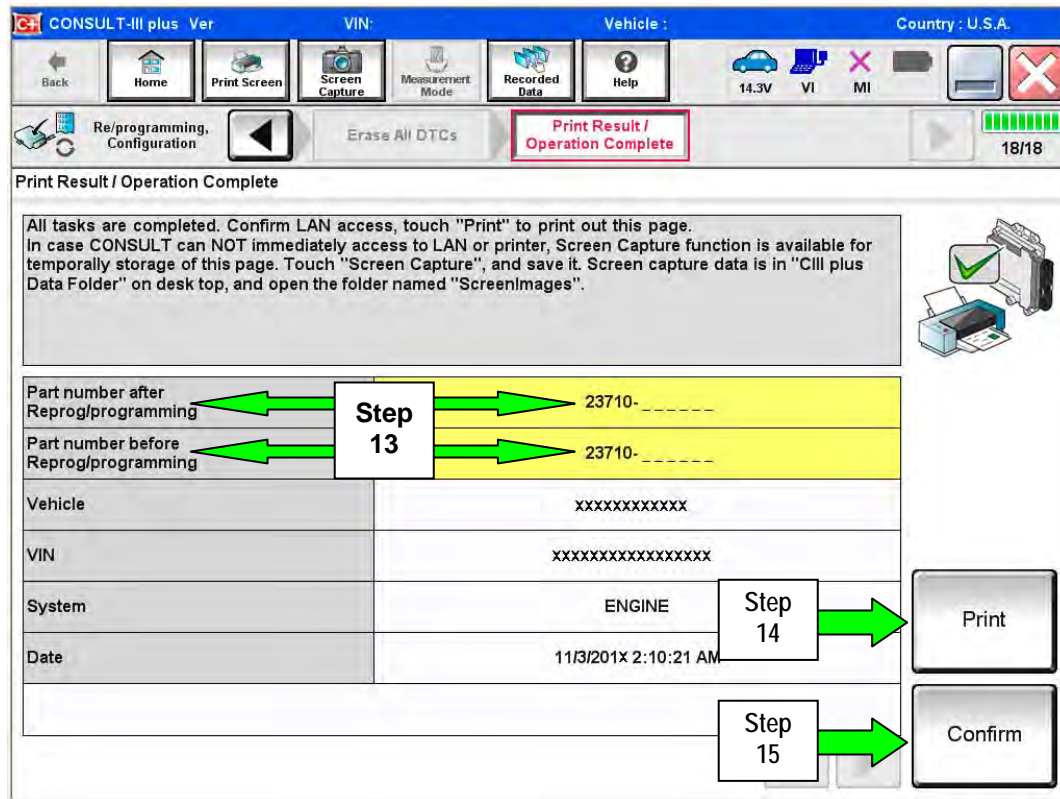
12. When the entire reprogramming process is complete, the screen in Figure 7 will display.
13. Verify the before and after part numbers are different.
14. Print a copy of this screen (Figure 7) and attach it to the repair order for warranty documentation.
15. Select **Confirm**.
